# ARBORICULTURAL IMPACT ASSESSMENT REPORT

relating to the proposed inclinor at

**106 PRINCE ALFRED PARADE  
NEWPORT NSW 2106**

22 November 2023  
Revision A

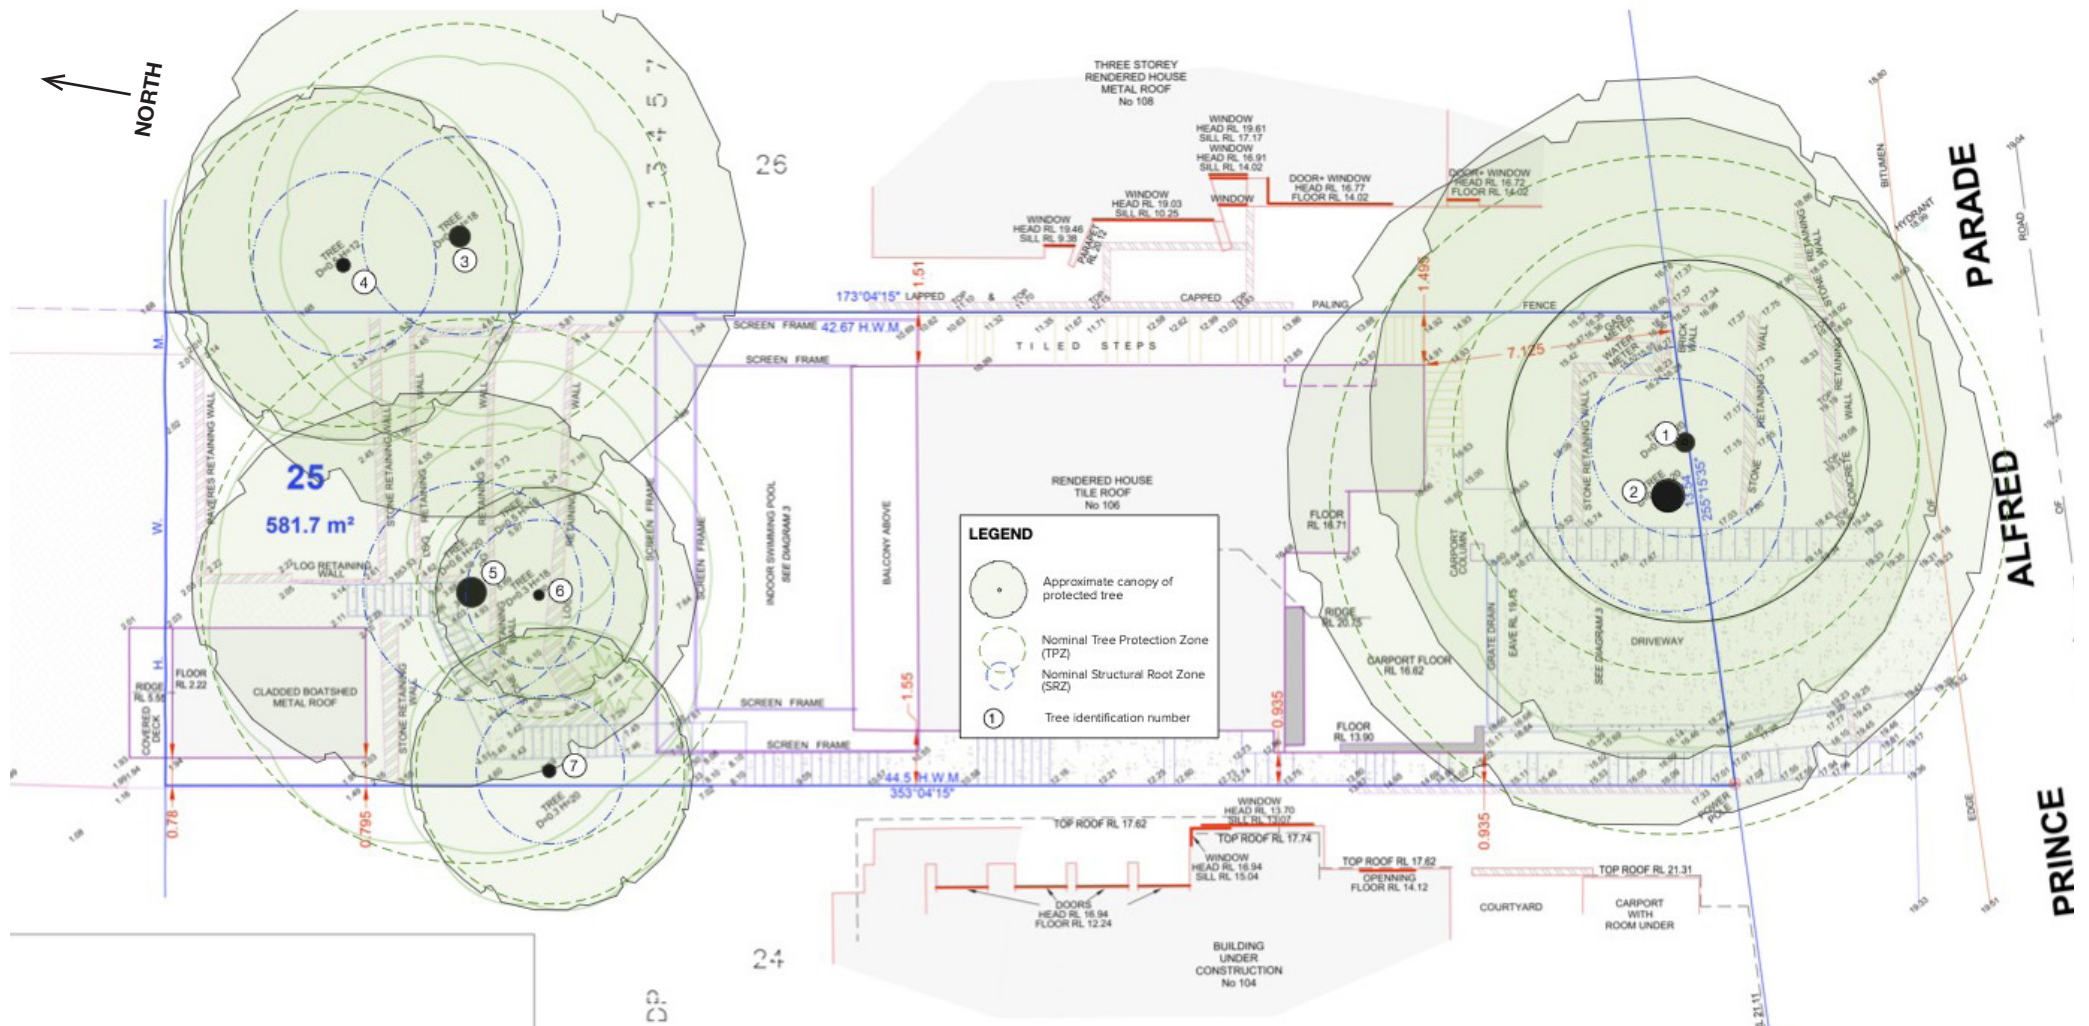
Figure 3: Tree Location Plan showing the existing trees located on the site using the survey plan as a base layer. Note, do not measure from drawings.
