| Address of site | <u>179 PLATEAU ROAD BILGOLA PLATEAU</u> |

**RISK ANALYSIS & MANAGEMENT  
FOR  
PROPOSED ALTERATIONS, ADDITIONS AND SECONDARY  
DWELLING  
AT  
179 PLATEAU ROAD BILGOLA PLATEAU**

MQ 30164

25<sup>th</sup> October, 2016

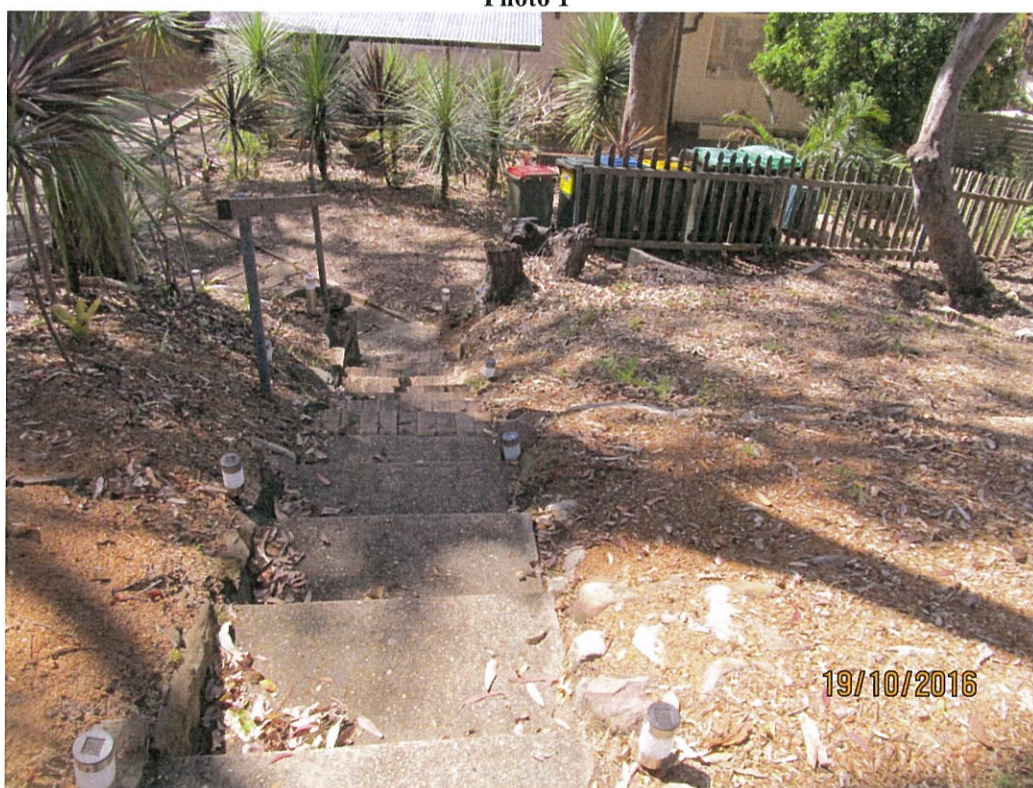
Photo 1

3.3 From the road frontage a short concrete vehicle crossing provides access to a long moderately sloping driveway which terminates in a single vehicle hardstand (Photo 1). Pedestrian access to the residence is via a paved moderately sloping footpath which terminates at the front of the residence (Photo 2). A largely open, terraced garden is located at the front of the block. These terraces are supported by stable non engineered mortared sandstone, brick and masonry structures (Photos 3 & 4). A paved patio area is located in a cut at the front of the house. The cut is supported by a stable well-constructed timber wall (Photo 5). Pedestrian access to the rear of the property is via an access corridor on the southern boundary of the block (Photo 6). A series of terraces are located at the rear of the house (Photo 7). The upper most terrace is supported by a partially dilapidated masonry block wall which shows signs of movement (Photos 8 & 9). At the time of inspection it appeared stable however we recommend that the wall be periodically monitored for further movement or instability. Should further movement be detected, we recommend a structural engineer or licenced builder be consulted to discuss potential remediation works. A small paved patio area is located on the middle terrace which is supported by stable timber soldier pile walls (Photo 10). A small timber deck is located on the lower most terrace which is supported by stable timber piers and a timber soldier pile wall (Photo 7).
