### **NEW ‘*Amending Development Application*’ Submission**

## ***Construction Impact & Management Statement***

**October 2020**

| <b>Site:</b> | <b>Lot 41 in DP 22361<br/>7 Ruskin Rowe<br/>AVALON BEACH, NSW</b> |

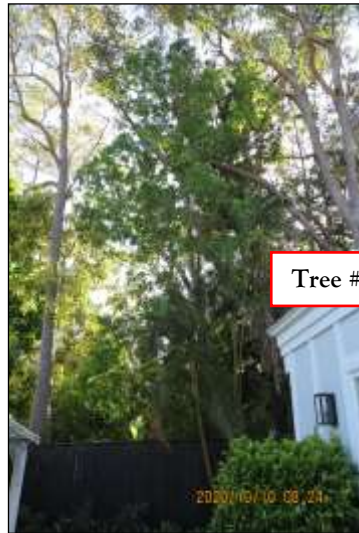
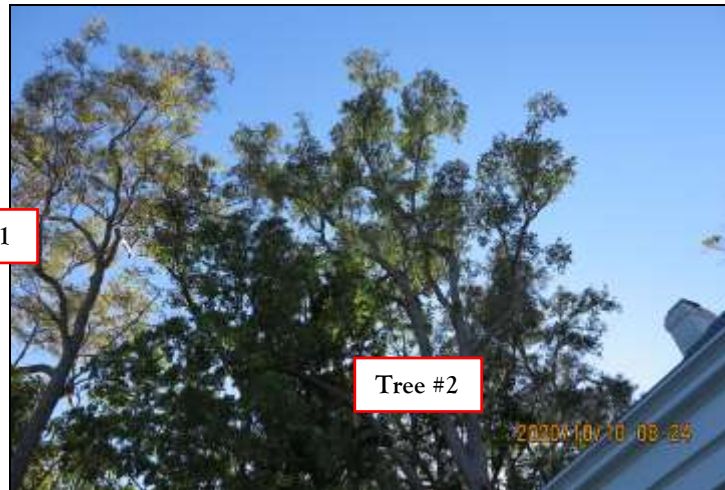
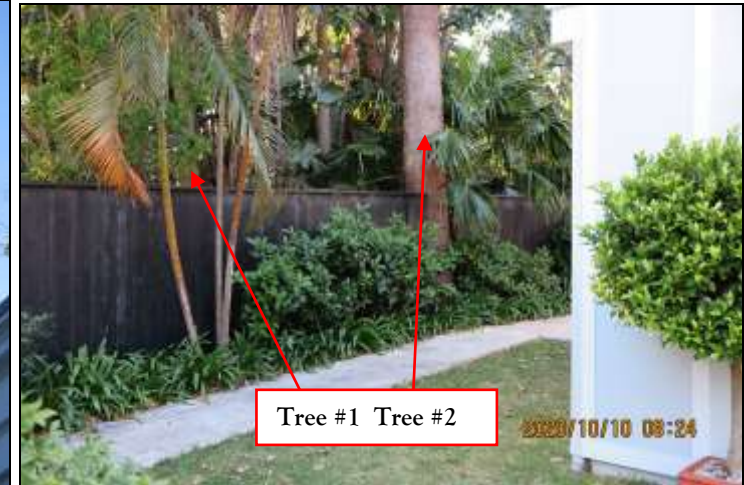
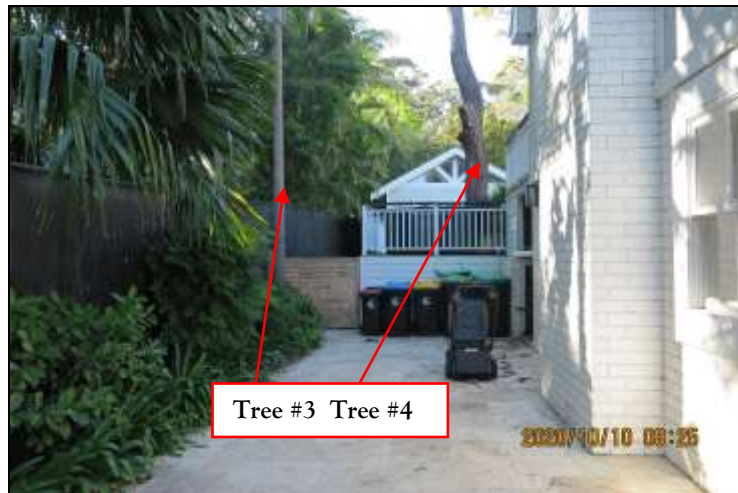
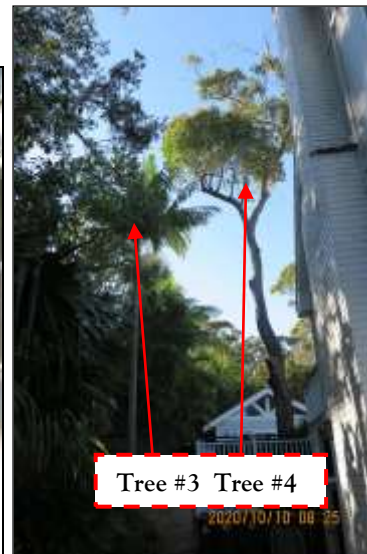
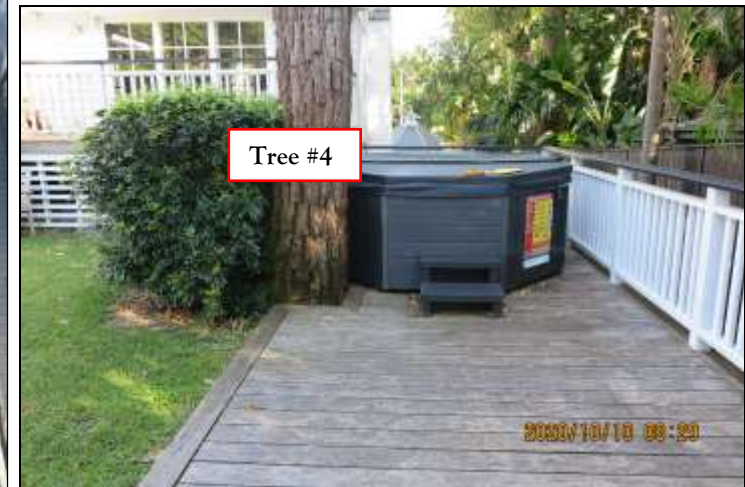
Figure 7; Illustrates tree locations & canopies as viewed from onsite on Saturday, 10 October 2020

| | Identification | Height (m) | Crown (m) | DBH (m) | TPZ (m) | SRZ (m) | Age | Health/Vigour | Structure | Significance/Retention Values | Comments |
|---|--|---|---|---|---|---|---|---|---|---|---|
| 4 | <i>Eucalyptus paniculata</i><br>Grey Ironbark | <18.00 | <13.50 | 0.57 | 6.84 | 2.81 | Over Mature | Poor & Poor | Atypical | High/Low | Replace:<br>Tree displays advanced 'symptoms of stress' & 'decline'. Canopy is almost totally 'epicormic'. Tree has been previously subjected to significant 'change of environment', hence its poor condition. |

Tree #4 is a NBC Tree Management' provisions protected tree (in fact locally indigenous), but is supported to be replaced on the grounds of declining health & vigour, likely most attributable to previous owners 'change of environment within both its TPZ (Tree Protection Zone) & SRZ (Structural Root Zone) calculated radial distances. Tree #4 is supported to be replaced by at least one (1) same species new tree/s in a more suitable location with the potential of replicating/improving the high level of amenity it previously provided as a healthy/vigorous individual. See below photograph confirming very significant 'branch tip dieback', interpreted to be an indicator or 'live root dysfunction' & nearly 100% 'epicormic shoot' by origin foliage.
