Report Title: Geotechnical Report 73 Dolphin Crescent, Avalon

Report Date: 3/5/23

## **GEOTECHNICAL INVESTIGATION:**

Alterations and Additions at **73 Dolphin Crescent, Avalon**

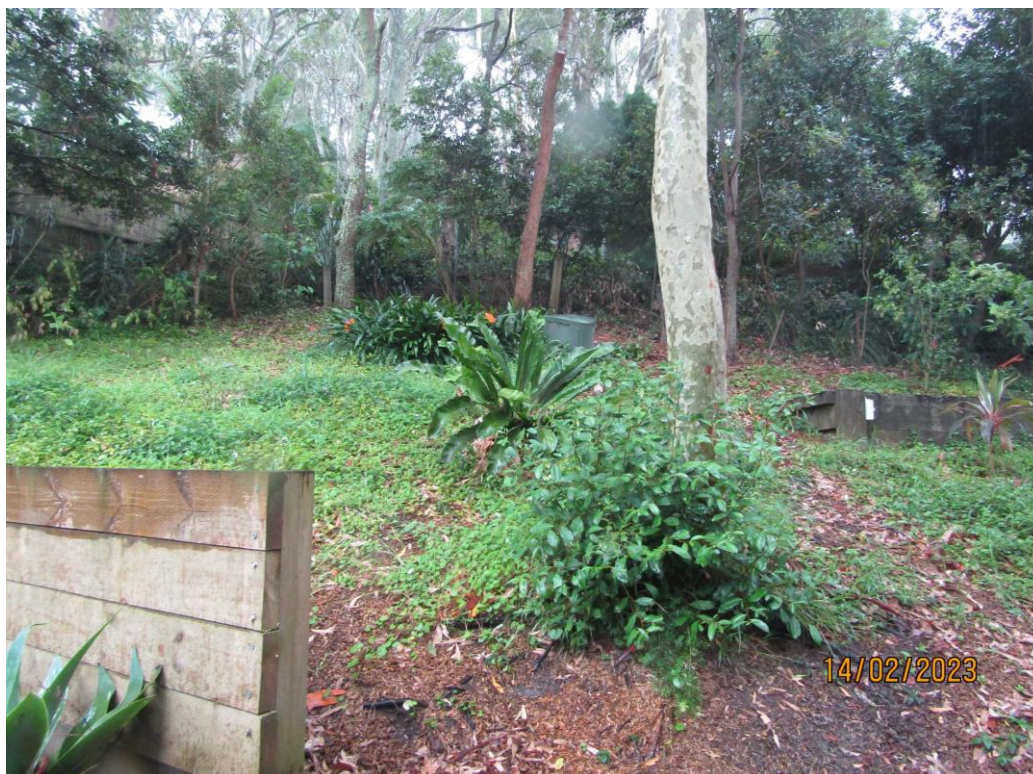
Photo 8

## AUGER HOLE 1 (~RL41.6) – AH1 (Photo 8)

The tilting timber retaining walls (Photo 8) are to be monitored by the owners on an annual basis or after heavy and prolonged rainfall events, whichever occurs first. A photographic record of these inspections is to be kept. Should further movement occur the walls are to be remediated or rebuilt so that they meet current engineering standards. We can carry out these inspections upon request.
