REPORT ON GEOTECHNICAL INVESTIGATION

PROPOSED ALTERATIONS AND ADDITIONS

6 -7 KARA CRESCENT, BAYVIEW, NSW

Project No.: 2023-081

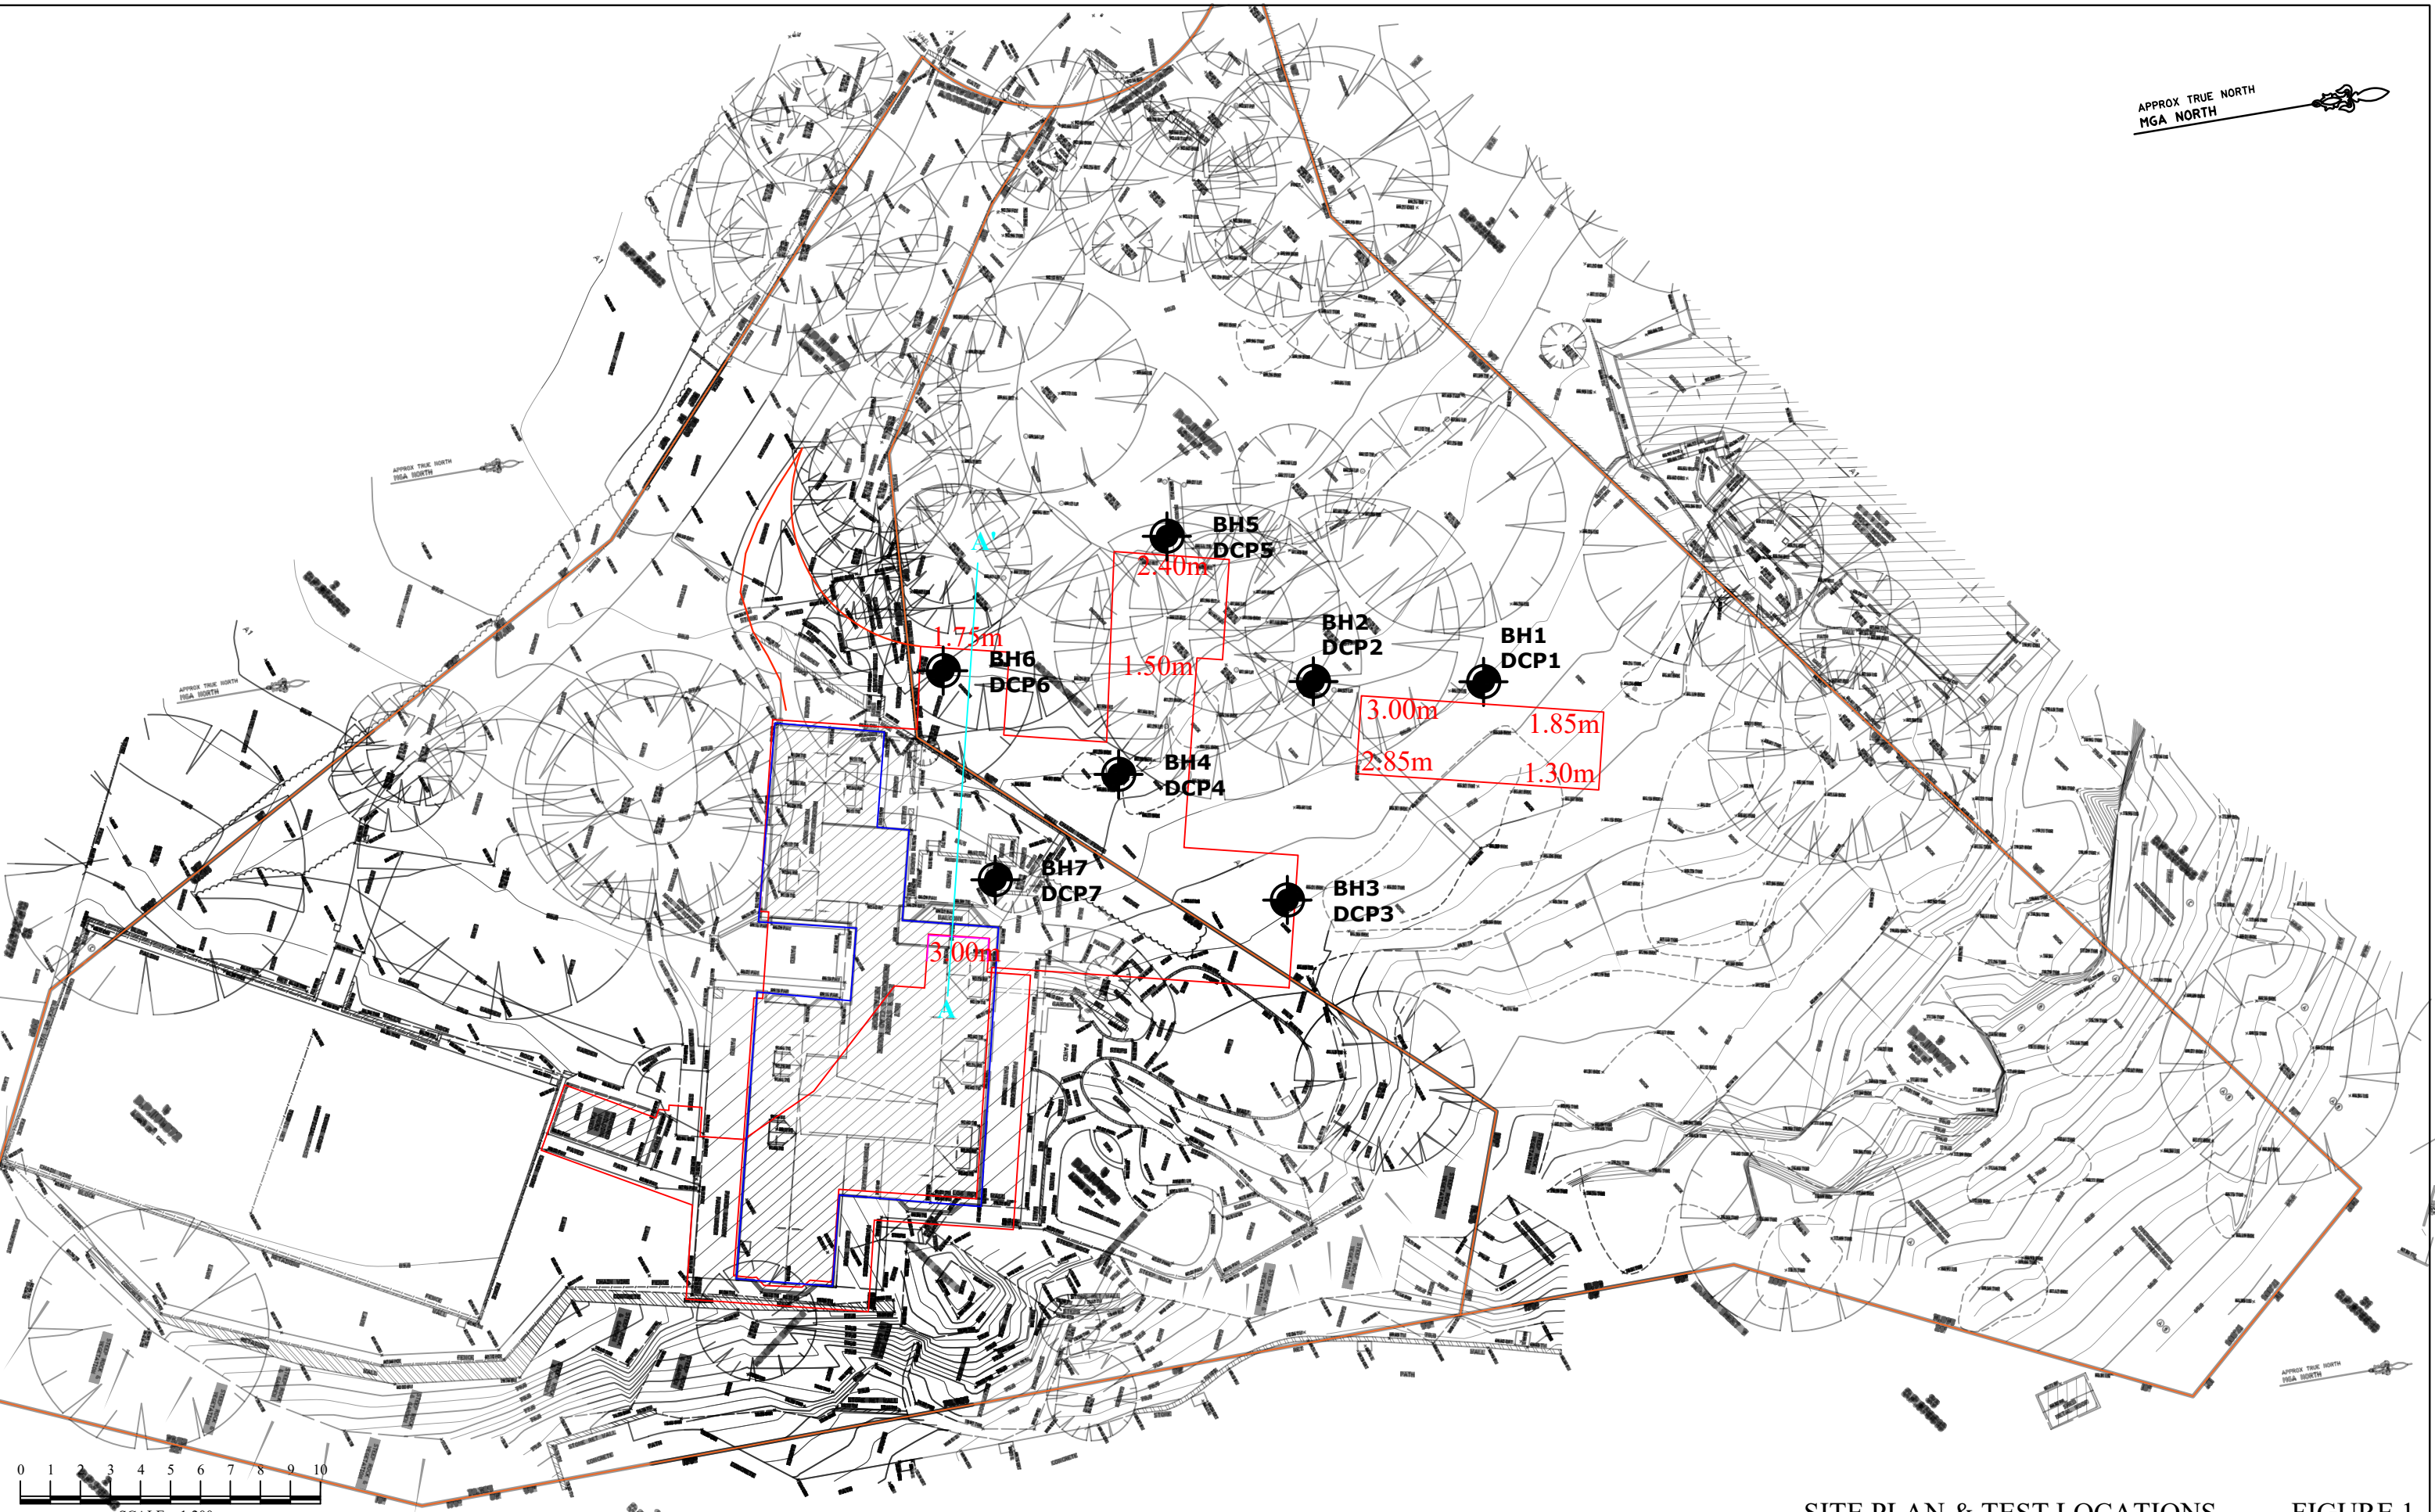
SITE PLAN & TEST LOCATIONS FIGURE 1.

Explanatory notes are included in Appendix: 1. Mapping information and test locations are shown on Figure: 1, along with detailed Borehole Log sheets and Dynamic Penetrometer Test Sheet in Appendix: 2. A geological model/section is provided as Figure: 2, Appendix: 2.
