Report Title: Geotechnical Report 52 Hilltop Road, Avalon

Report Date: 4/9/23

Alterations and Additions at **52 Hilltop Road, Avalon**

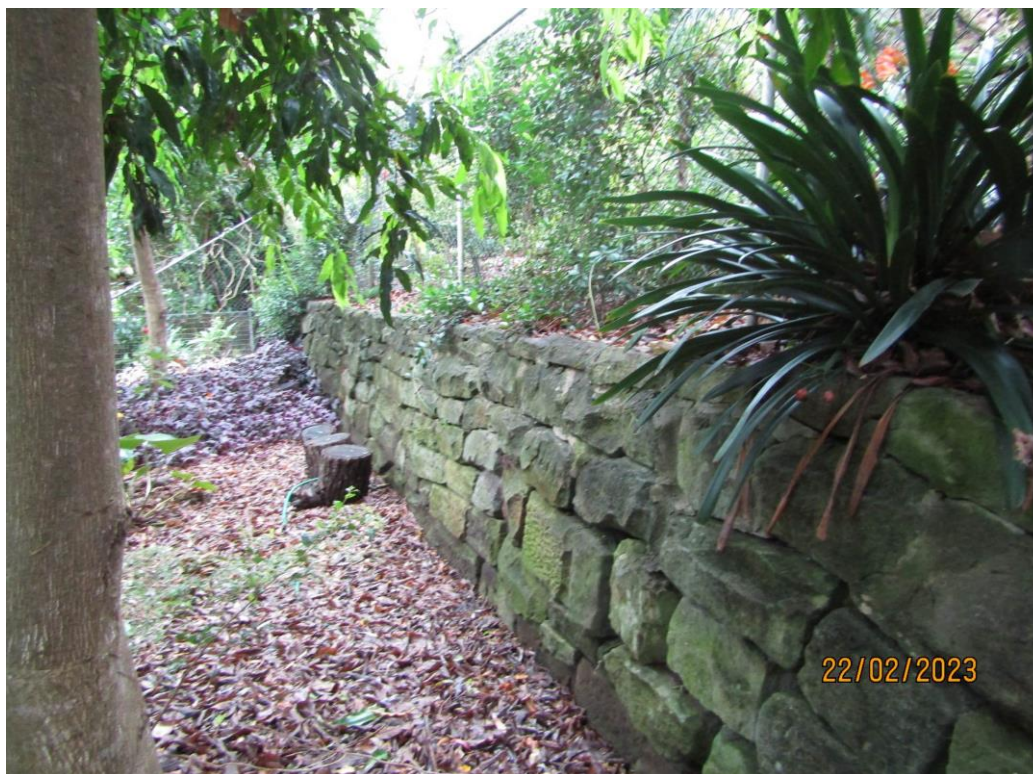
Photo 3

**2.3** At the road frontage, a concrete driveway runs down the slope to a garage on the lower ground floor of the house (Photos 1 & 2). A stable stack rock retaining wall up to  $\sim 1.5$ m high supports a fill for the road reserve and a cut for a garden area on the subject property (Photo 3). Between the road reserve and the house are gently sloping lawn and garden areas (Photos 4 & 5). Stable low stack rock retaining walls support cuts and fills for the lawn/garden areas and a cut for the house. The part two storey rendered masonry house is supported by masonry walls and brick piers (Photos 5 & 6). The external supporting walls show no significant signs of movement. The supporting piers stand vertical (Photo 7).

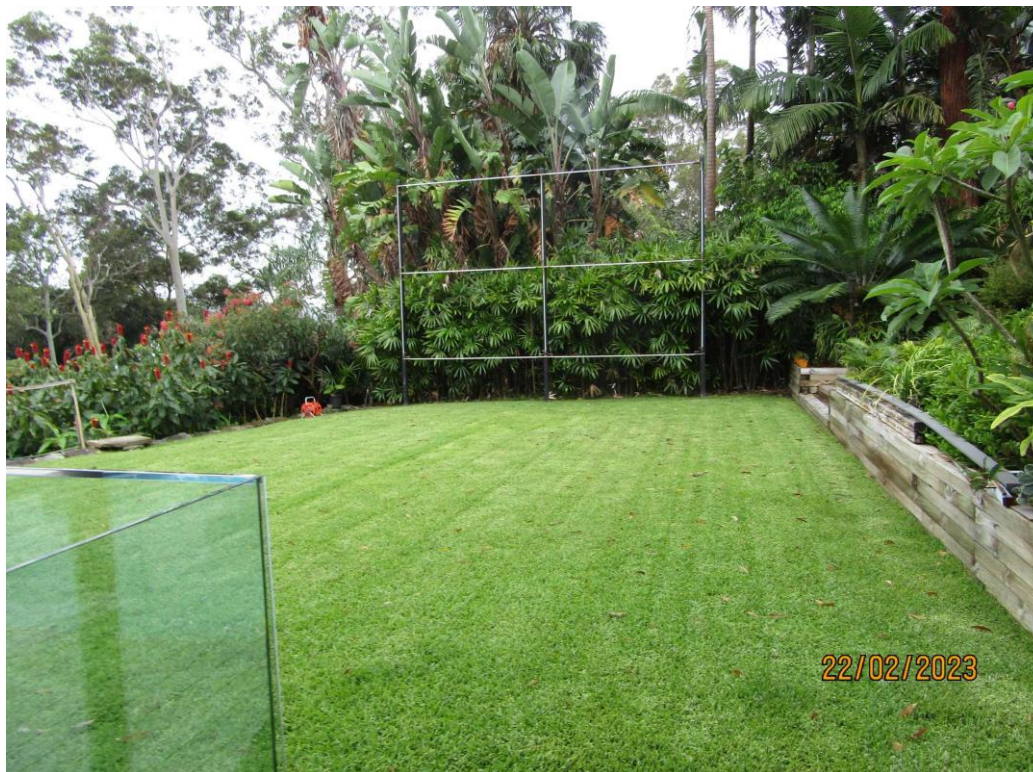
Photo 9

A pool that shows no significant signs of movement is located on the downhill side of the house (Photo 8). Fill provides level platforms for lawn and garden areas beside and downhill of the pool (Photo 9). The fills are supported by stack rock and timber retaining walls up to  $\sim 1.5$ m high (Photos 10 & 11). The timber posts that support timber retaining walls on the SW side of the pool (Photo 12) are tilting downslope slightly, but due to their low height and location, they are not considered a significant threat to life or property. Other lawn and garden areas extend from the downhill side of the retaining walls to the downhill property boundary (Photos 13 & 14). A pathway
