## **GEOTECHNICAL INVESTIGATION:**

### **Alterations and Additions at 108 Cabarita Road, Avalon Beach**

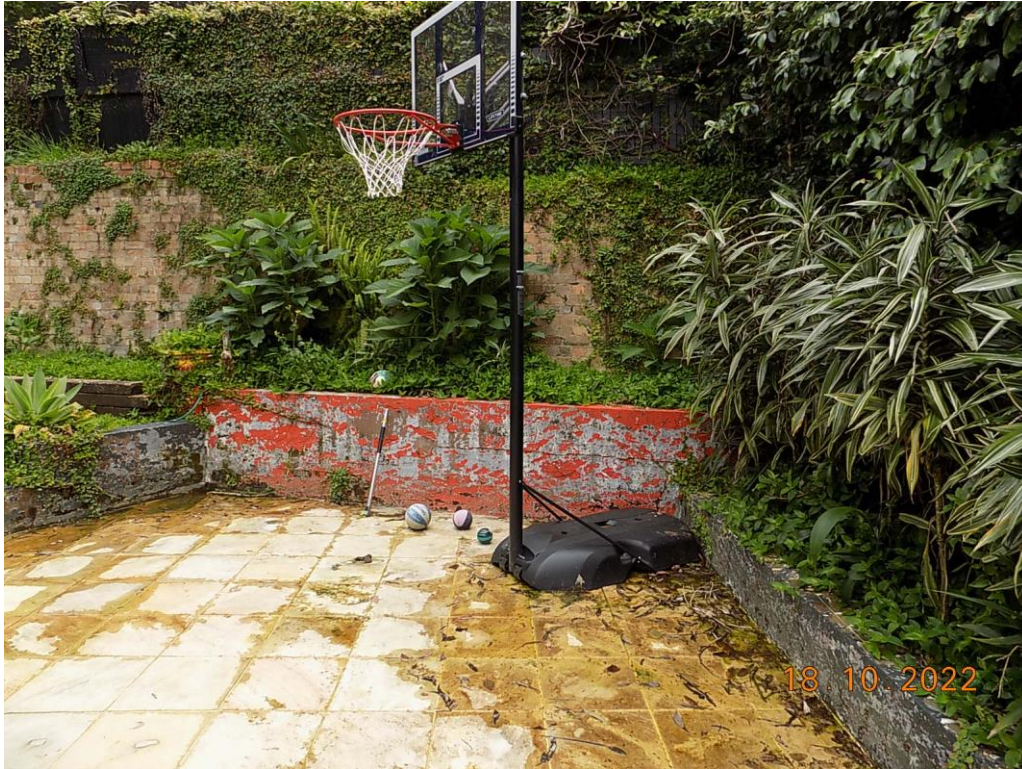
Photo 2

- 2.3** A brick retaining wall ~2.1m high is located along the uphill property boundary that supports the fill for the road reserve and a cut for lawn and garden area on the subject property (Photo 1). Stepped cracking was observed in the mortar between the bricks of the wall (Photo 2). **See Section 12** for recommendations regarding this wall. Low brick and rendered masonry retaining walls support cuts for level paved and lawn/garden areas on the uphill side of the house (Photo 3). A cut has been made in the slope to create a level platform for the S corner of the house. This cut is supported

Stepped cracking was observed in the mortar between the bricks of the walls supporting the fill and cut on the uphill side of the property (Photo 2). To be prudent, we recommend the retaining walls be inspected by the owners on a biannual basis or after heavy prolonged rainfall, whichever occurs first, keeping a photographic record of the inspections. We can carry out these inspections upon request. Should any new movement be observed, the geotechnical consultant is to be engaged to assess the movement and provide remedial advice if necessary.

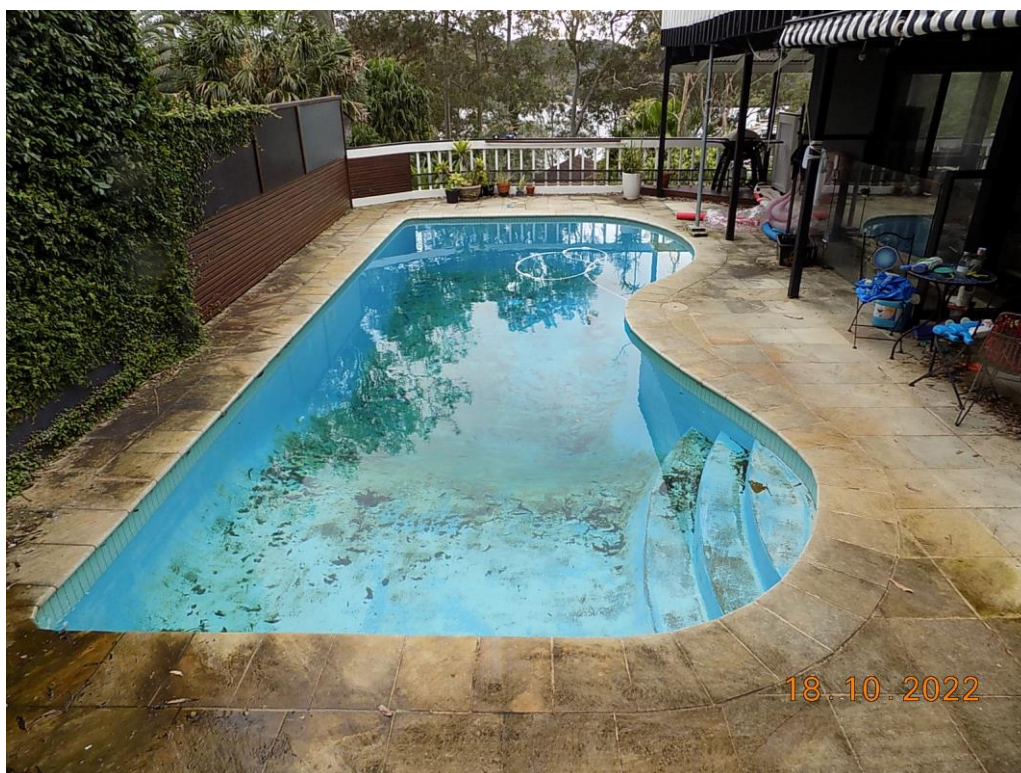
Photo 5

by a stable stack rock wall ~1.0m high (Photo 4). The part three-storey house is supported on brick walls and brick piers (Photo 5). The walls and piers appear to stand vertical and show no signs of deflection. An excavation has been made under the house for the lower floor (Photo 5). The cut has been taken entirely through competent sandstone bedrock and displays no signs of geological defects. This is expected to be a band of sandstone in an otherwise shale dominated profile. On the N side of the house is a pool (Photo 6). The water level of the pool indicates no ground movement has occurred in the shell of the pool since its construction. A partially suspended concrete driveway in the NE corner of the property is accessed by a Right of Carriageway (ROW) off Cabarita Road and runs up the slope to a garage on the lower ground floor of the house (Photo 7). The concrete columns supporting the downhill side of the driveway appear to stand vertical (Photo 8). On the downhill side of the driveway, the slope falls steeply to the E corner of the property (Photo 9). This slope is densely vegetated. Immediately underneath the driveway is an exposed fill batter (Photo 10). The slope is partially terraced on the S side of the slope. The terraces are supported by a series of timber retaining walls ~1.0m high (Photo 11). The walls were observed to be tilting downslope at a maximum angle of ~5°. The owner has informed us that the exposed batter and retaining walls will be replaced in the future. We recommend this be carried out within 2 years of the date of this report.

The slope materials are colluvial at the near surface and residual at depth. In the test locations, the ground materials consist of fill, topsoil and clayey soil over firm to stiff sandy clays. Sandstone bedrock is exposed under the house (Photo 5). This is expected to be a band of sandstone in an otherwise shale dominated profile. In the test locations, the depth to weathered rock ranged from ~1.7m to ~2.2m below the current surface. The weathered zone of the underlying rock is interpreted as Very Low to Low Strength. It is to be noted that this material is a soft rock and can appear as a mottled stiff clay when it is cut up by excavation equipment. See Type Section attached for a diagrammatical representation of the expected ground materials.
