GEOTECHNICAL REPORT

REMEDIATION DESIGN

60 ALEXANDER STREET, COLLAROY

Project No.: 2020-097

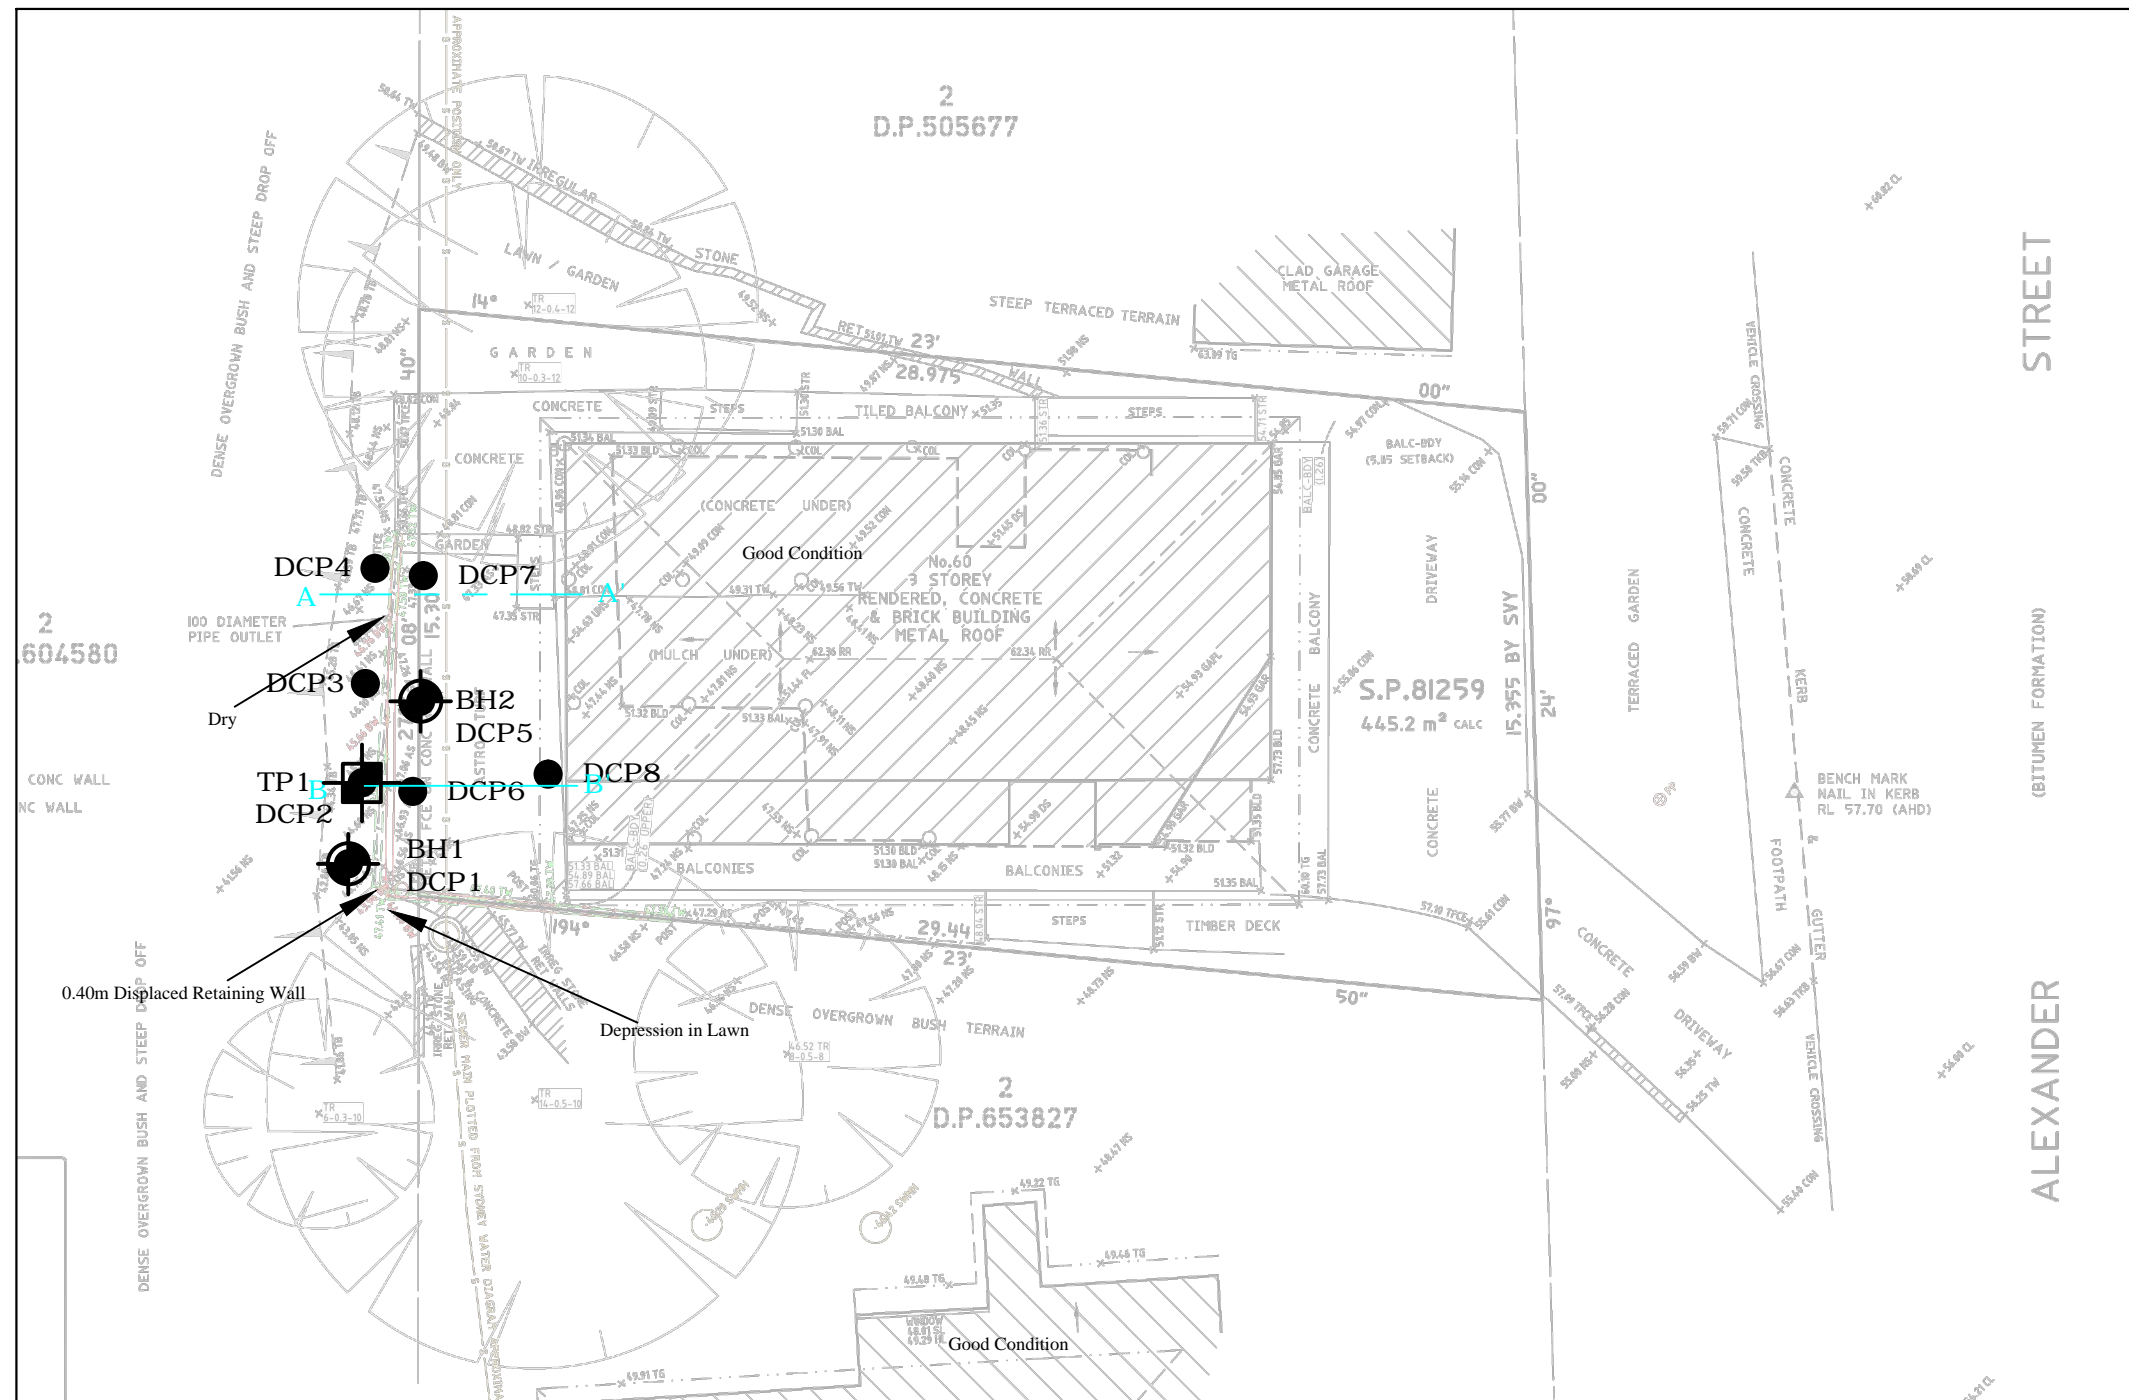
SITE PLAN & TEST LOCATIONS **FIGURE 1.**

The sub-surface investigation comprised eight Dynamic Cone Penetrometer tests undertaken within the rear garden and within the area at the base of the distressed retaining wall. One auger borehole and one test pit were completed within the area near the base of the retaining wall to assess ground/retaining wall footing conditions. A second borehole was undertaken within the rear garden. The ground conditions restricted the capabilities of the hand auger to provide sufficient information, therefore additional DCP tests were undertaken than originally proposed. The investigation was limited to the use of hand tools due to site access limitations.

Explanatory notes are included in Appendix: 1. Mapping information and test locations are shown on Figure: 1, along with detailed Borehole/Test Pit Log sheets and Dynamic Penetrometer Test Sheet in Appendix: 2. A geological model/section is provided as Figure: 2, Appendix: 2.

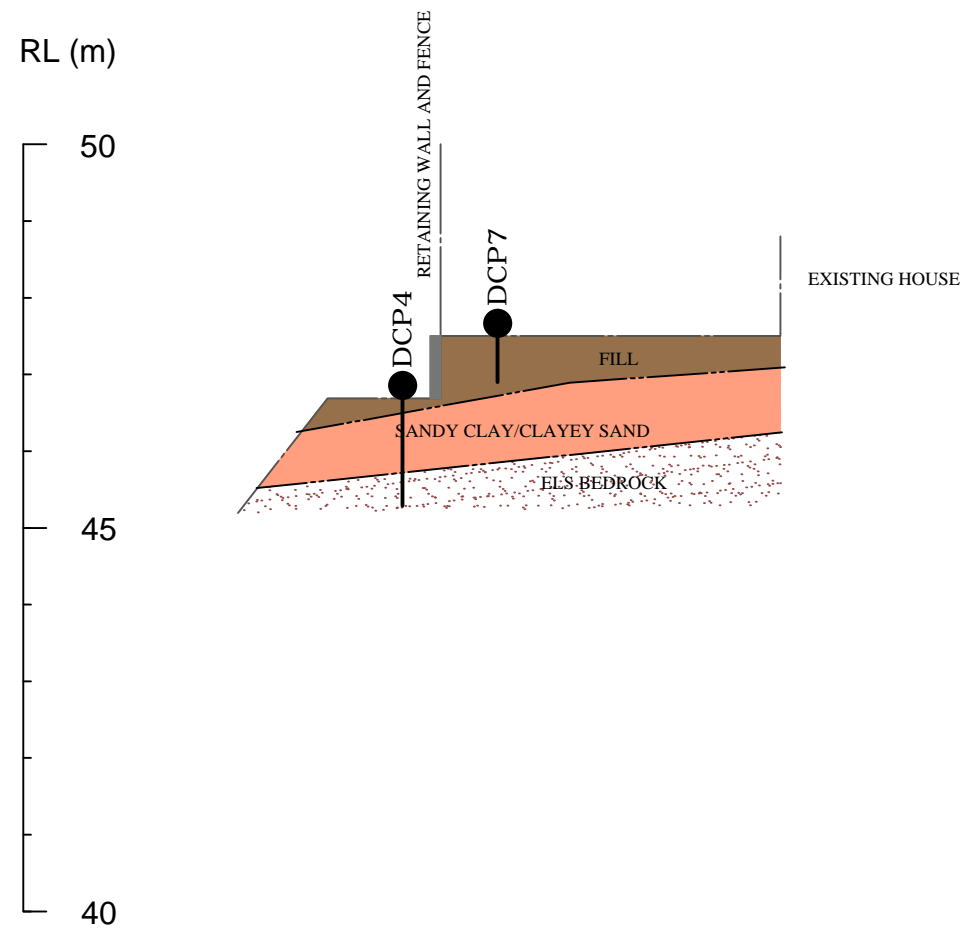
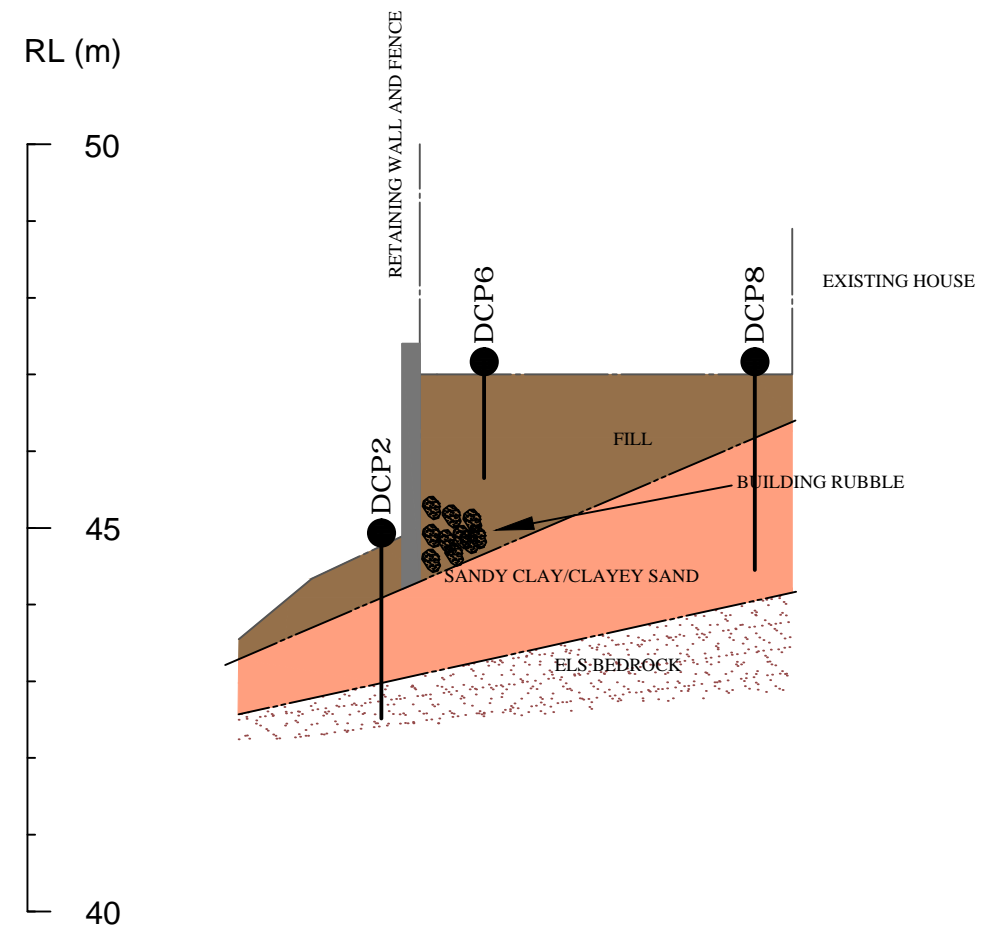
A ——— A' B ——— B'

- **Fill** – Fill was encountered in both the test pit and boreholes and has been interpreted to have been encountered at all DCP test locations. It appears that the fill is thickest under the existing garden and was encountered to at least 1.35m below ground surface level in DCP6. It comprised very loose sand underlain by what is thought to be building rubble which was observed where displacement of the wall had occurred at the south east corner of the site. It was noticeable that the depth to the interpreted building rubble increased progressively toward the east end of the wall from 0.60m (DCP7) to 1.35m (DCP6). Within DCP8, natural soils have been interpreted as being present from around 0.75m depth.

- **Clayey Sand/ Sandy Clay** – this layer was only observed in TP1 and comprised moist to wet sandy clay/clayey sand from approximately 0.50m below the ground surface level at the base of the wall. The test pit indicated that the base of the retaining wall footing may be at or around 0.6m depth below ground surface level. The results of DCP1 and DCP2 undertaken near TP1 indicated that at or below this depth zones of very weak soils/fill are present. Below around 1.35m to 1.65m the soils apparently became stronger. It should be noted that it is feasible that the retaining wall has become detached from the footing however this could not be determined based on the level of investigation undertaken to date.
