## ***Construction Impact & Management Statement & Preliminary Plan of Management***

**October 2023**

**24 Hilma Street Collaroy Plateau NSW 2097**

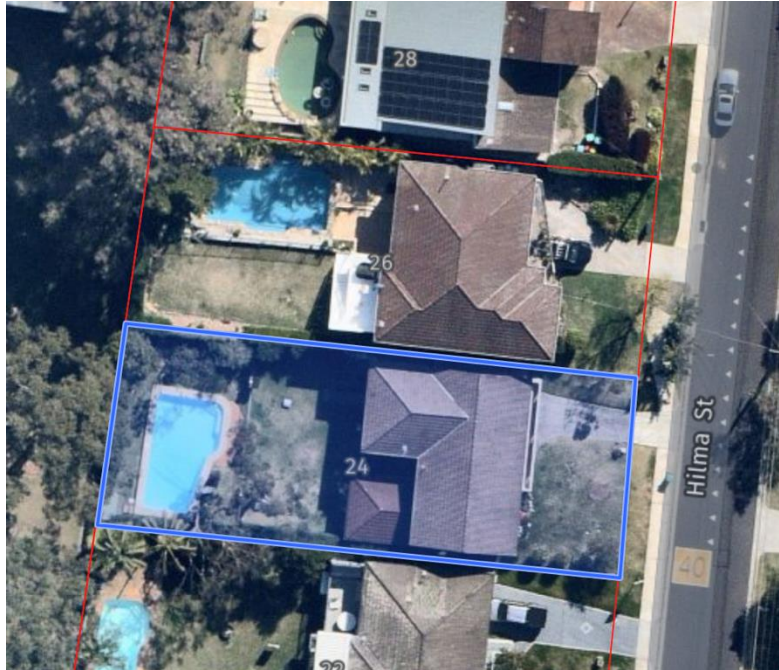
FIGURE 1: ABOVE ILLUSTRATES THE DISCUSSED TREES RELATIVE TO THE SITE 24 HILMA STREET COLLAROY PLATEAU NSW. (AERIAL PHOTOGRAPH ON WEDNESDAY 30 AUGUST 2023, MAP DATA COURTESY OF NEARMAP™)
