## **Geotechnical Assessment**

**Project:** Alterations and Additions  
11 Wandearah Avenue, Avalon Beach NSW.

**REF: AG 20205**  
18<sup>th</sup> August, 2020

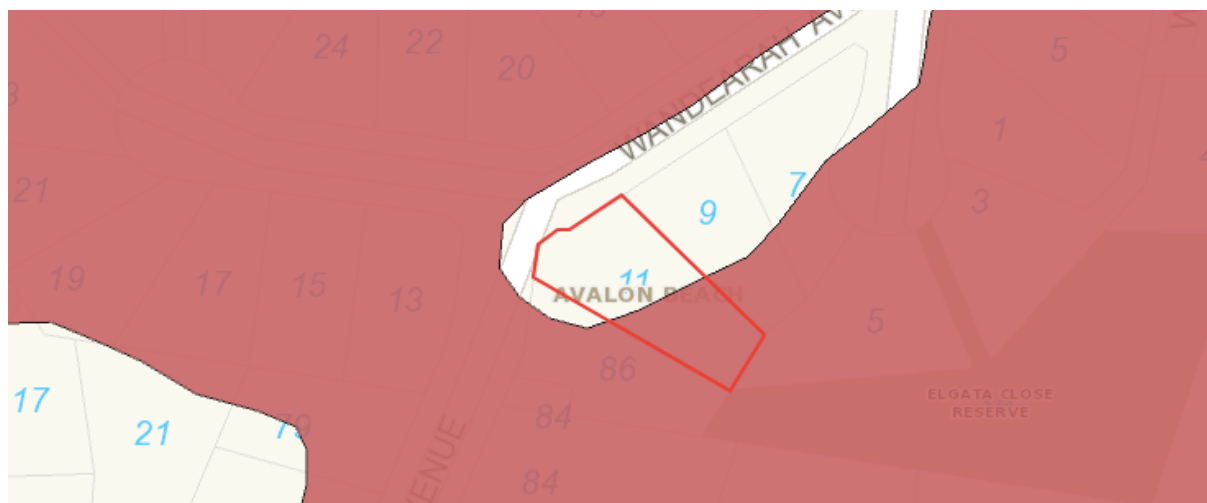
- No evidence of significant soil creep, tension cracks or large-scale landslip instability were identified across the site or on adjacent properties, as viewed from the subject site, at the time of our inspection.
- Minor movement of the recently constructed timber walls is attributed to inadequate spacing and embedment of supporting posts, rather than slope instability.
- The property is classified as **Geotechnical Hazard H1** with reference to Northern Beaches Council PLEP Landslip Risk Map Sheet (PLEP Geotechnical Hazard Map **Image 2** below).
