Report Title: Geotechnical Report 201 Whale Beach Road, Whale Beach  
Report Date: 14/12/23

## **GEOTECHNICAL INVESTIGATION:**

New Pool at **201 Whale Beach Road, Whale Beach**

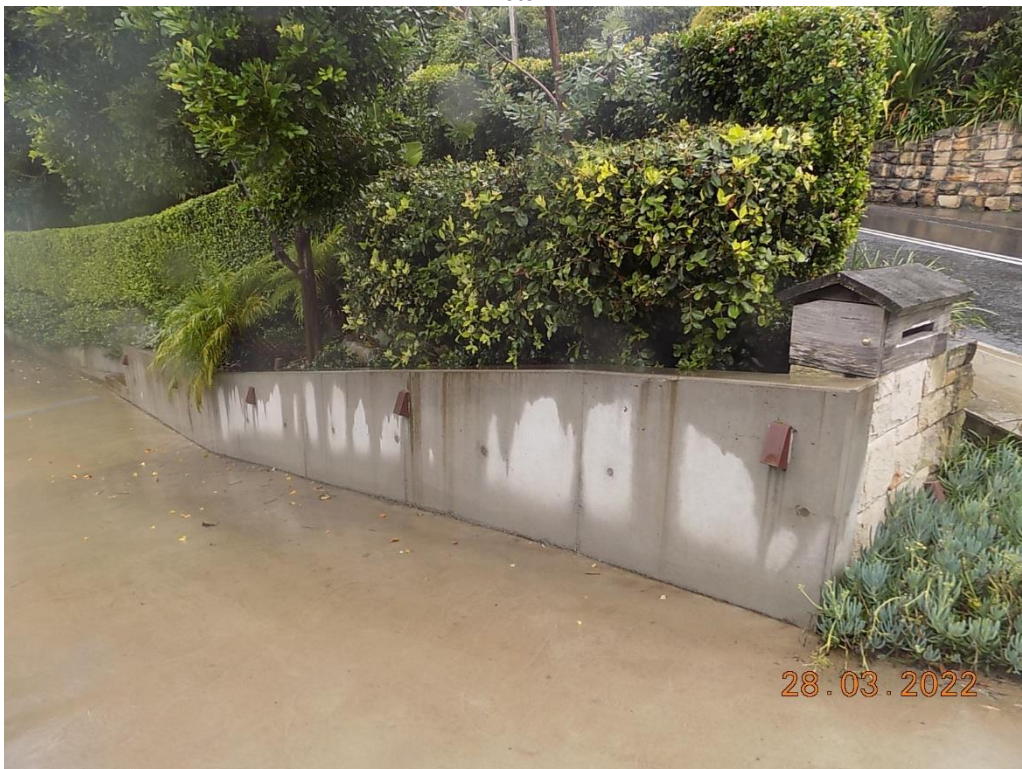
Photo 1

- 2.3** At the road frontage, a partially suspended concrete driveway runs across the slope to a garage attached to the uphill side of the house (Photo 1). The cut for the driveway is supported by a ~1.0m high stable concrete retaining wall (Photo 2). In between the road frontage and the house is a moderately sloping garden area. A stable, ~0.8m high timber log retaining wall supports a fill for a garden bed on the uphill side of the property (Photo 3). A second, stable ~1.2m high timber log retaining wall supports a cut to create the level platform for the uphill side of the house (Photo 4). The cut has been partially taken through an outcropping dislodged joint block that is embedded in the slope. The part four-storey timber clad and rendered
