**FINAL OCCUPATION CERTIFICATE**

**CC2008-00439**

Address 213-215 Riverview Road, AVALON 2107  
Lot No Y  
DP - 110460

| Description | Demolition of existing structures & Construction of new dwelling & swimming pool |

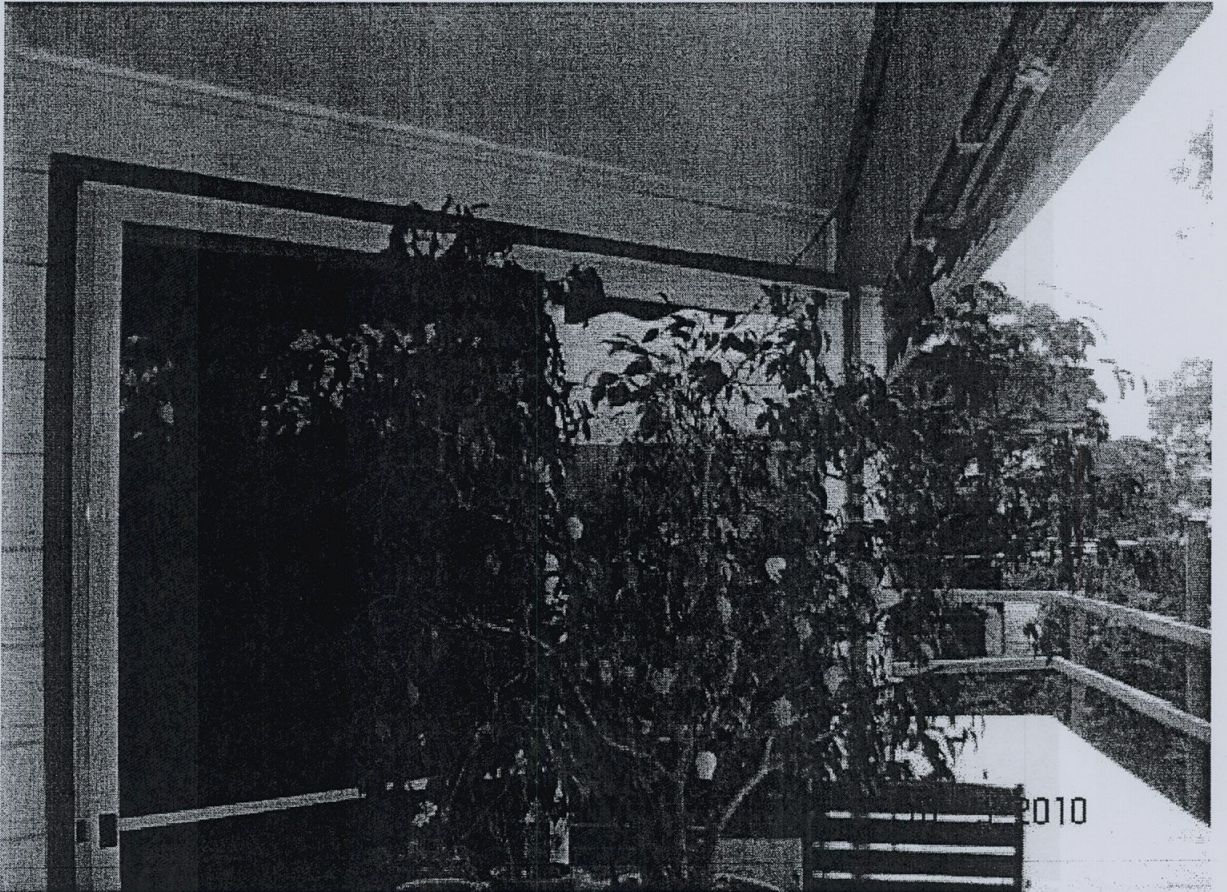
PHOTO 8: As previous and deck being extended.

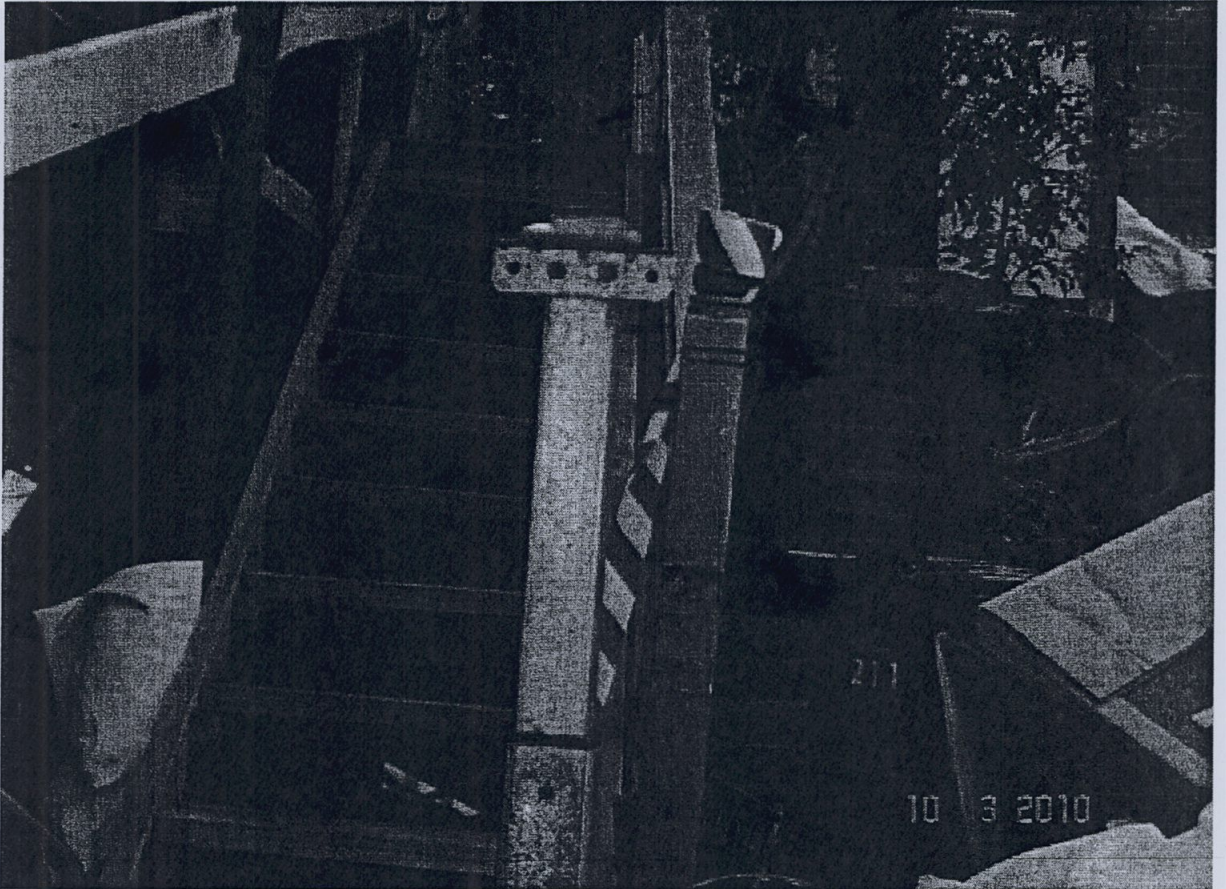
PHOTO 42: Temporary site stairs.

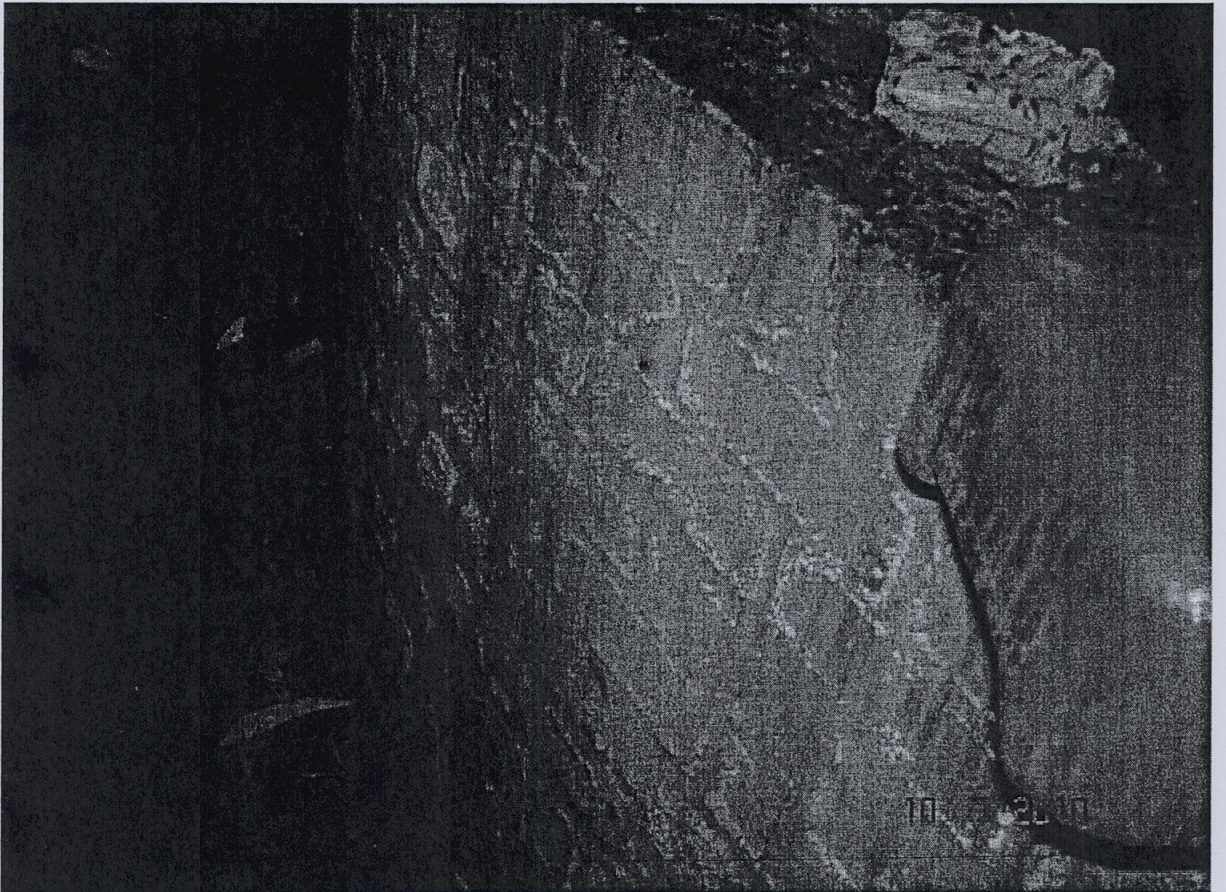
PHOTO 48: Garden retaining wall undergoing renovation.
