Preliminary Geotechnical Assessment – Minor Works: Alterations & Additions – Landslip Area G4 (MDCP) – Site Conditions

2 New Street, East Balgowlah, NSW 2093

In response to the request for Additional Information we provide a copy of the Preliminary Assessment of Site Conditions in accordance with Schedule 11 of the Manly DCP 2013

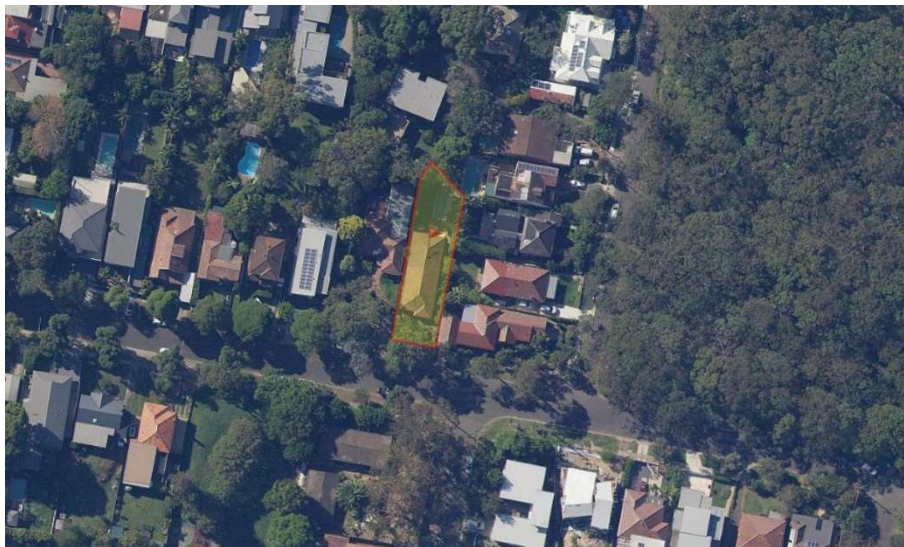
Image 3. Six Maps satellite image – site

- 2.1. Site Location: No. 2 is located in Balgowlah, on New Street East. The subject site has a fall from South to North along the length of the site, falling away from street level (New Street). The site also has a fall from East to West across the width of the site. The site is irregular in shape with an area surveyed at $550.m^2$ by Survey. A site width surveyed at 12.19m, and the overall length of the site is 43.91m with an additional triangulation towards the rear of the site. New Street binds the site to the South. 6 neighbouring properties bind the site to the North, West and East.

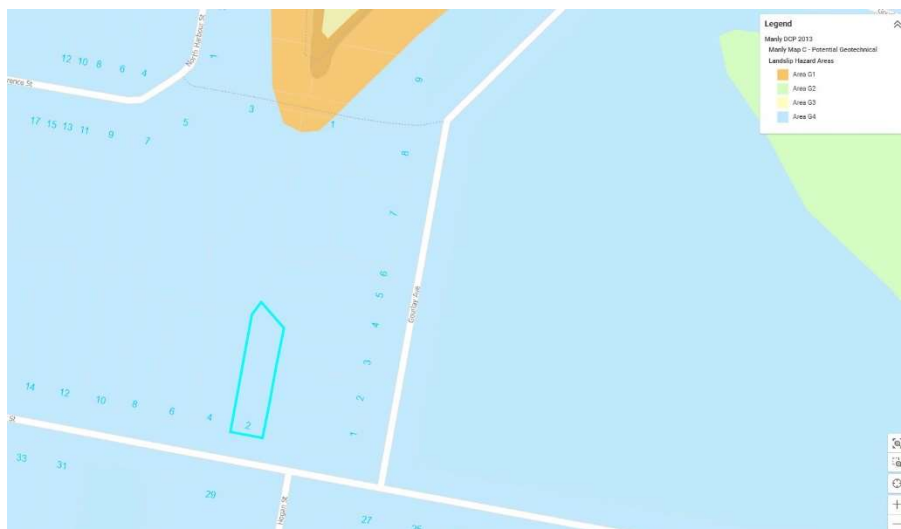
Image 5: Map C overlay of Site – Identified within Area G4

- 2.2. Geotechnical Area: The site is mapped within the G4 Area of the 'Potential Geotechnical Landslip Hazard Areas Manly Map C', being 'Ridge crests, major spur slopes and dissected plateau areas < 15°'. The site is not mapped within the Manly Landslip Risk Areas.

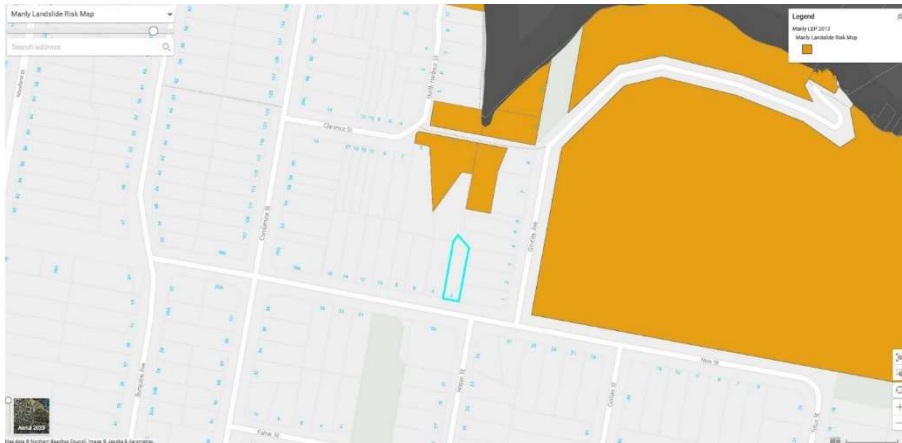
Image 6: Manly Landslip Risk Map
