## Preliminary Geotechnical Assessment

For Alterations and Additions at  
**3 Marcus Place, Frenchs Forest NSW**

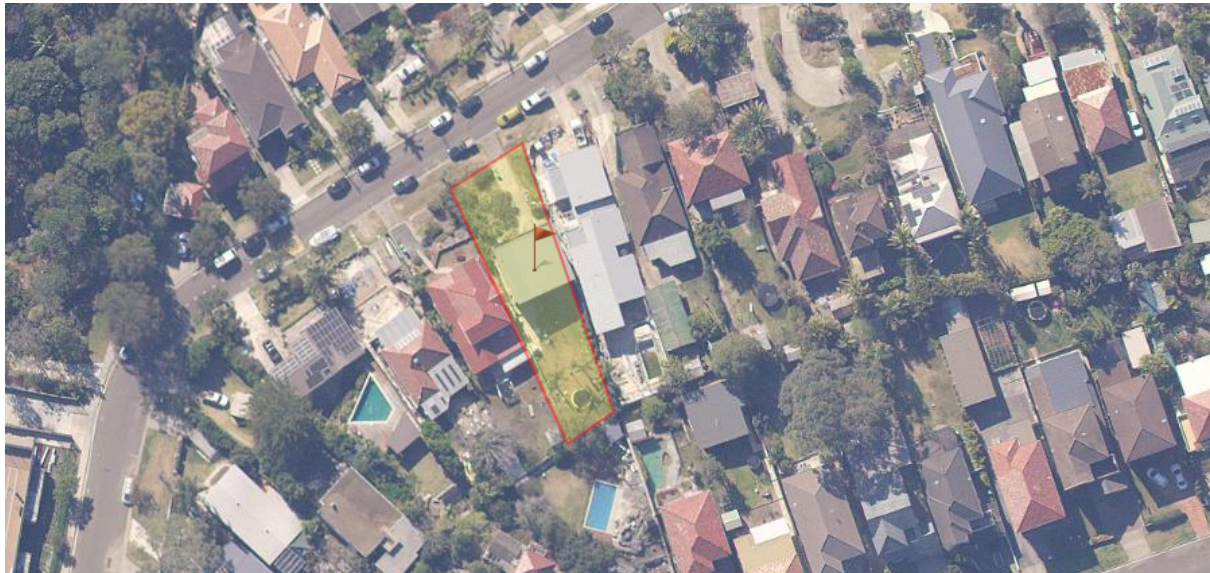
**Image 2:** Site location – 15 Tango Avenue, Dee Why NSW – Red Polygon (© SIX Maps)
