## **PRELIMINARY GEOTECHNICAL ASSESSMENT:**

### **4A Cambridge Avenue, Narraweena**

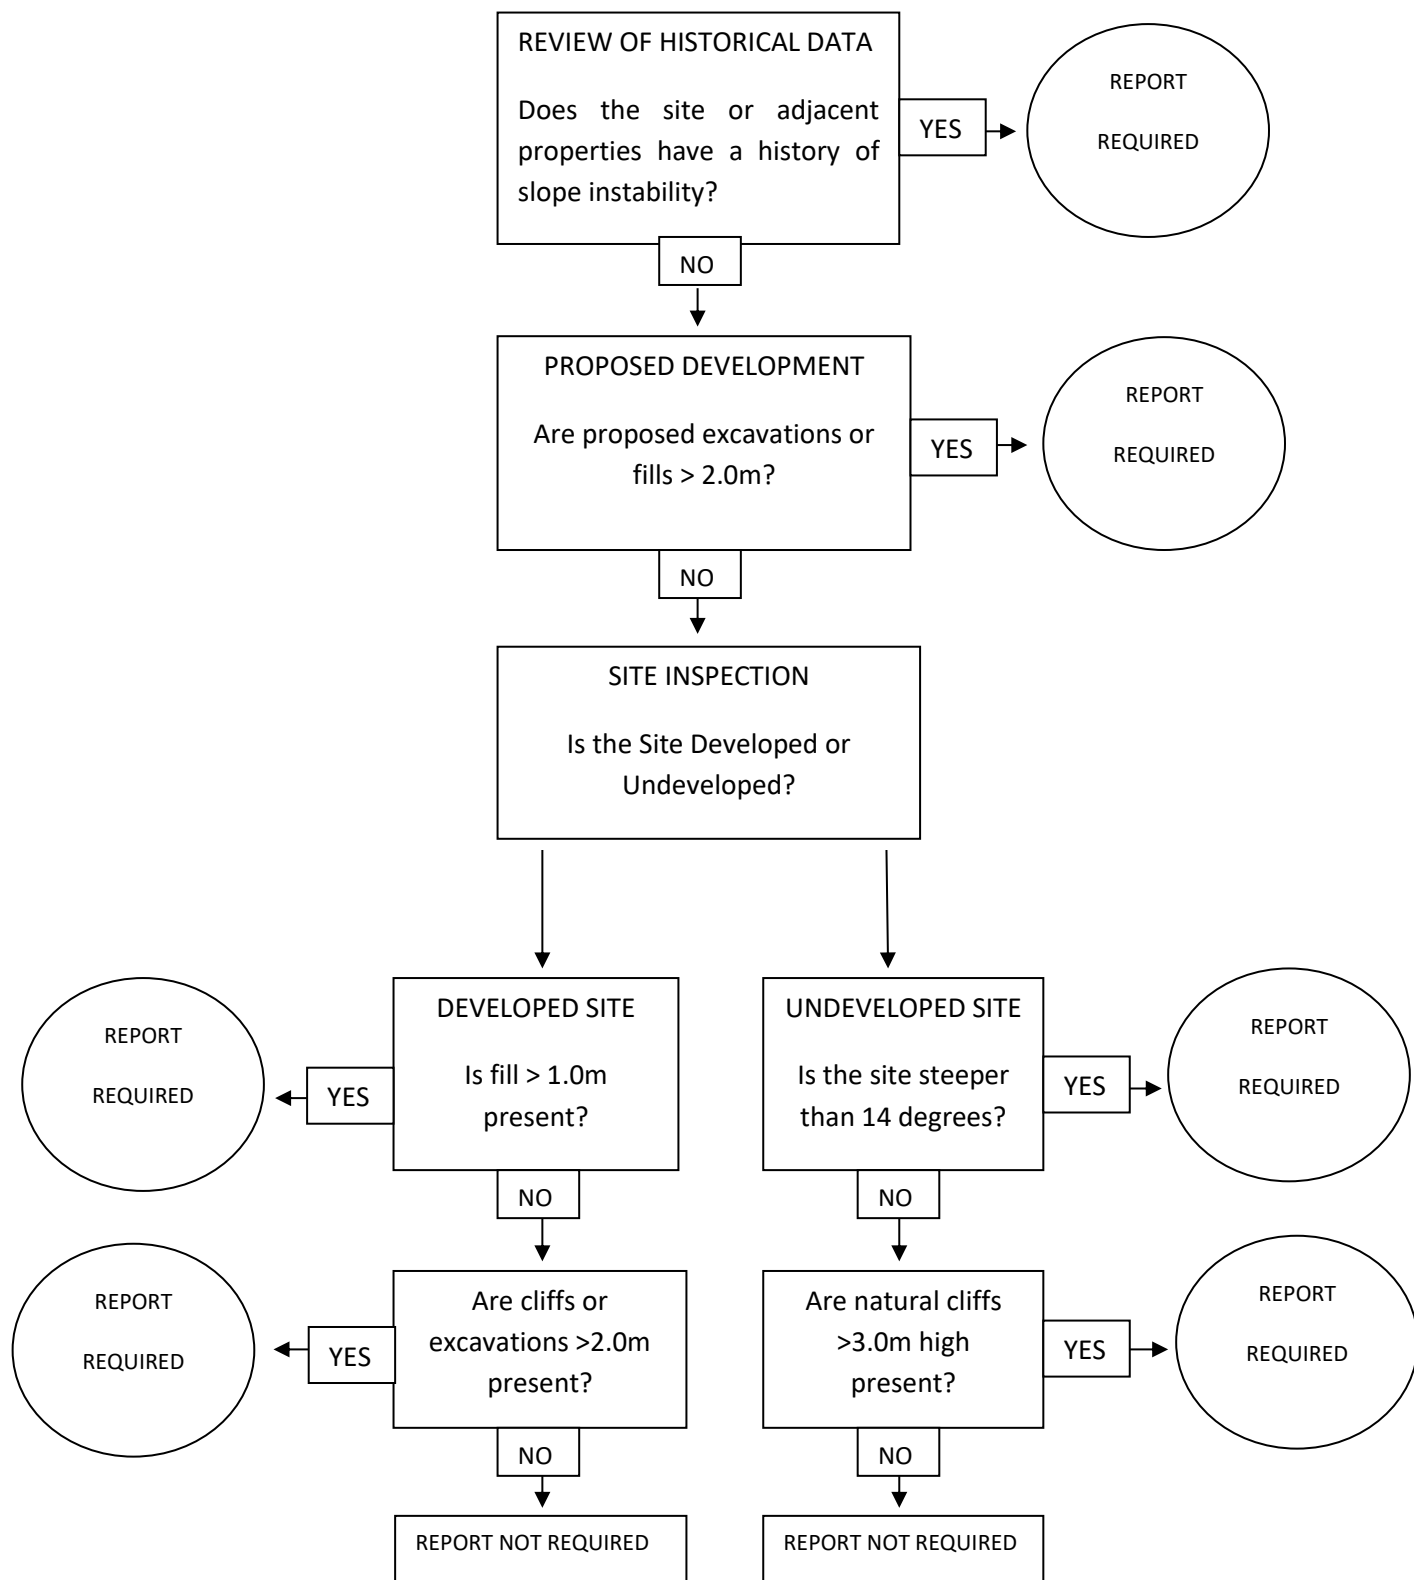
## Preliminary Assessment Flow Chart – Northern Beaches Council (Warringah)

The proposed development and site conditions were considered and applied to the Council Flow Chart.
