PRELIMINARY GEOTECHNICAL ASSESSMENT:

84 Lincoln Avenue, Collaroy

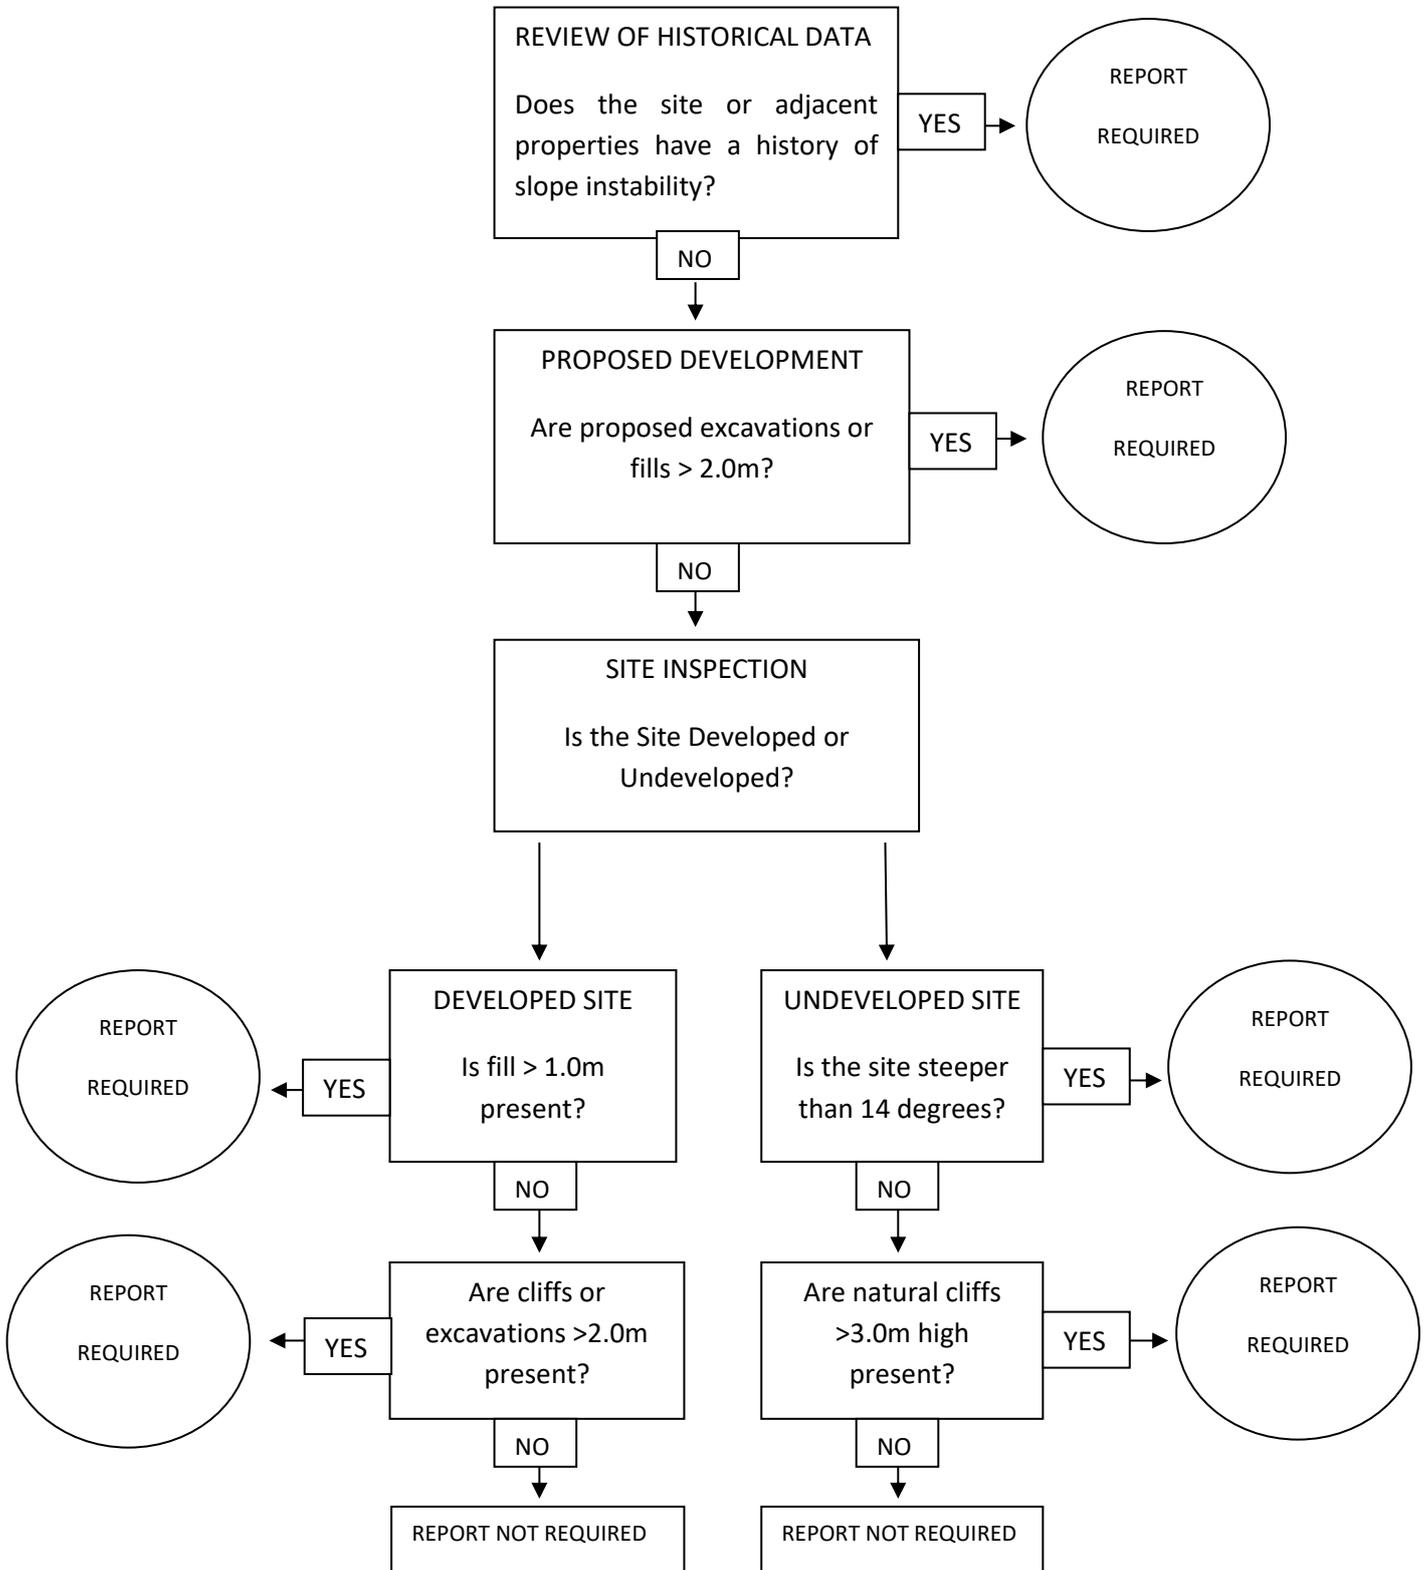
Preliminary Assessment Flow Chart – Northern Beaches Council (Warringah)

The proposed development and site conditions were considered and applied to the Council Flow Chart.
