Preliminary Geotechnical Assessment

Project: Alterations & Additions
56 Attunga Road, Newport NSW

REF: AG 21348
19 October 2021

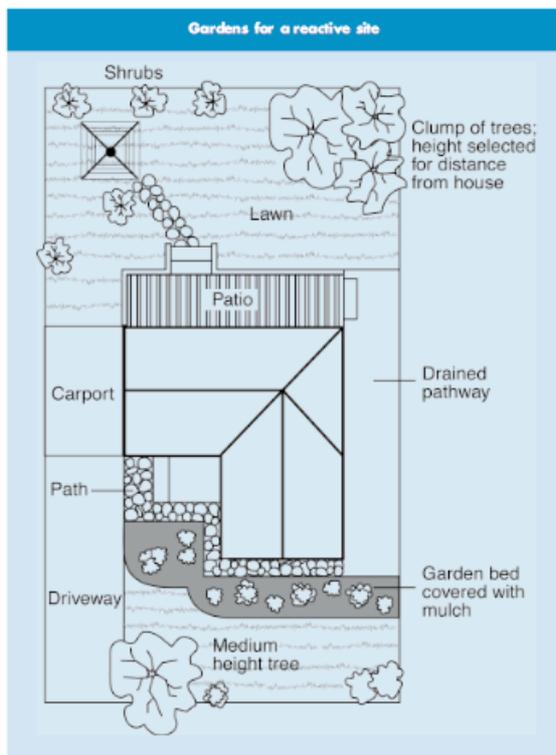
should extend outwards a minimum of 900 mm (more in highly reactive soil) and should have a minimum fall away from the building of 1:60. The finished paving should be no less than 100 mm below brick vent bases.

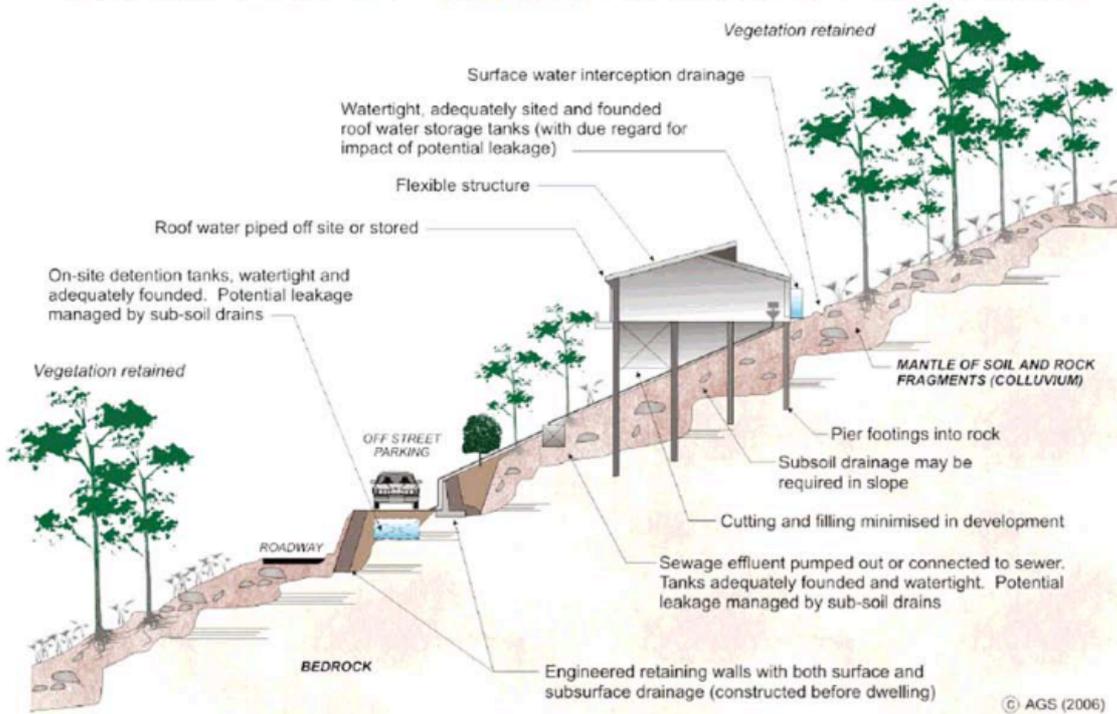
EXAMPLES OF **GOOD** HILLSIDE PRACTICE

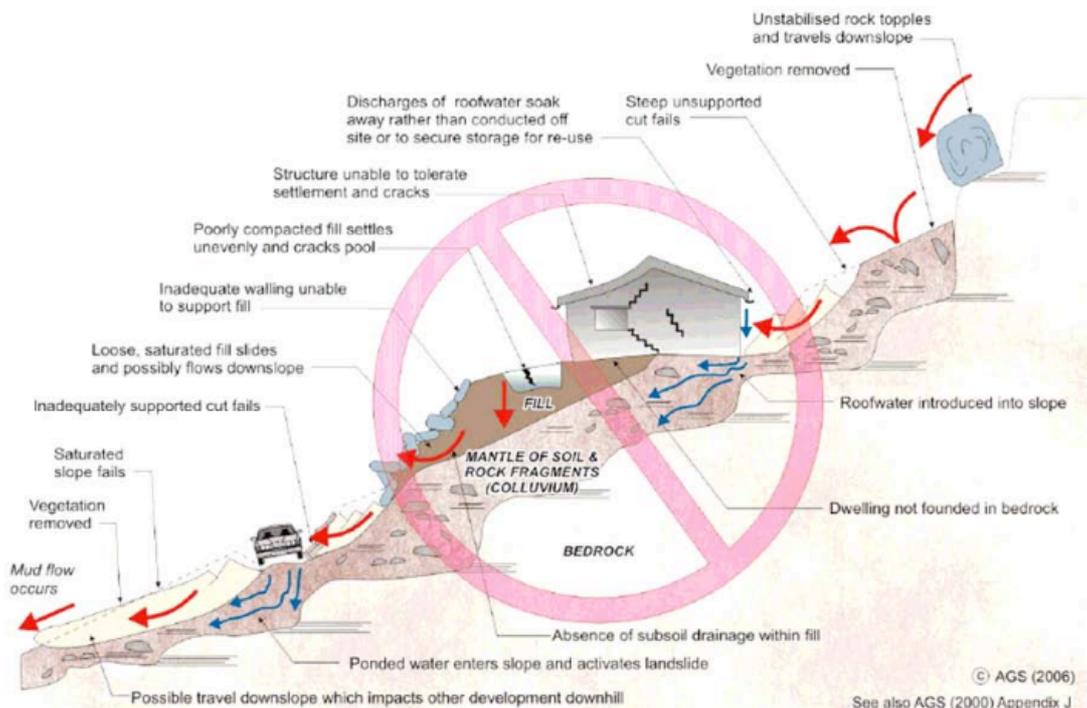
EXAMPLES OF **POOR** HILLSIDE PRACTICE
