AS2870-2011 SITE CLASSIFICATION

**Lot 33, No 7 Ross Street
Balgowlah NSW**

| AS2870 SITE CLASSIFICATION |
| Class P |

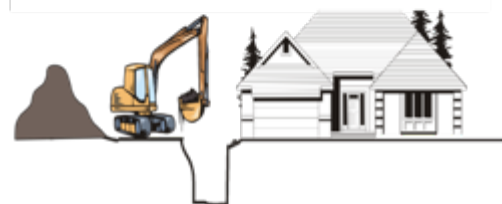
Fig. 11 De-stabilizing house foundations

- Ensuring that excavations are well supported or are dug to avoid collapses. (Fig. 11)
- Constructing well-compacted and retained 'soil aprons' around the building to stop erosion.

- Special considerations if any excavations are to be dug near adjoining structures. (Fig. 11)
- Sloping the soil and paths away from the building by the minimum amount required by the building regulations to prevent water flowing towards the building foundations. (Fig. 10 & 18)

- Running machinery over shallow drain pipes may break them causing leaks and subsequent foundation movements.
- Any excavations close to building footings can cause them to sink by disturbing the foundation material or by drying the foundation clay. (Fig 11)
