## **Geotechnical Investigation Report**

**Proposed New Residence**

**Lot 02, 10 Fern Creek Road, Warriewood NSW**

**Report No. R22009.02.Rev0**

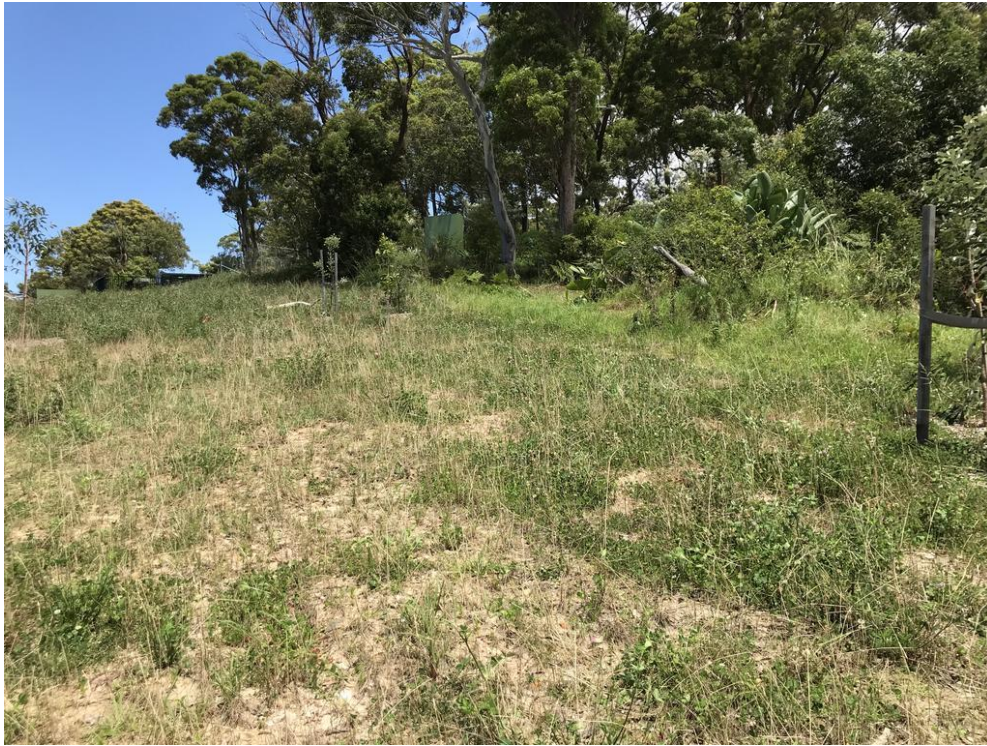
Photograph 1 – General site conditions, looking south

Site vegetation comprised grasses, weeds and native trees along the north-east and southern boundaries. The trees were in upright position. The following site photographs show the general site conditions at the time of field work:

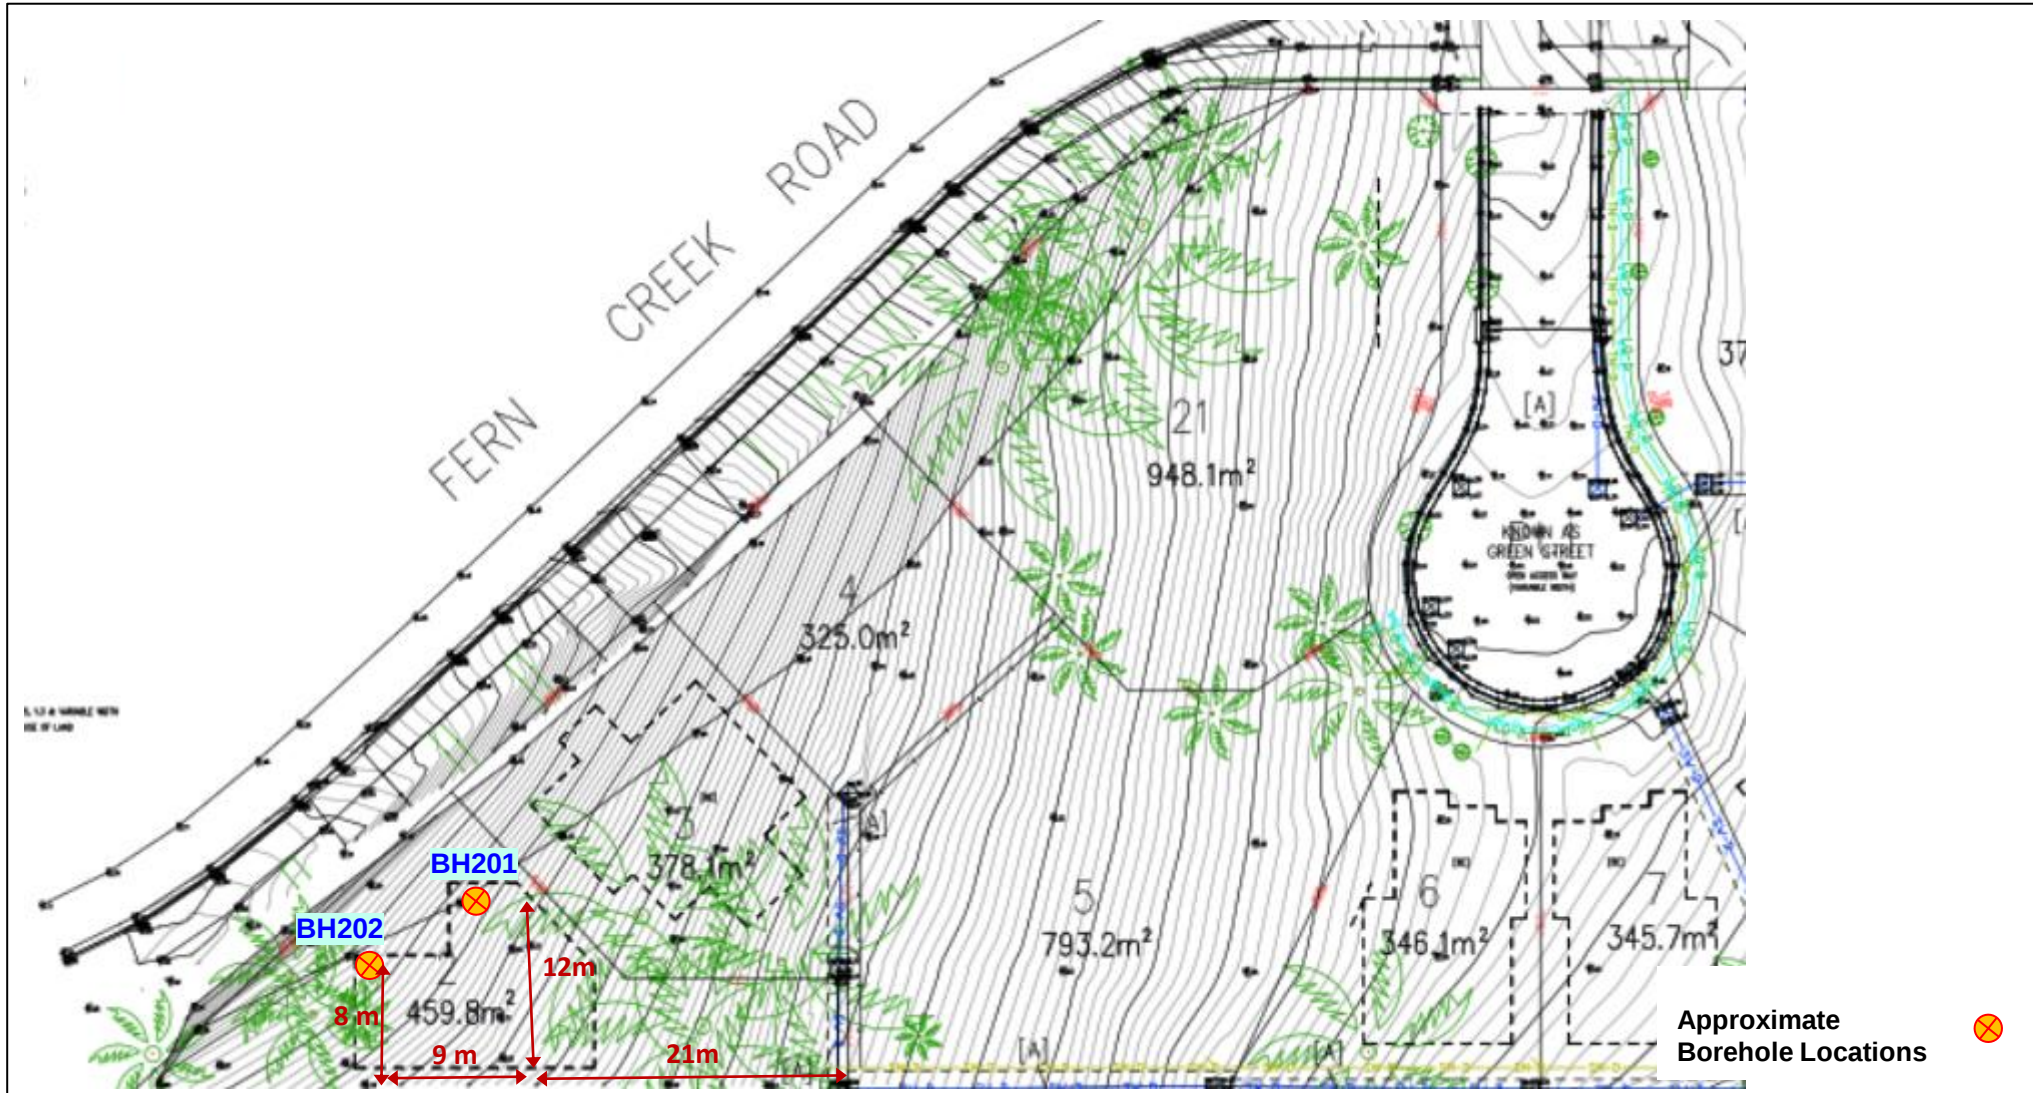
## Drawing 1

Approximate Borehole Locations,  
Conceptual Design Drawings

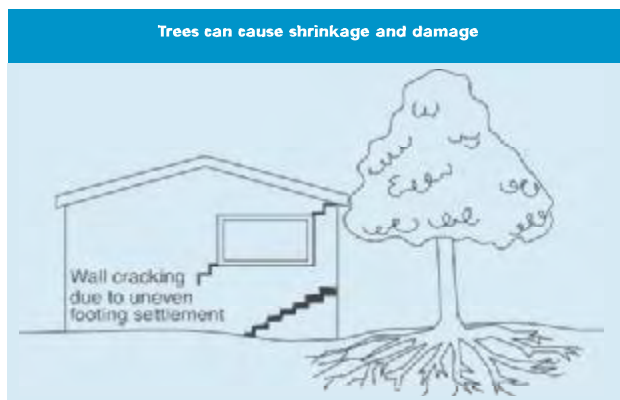
As the moisture absorption process completes its journey to the innermost areas of the building, the internal footings will rise. If the spread of moisture is roughly even, it may be that the symptoms will temporarily disappear, but it is more likely that swelling will be uneven, creating a difference rather than a disappearance in symptoms. In buildings with timber flooring supported by bearers and joists, the isolated piers will rise more easily than the strip footings or piers under walls, creating noticeable doming of flooring.

As the weather pattern changes and the soil begins to dry out, the external footings will be first affected, beginning with the locations where the sun's effect is strongest. This has the effect of lowering the external footings. The doming is accentuated and cracking reduces or disappears where it occurred because of dishing, but other cracks open up. The roof lines may become convex.

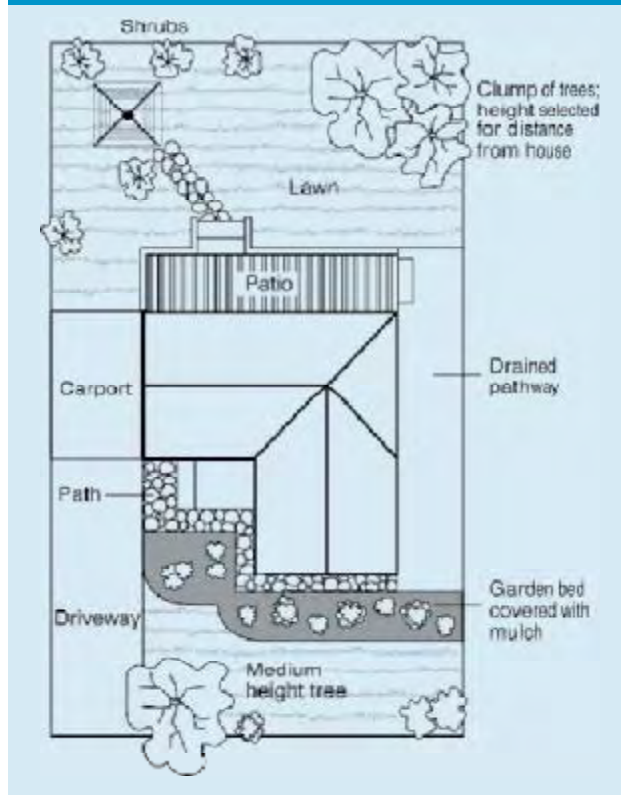
### Gardens for a reactive site

should extend outwards a minimum of 900 mm (more in highly reactive soil) and should have a minimum fall away from the building of 1:60. The finished paving should be no less than 100 mm below brick vent bases.
