Ref: SRE/1409/BC/25

RE: PRELIMINARY GEOTECHNICAL ASSESSMENT FOR PROPOSED DEVELOPMENT AT 3 DRESDEN AVENUE, BEACON HILL NSW 2100 - PRELIMINARY GEOTECHNICAL ASSESSMENT

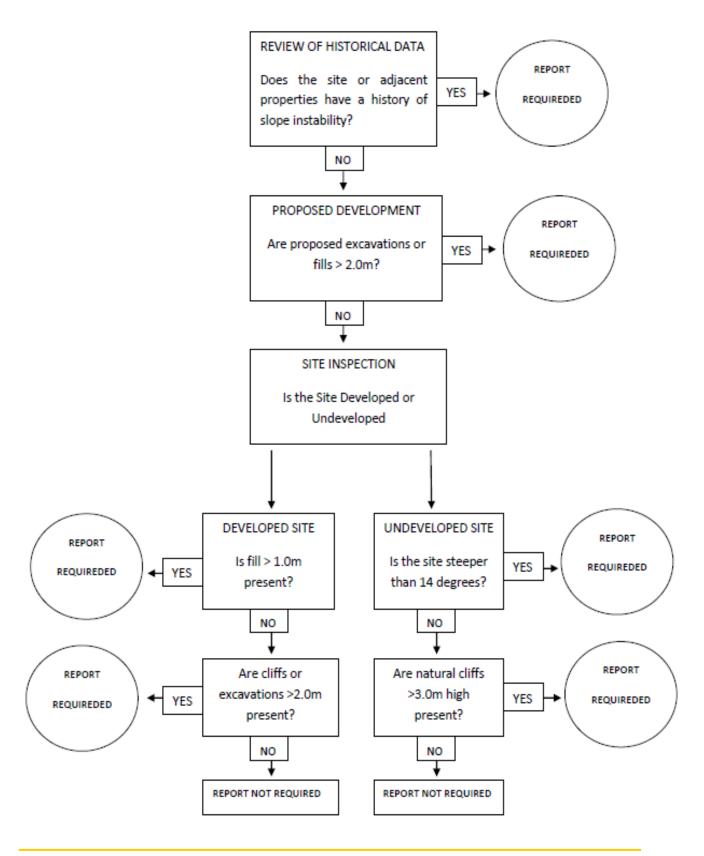
APPENDIX 1

CHECKLIST FLOW CHART FOR COUNCIL'S ASSESSMENT OF SITE CONDITIONS AND NEED FOR GEOTECHNICAL REPORT IN LANDSLIP RISK CLASSES B AND D

Appendix 1 – Checklist Flow Chart for Council's Assessment of Site Conditions and Need for Geotechnical Report in Landslip Risk Classes B and D
