# **MARINE POLLUTION RESEARCH** PTY LTD

## **PROPOSED BOATING FACILITY MODIFICATIONS AT LOTS 1 & 3 DOUGLAS ESTATE McCARRS CREEK - AQUATIC ECOLOGY ASSESSMENT**

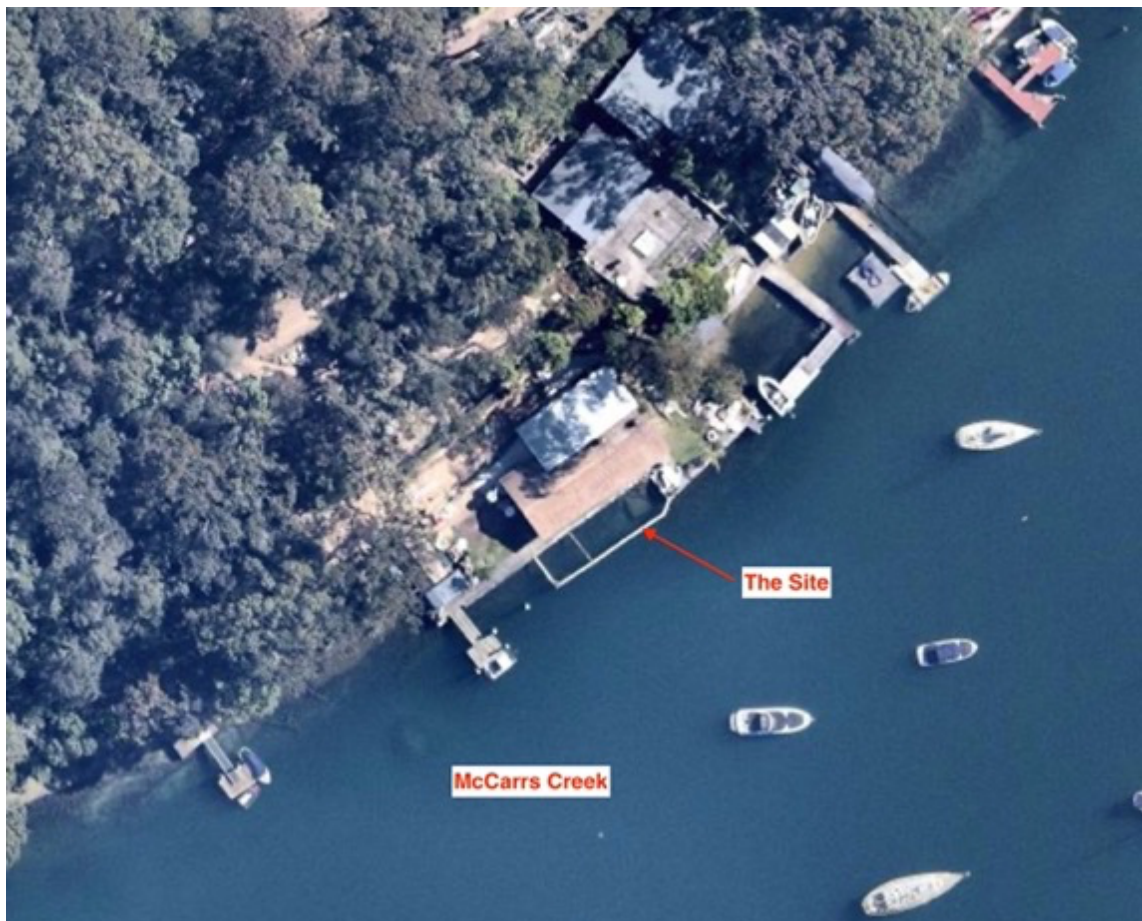
**Figure 1** SixMap Aerial View of Existing Boating Facilities at Lots 1&3 Douglas Estate.

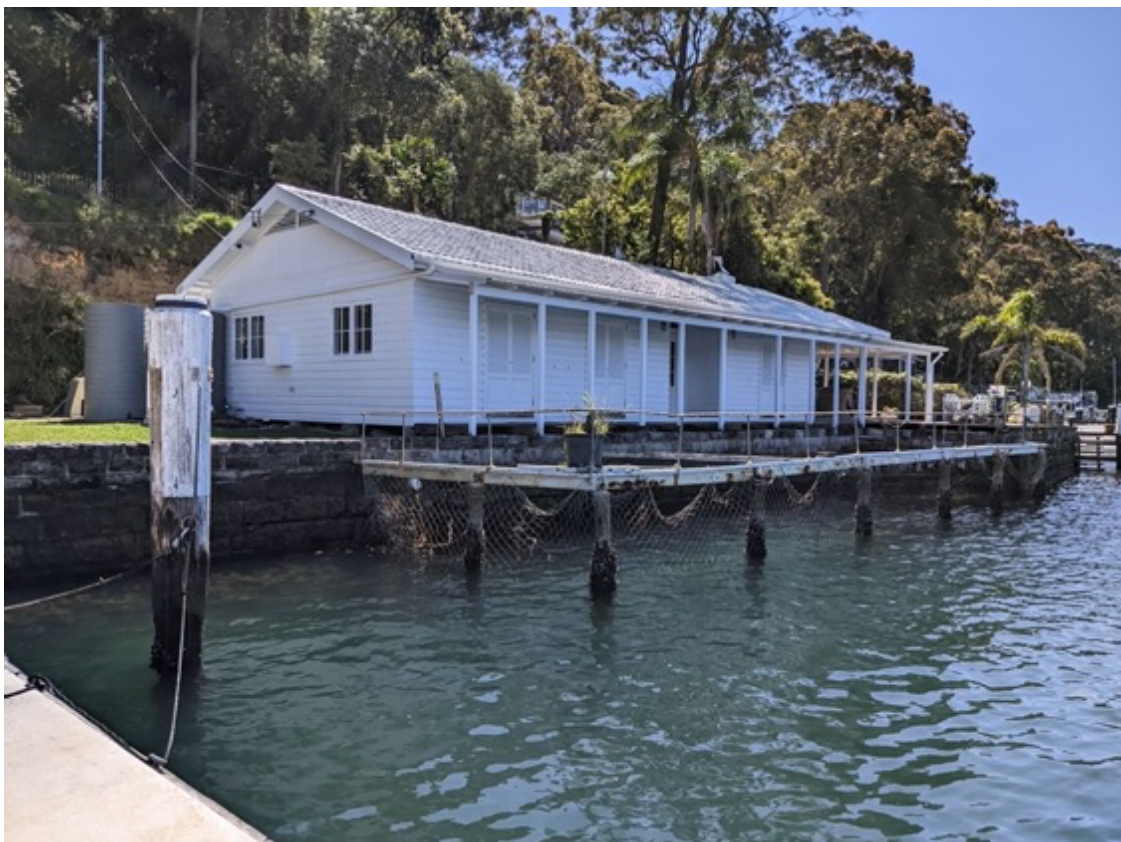
**Figure 2** View of existing sea-pool facility, looking north-east. The riparian edge at this property comprises a block sandstone seawall with a paved reclamation behind.

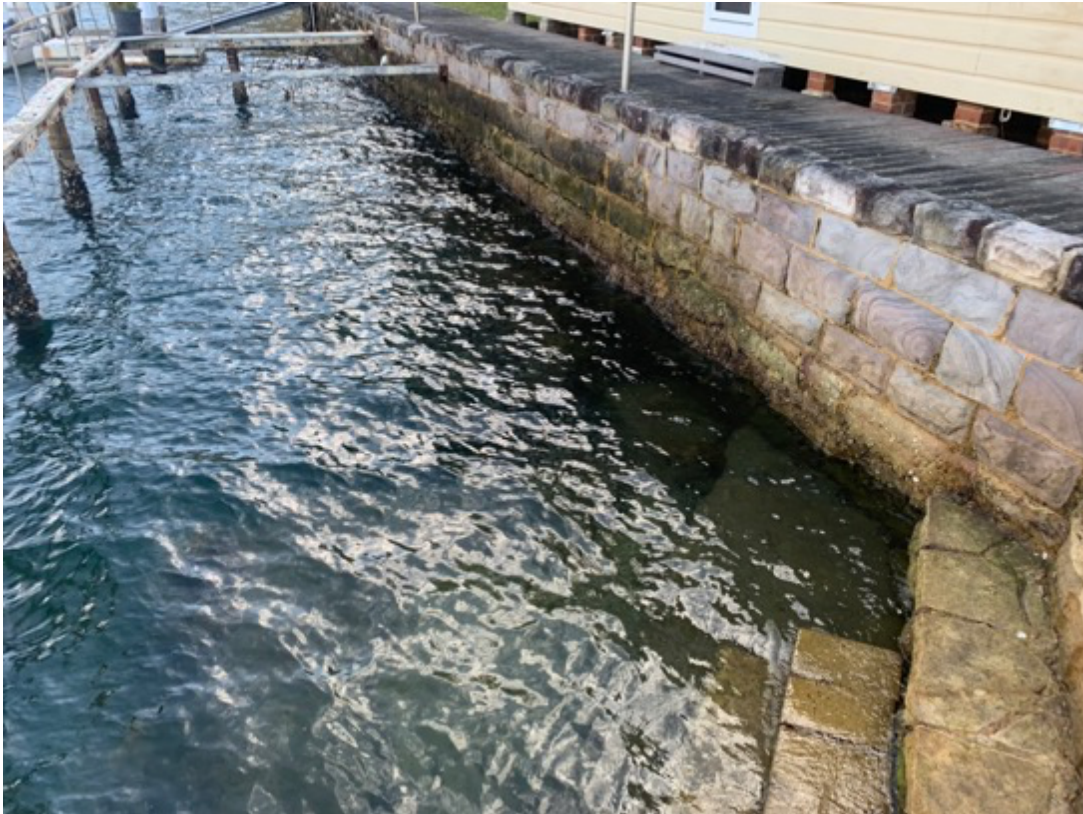
**Figure 3** View of existing sea pool and sand-stone wall facility, looking upstream.

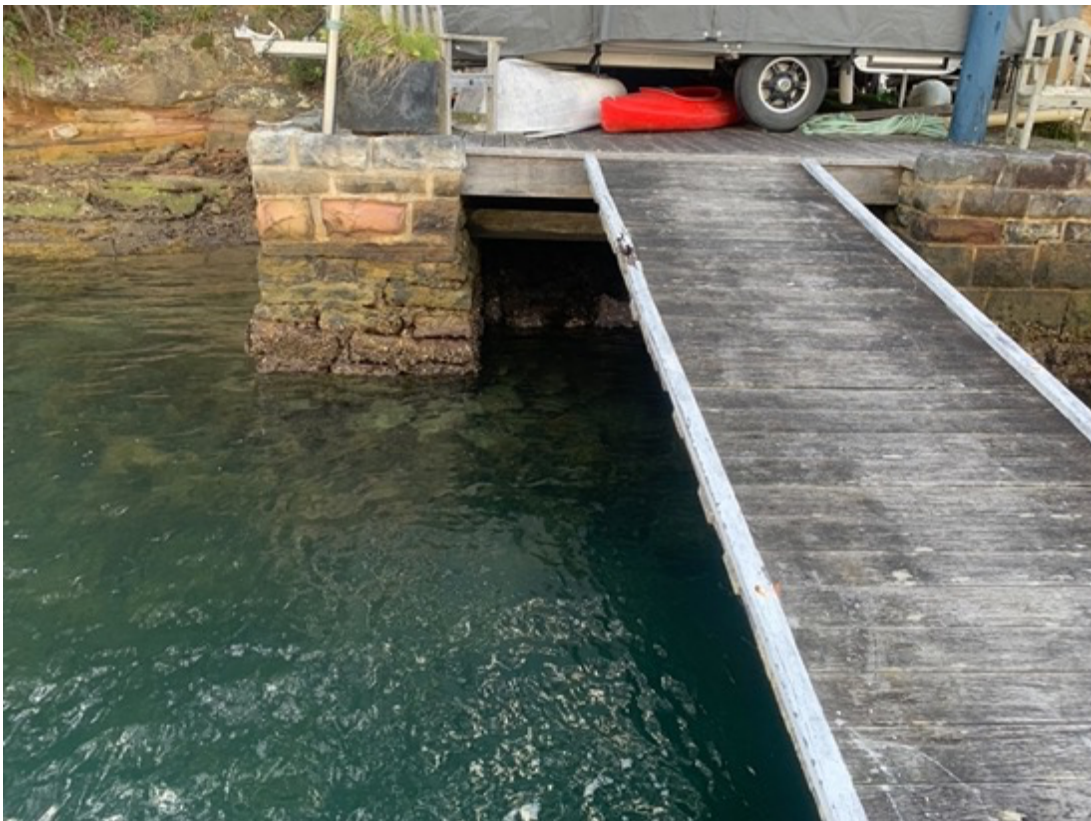
**Figure 4** View of existing reclamation, seawall and ramp facility upstream of the sea pool facility, note intertidal oyster band on lower wall.

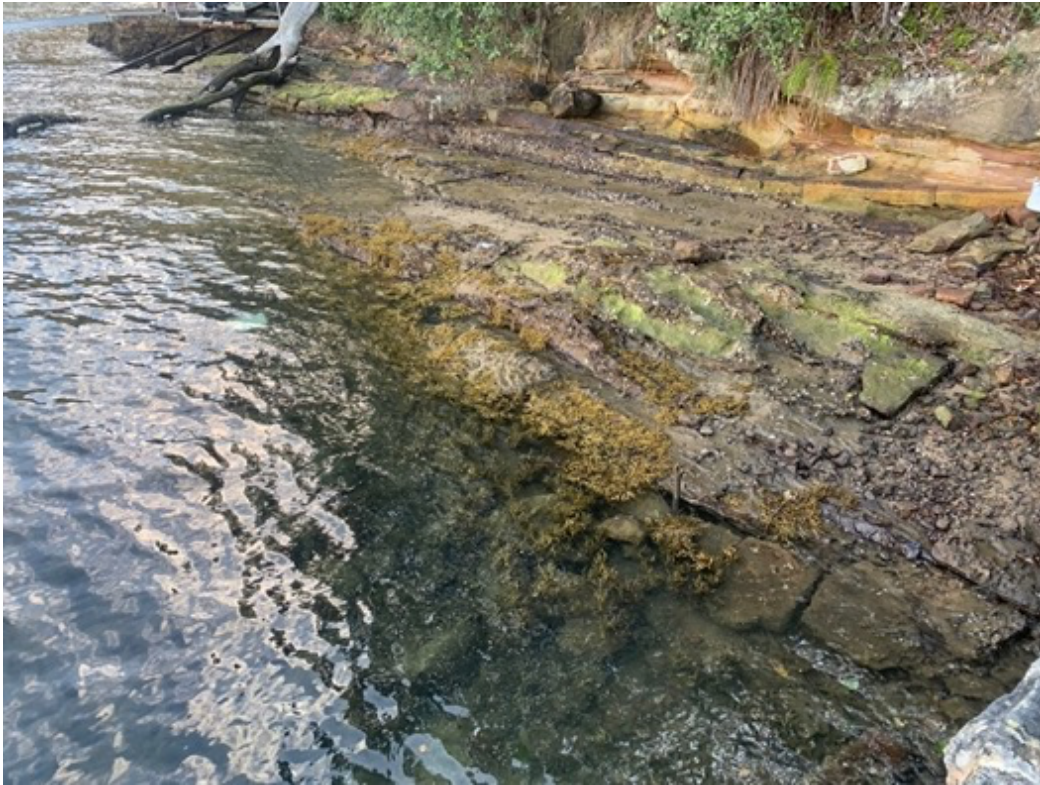
**Figure 5** Natural rock shore upstream of property supports an oyster and gastropod mollusc assemblage with a fringe of *Hormosira* algae in the lower intertidal to shallow subtidal

- The immediate inshore natural habitat to the north-west of the site (**Figures 5 and 6**) comprises a sloping rocky shore that supports an oyster and gastropod mollusc assemblage in the intertidal with a fringe of *Hormosira* algae in the lower intertidal to shallow subtidal with a steep rock boulder sub-tidal habitat that terminates on a silty-sand seabed with some rock rubble inshore.

With regard to operational impacts arising from the use of the facility, the main potential impact from using the new ramp is damaging inshore rock habitat biota at very low tides when launching or retrieving vessels from the boat ramp. The potential for this impact will be proportional to the actual height of the ramp above the habitats and can be minimised by ensuring that the launching height is set 0.3m above the natural upper limit of the *Hormosira* algae as indicated in **Figure 5**.

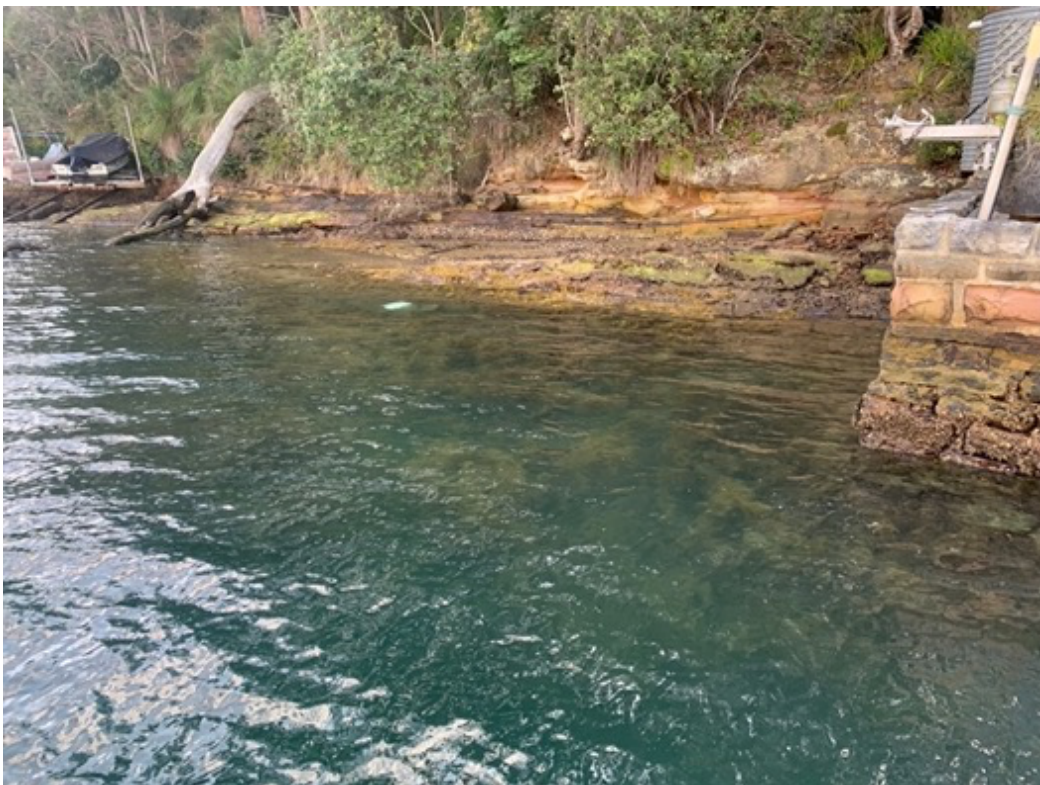
**Figures 6** Views upstream of the property showing natural riparian edge and sloping intertidal rocky reef

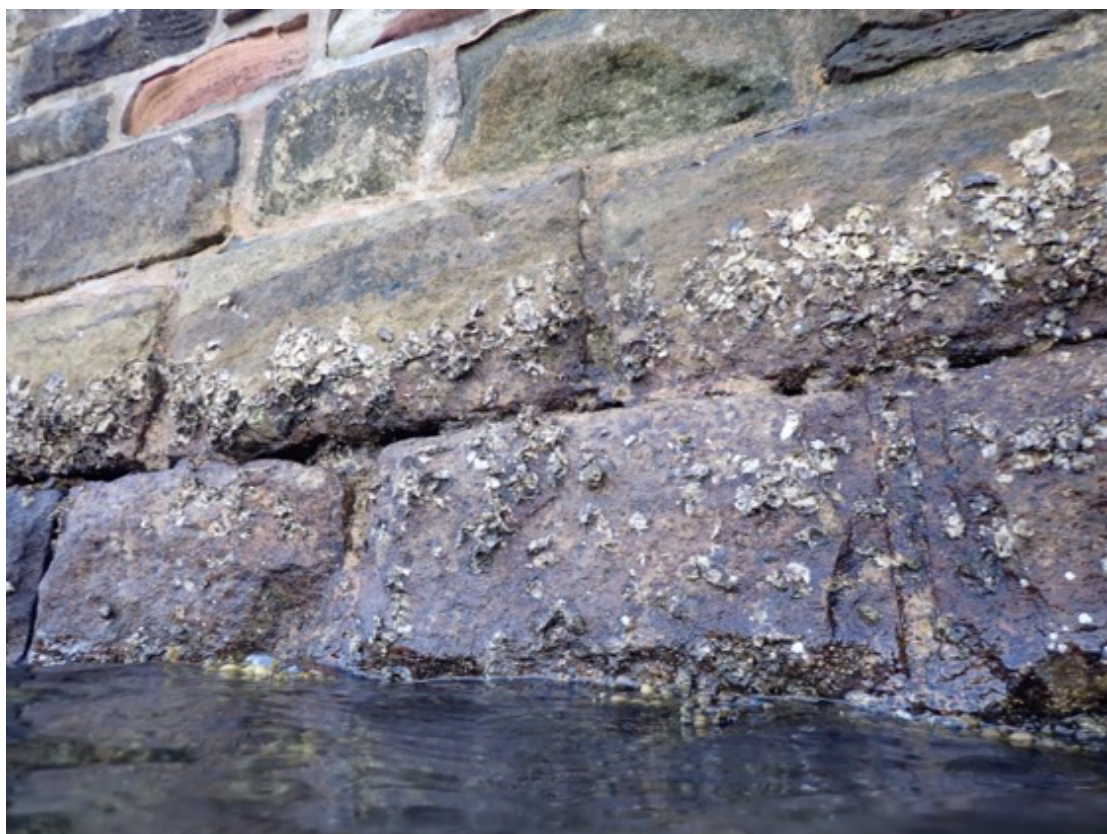
**Figure 9** Mid to Upper, Intertidal Oyster and mollusc band on seawalls.

- This intertidal habitat is replaced by the block sandstone wall and reclamation that separates the subject property boundary from the upstream natural habitats, and the block sand stone seawall has been placed along the edge of the intertidal drop-off embedded in the top of the steep rock boulder embankment above the silty-sand seabed. The seawall supports a mixed oyster and gastropod assemblage in the low intertidal that continues with *Hormosira* in the lower intertidal (**Figures 9 and 10**).

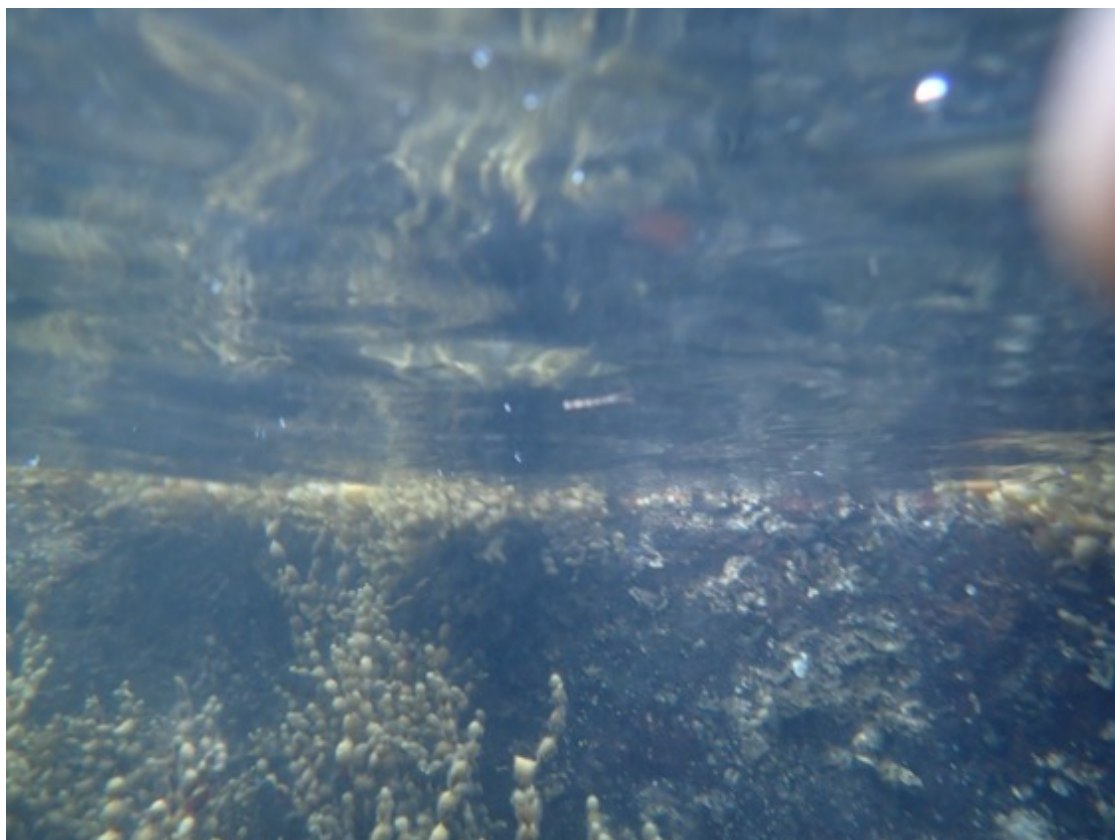
**Figure 10** Low intertidal oysters grading to *Hormosira* cover on lower portions of seawall.

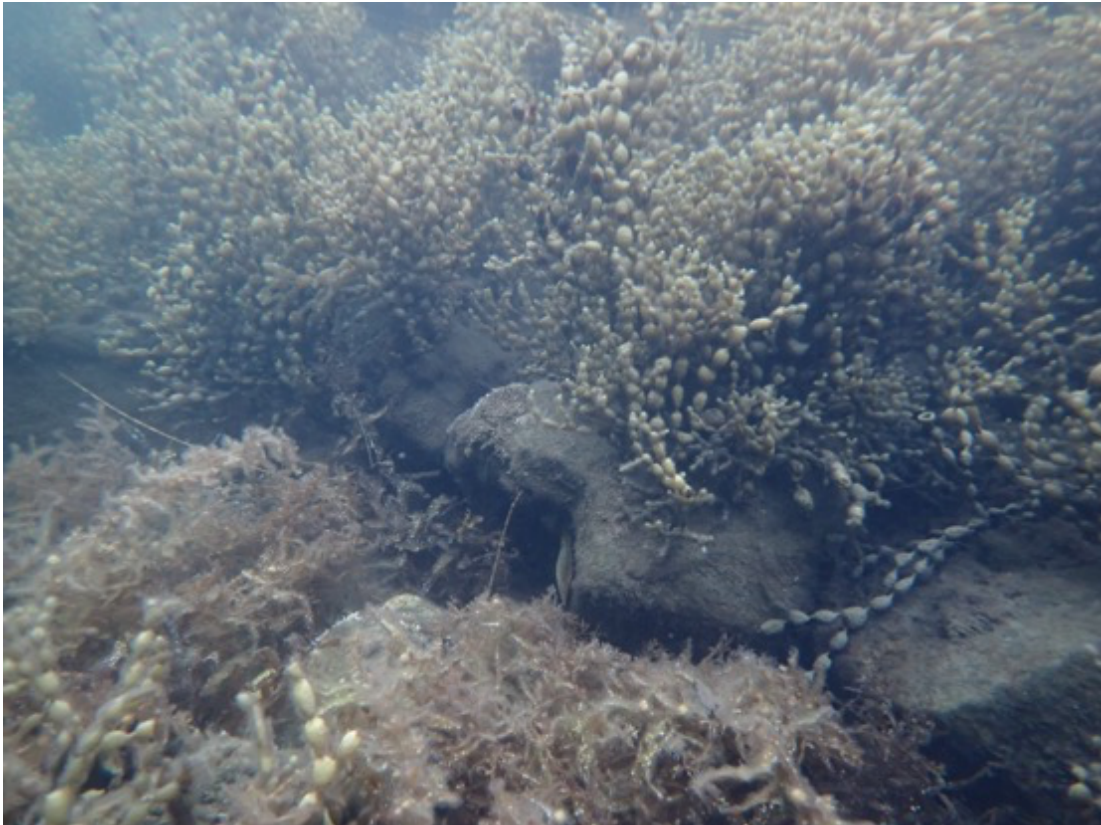
**Figure 11** Transition from low intertidal *Hormosira* to mixed *Hormosira*, red algae and *Sargassum* in the sub-tidal fringe (at natural rocky shore and below property seawall).

- The *Hormosira* band then continues deeper to the top of the rock boulder habitat with a mix of small red fringing algae and *Sargassum* in the narrow sub-tidal fringe (**Figure 11**).

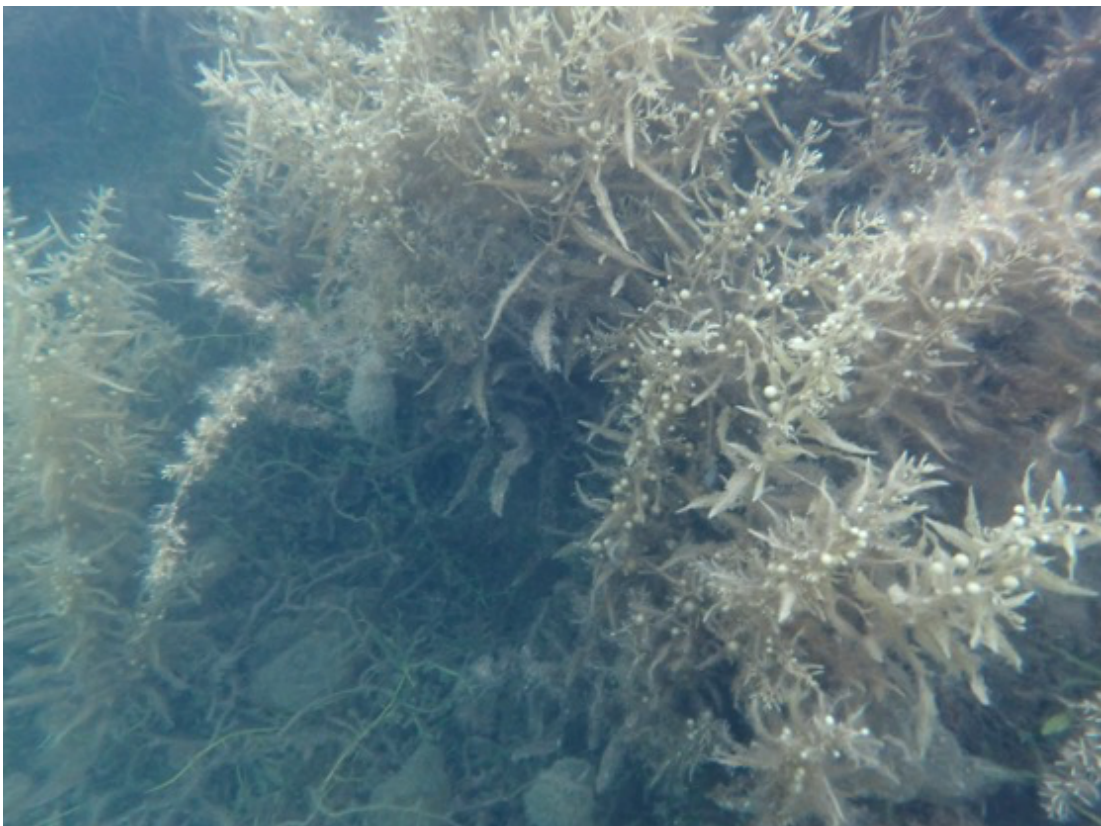
**Figure 12** *Sargassum* growth on rock boulder slope (from about -0.2 m to -1.2m chart datum depth. Note *Caulerpa* plants under the *Sargassum* canopy.

- The rock boulder habitat below the sub-tidal fringe supports a relatively dense cover of *Sargassum* (**Figure 12**) and this cover thins out at the toe of the slope where the rock rubble has a proportionally higher smothering silt cover (**Figures 13 and 14**).

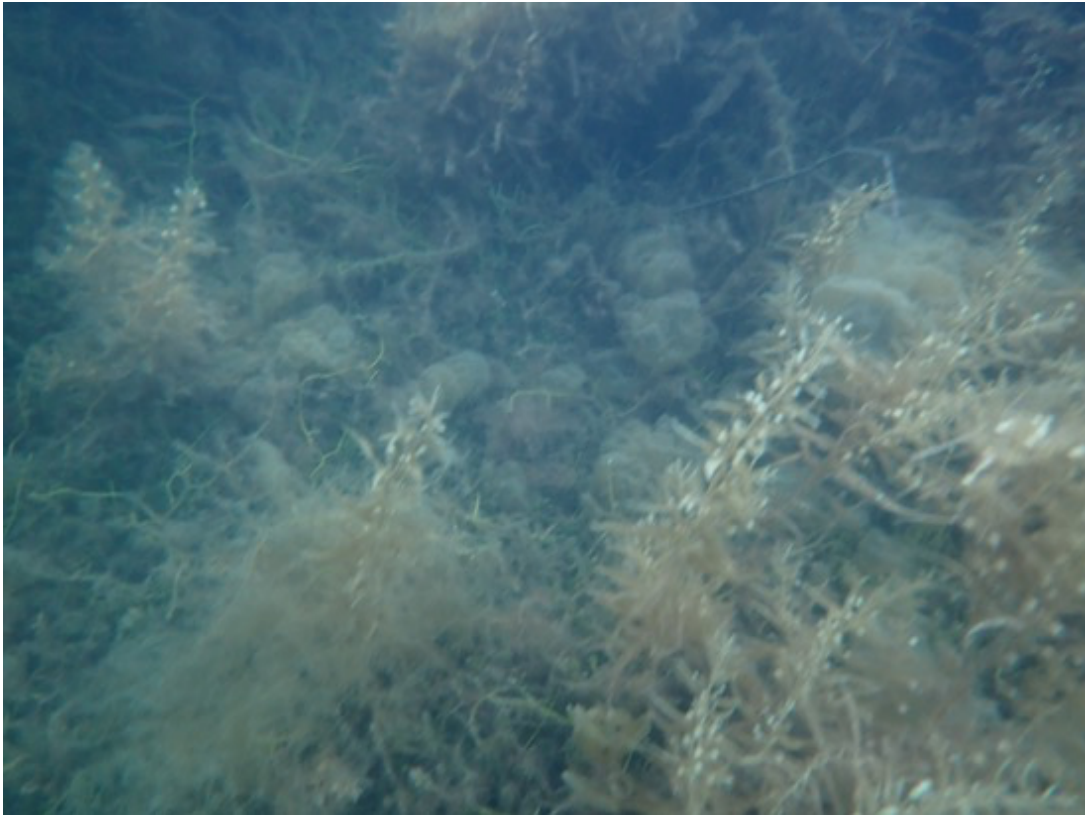
**Figure 13** Looking downslope to rock rubble toe at about -1.5m chart datum showing transition to silty-sand seabed with *Caulerpa* cover.

- The lowest portion of the rock boulders and the inshore rock rubble plus the silty-sand seabed beyond supports a dense and complete cover of the pest algae *Caulerpa taxifolia* (**Figure 15**) with this species also reaching upslope into the lower *Sargassum* zone (**Figures 13 and 14**).

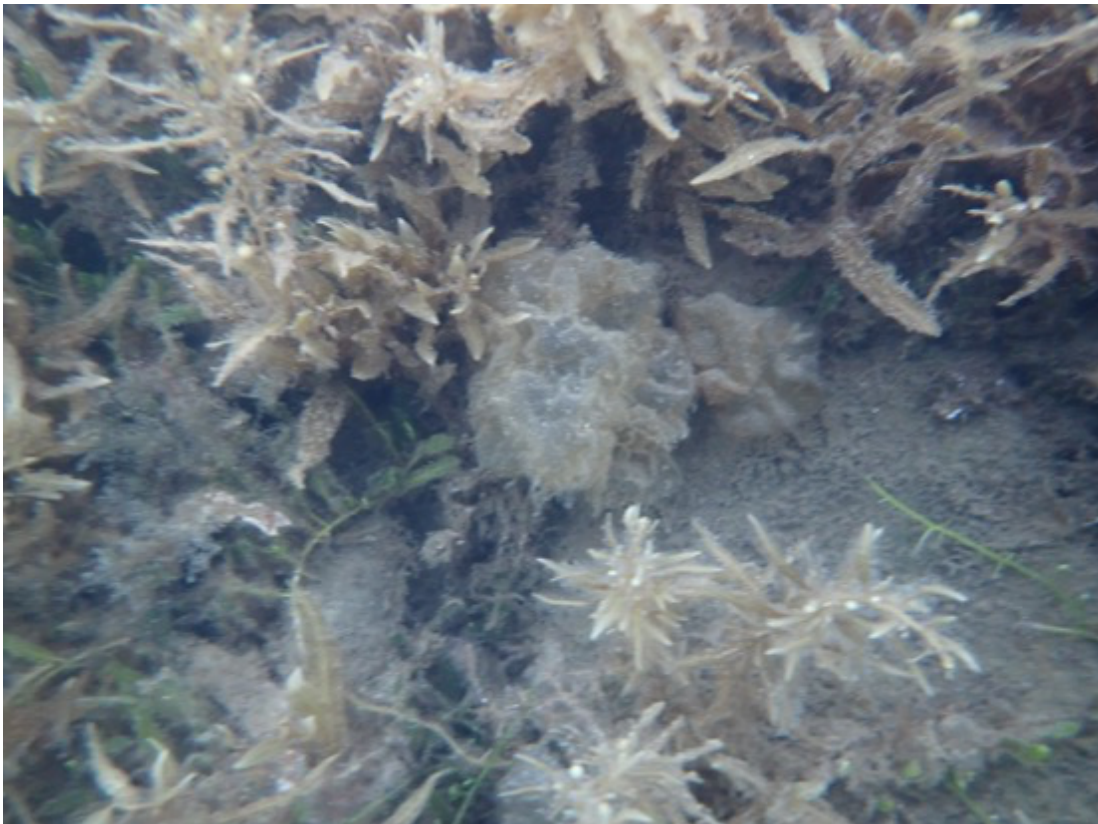
**Figure 14** The lower rock rubble has a silt cover, small *Sargassum* plants and invading *Caulerpa* rhizomes.

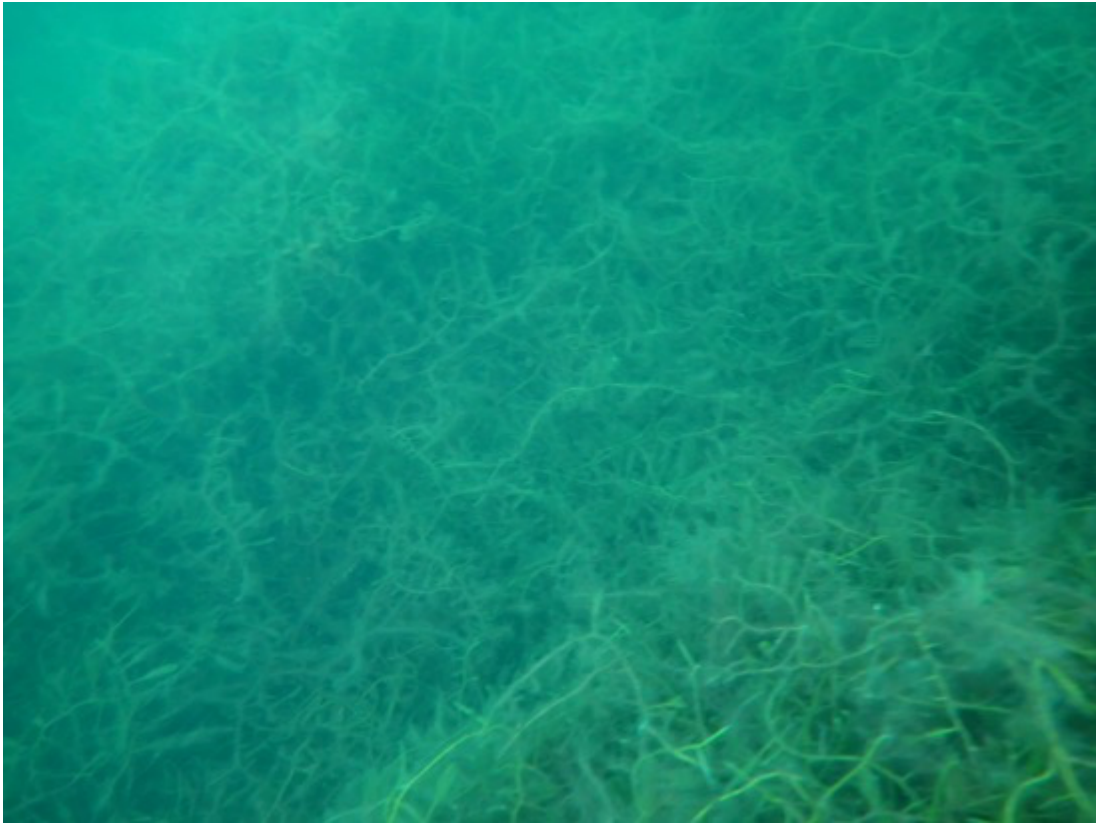
**Figure 15** The seabed offshore from the boulder rock reef supports a uniform and dense *Caulerpa taxifolia* bed.

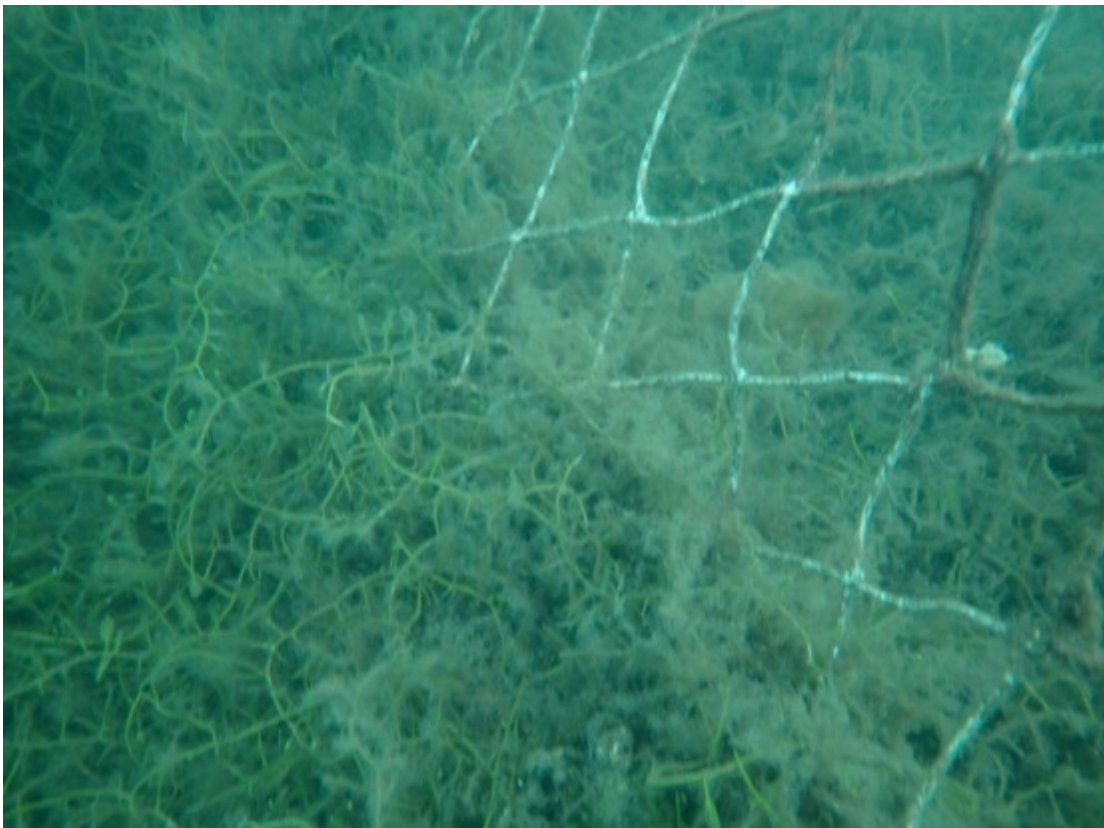
**Figure 16** The *Caulerpa* bed extends into the netted pool seabed.

- The *Caulerpa* bed also extends inside the netted pool sandy seabed (**Figure 16**).
- The mesh net itself supports clumps of attached biota including water borne filamentous algae and clumps of tunicates (**Figure 17**).

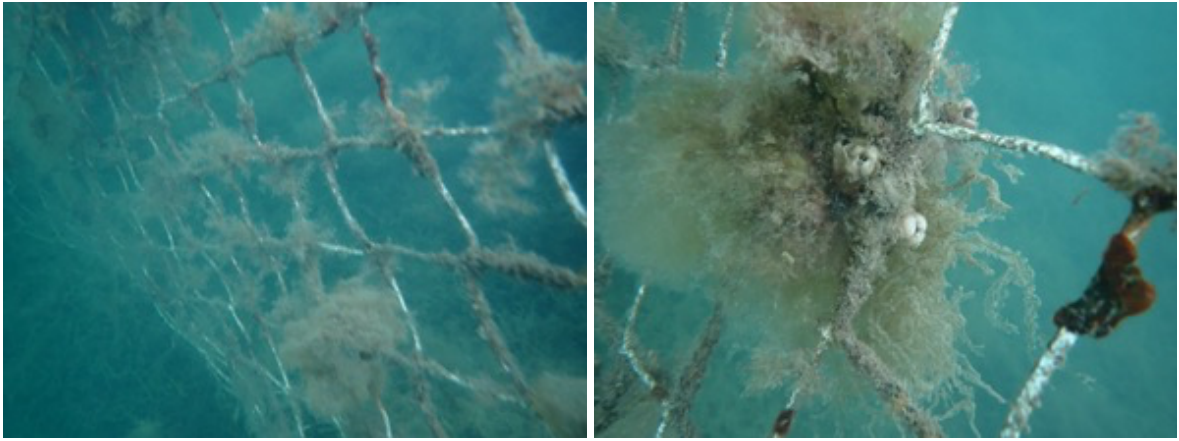
**Figure 17** The net supported some attached or caught algae and a few clumps of attached biota include this cluster of tunicates.

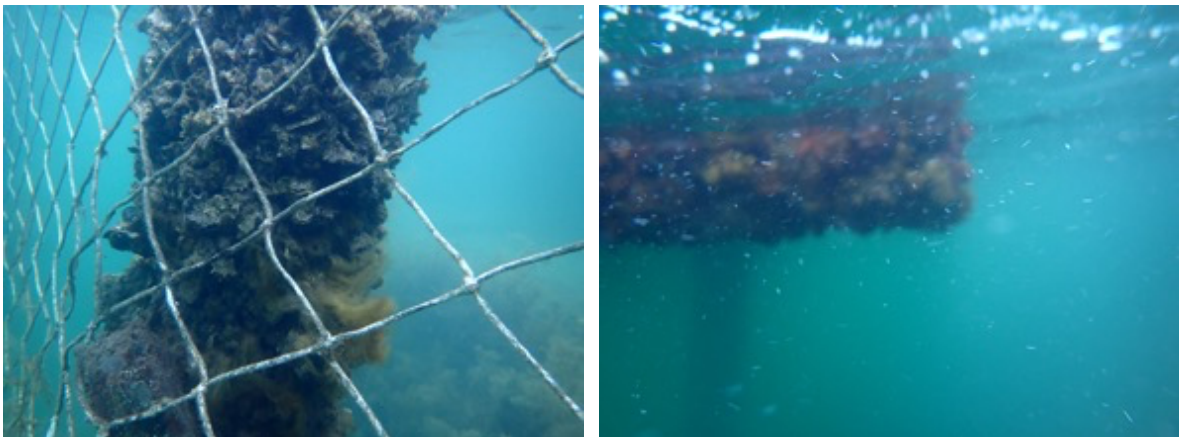
**Figure 18** Piles and Pontoon do not support algae in the shallows, likely due to flood waters.

- Piles associated with the facility support a good growth of oysters in the lower to subtidal (**Figure 18 left**) with less biota with depth due to silt smothering.

- The wetted surfaces of the floating pontoon at the site supports a relatively diverse attached and encrusting fauna (sponges, brzozoans, molluscs) but with almost no algae, (**Figure 18 right**) presumably due to constant freshwater flooding down McCarrs Creek.
