# Preliminary Geotechnical Assessment

**Project:** Alterations & Additions  
52 Collaroy Street, Collaroy NSW

**Ref:** AG 25329  
22 September 2025

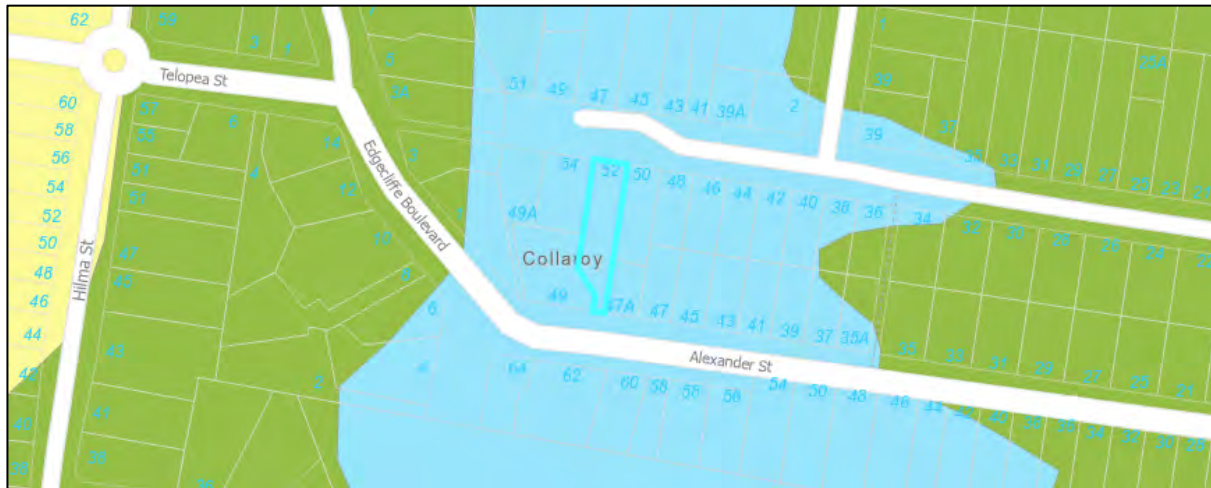
The site is mapped as **Area E** subject to specific landslip risk/geotechnical hazard mapping with reference to the Warringah (WLEP) Landslip Risk Map, Northern Beaches Council (**Image 1**).

**Figure 1.** Warringah Landslip Risk Map:  
52 Collaroy Street, Collaroy NSW (© NBC Maps)
