Geotechnical Assessment: Green Renovation Works - Bayview Golf Course, Bayview, NSW

P2309440JR01V01 April 2023

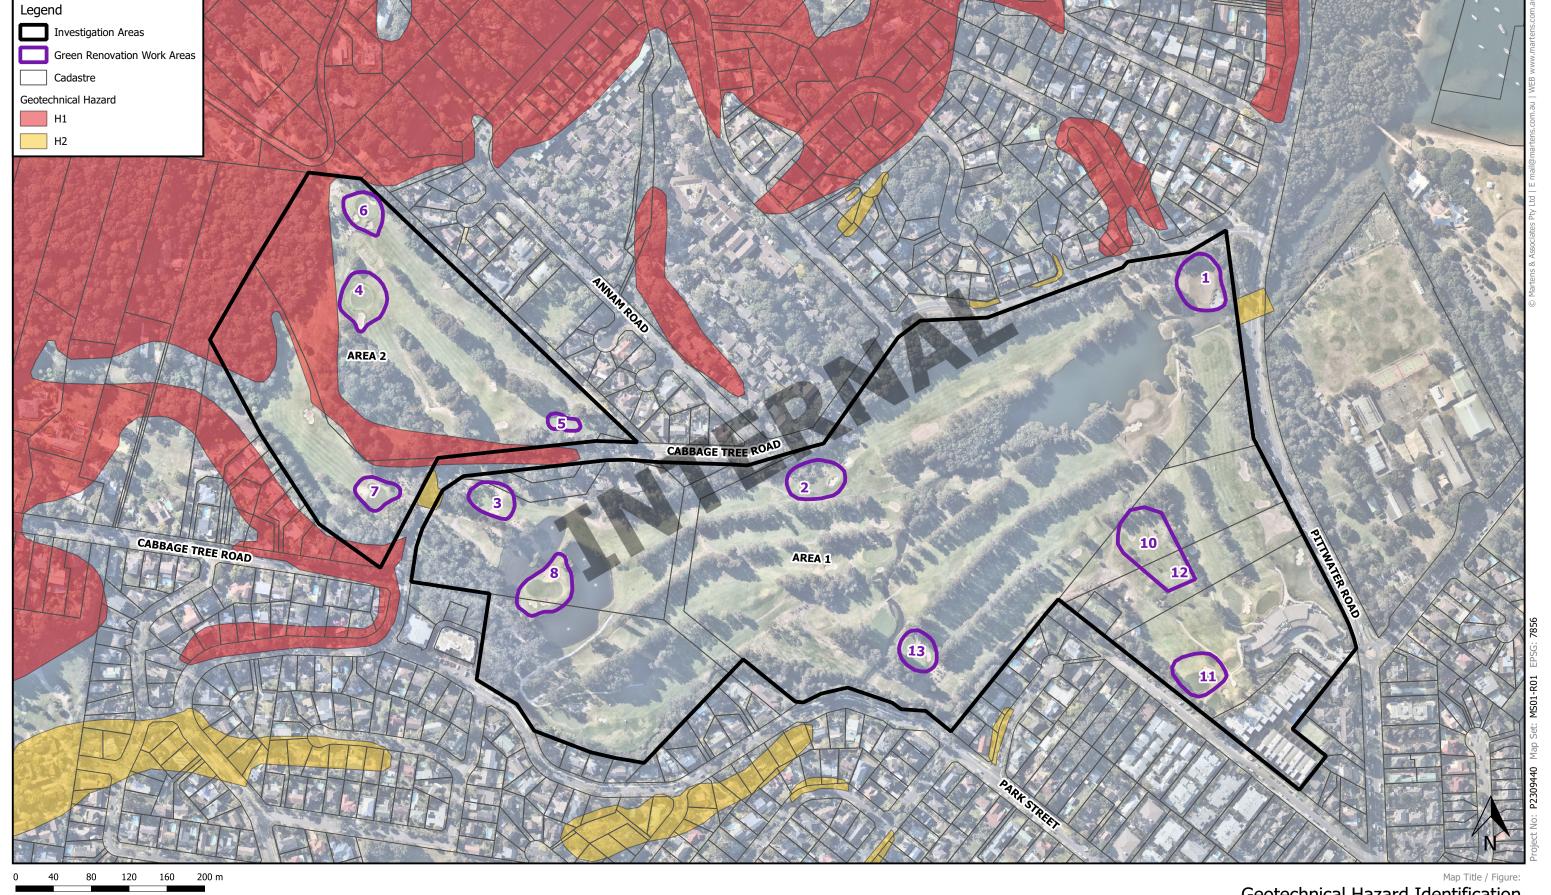
- Notes:
   Aerial from Nearmap (2021)
   Cadastre from NSW DFSI Clip and Ship (2023)
   Geotechnical hazard areas from Pittwater Local Environmental Plan LEP 2014

# **Geotechnical Hazard Identification**
