GEOTECHNICAL INVESTIGATION AND ASSESSMENT REPORT

FOR THE PROPOSED NEW DEVELOPMENT

1749-1753 PITTWATER ROAD, MONA VALE, NSW

JOB NO: 2025-136

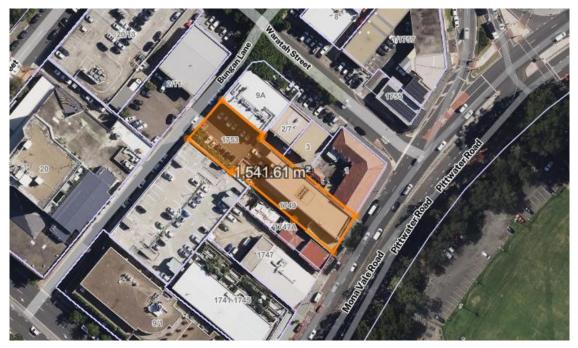
Figure 1. Site view (NSW Gov't Six Map Spatial Data).

The site is roughly rectangular in shape and comprises of both 1749 and 1753 Pittwater Road, Mona Vale. The site is gently ($\leq 5^{\circ}$) southeasterly dipping and extends from the road reserve of Bungan Lane down to the road reserve of Pittwater Road.

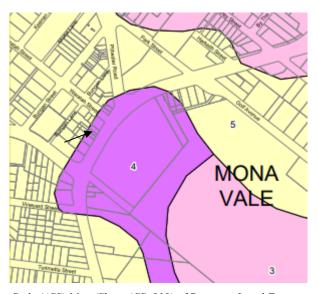
Figure 2. Acid Sulphate Soils (ASS) Map (Sheet ASS_018) of Pittwater Local Environmental Plan 2014. Black arrow indicating location of the site (Class 4 area).

Reference to Northern Beaches (Pittwater Council's Local Environment Plan (LEP) 2014) including Landslip Risk Map (GTH_018) and Acid Sulfate Soils Map (Sheet ASS_018), the property is not categorised as subject to landslip however it is classified as both Class 4 and Class 5 Acid Sulfate Soils Hazard. The Class 4 designation requires an assessment for works more than 2 m below the natural ground surface and works by which the water table is likely to be lowered more than 2 m below the natural ground surface.

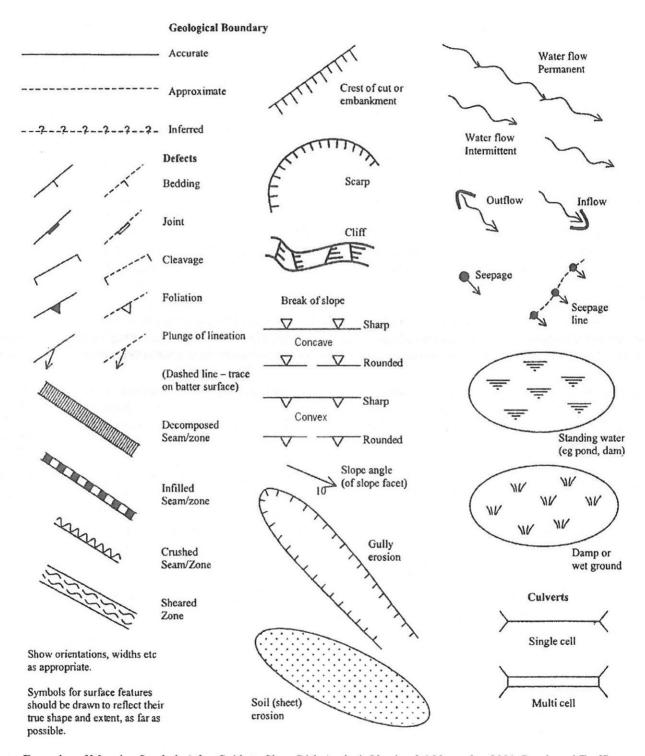
Examples of Mapping Symbols (after Guide to Slope Risk Analysis Version 3.1 November 2001, Roads and Traffic Authority of New South Wales).

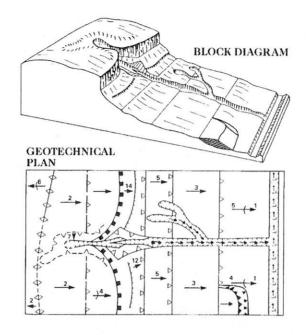
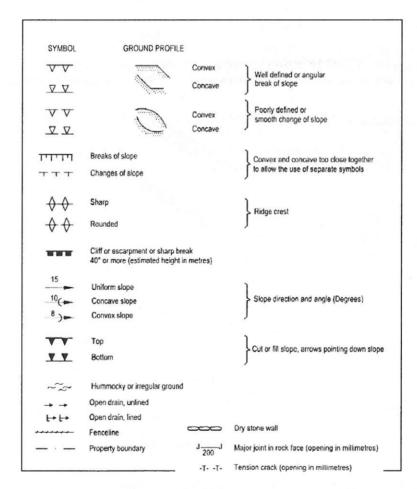
Example of Mapping Symbols

(after V Gardiner & R V Dackombe (1983). Geomorphological Field Manual. George Allen & Unwin).
