PRELIMINARY GEOTECHNICAL ASSESSMENT:

69 Evans Street, Freshwater

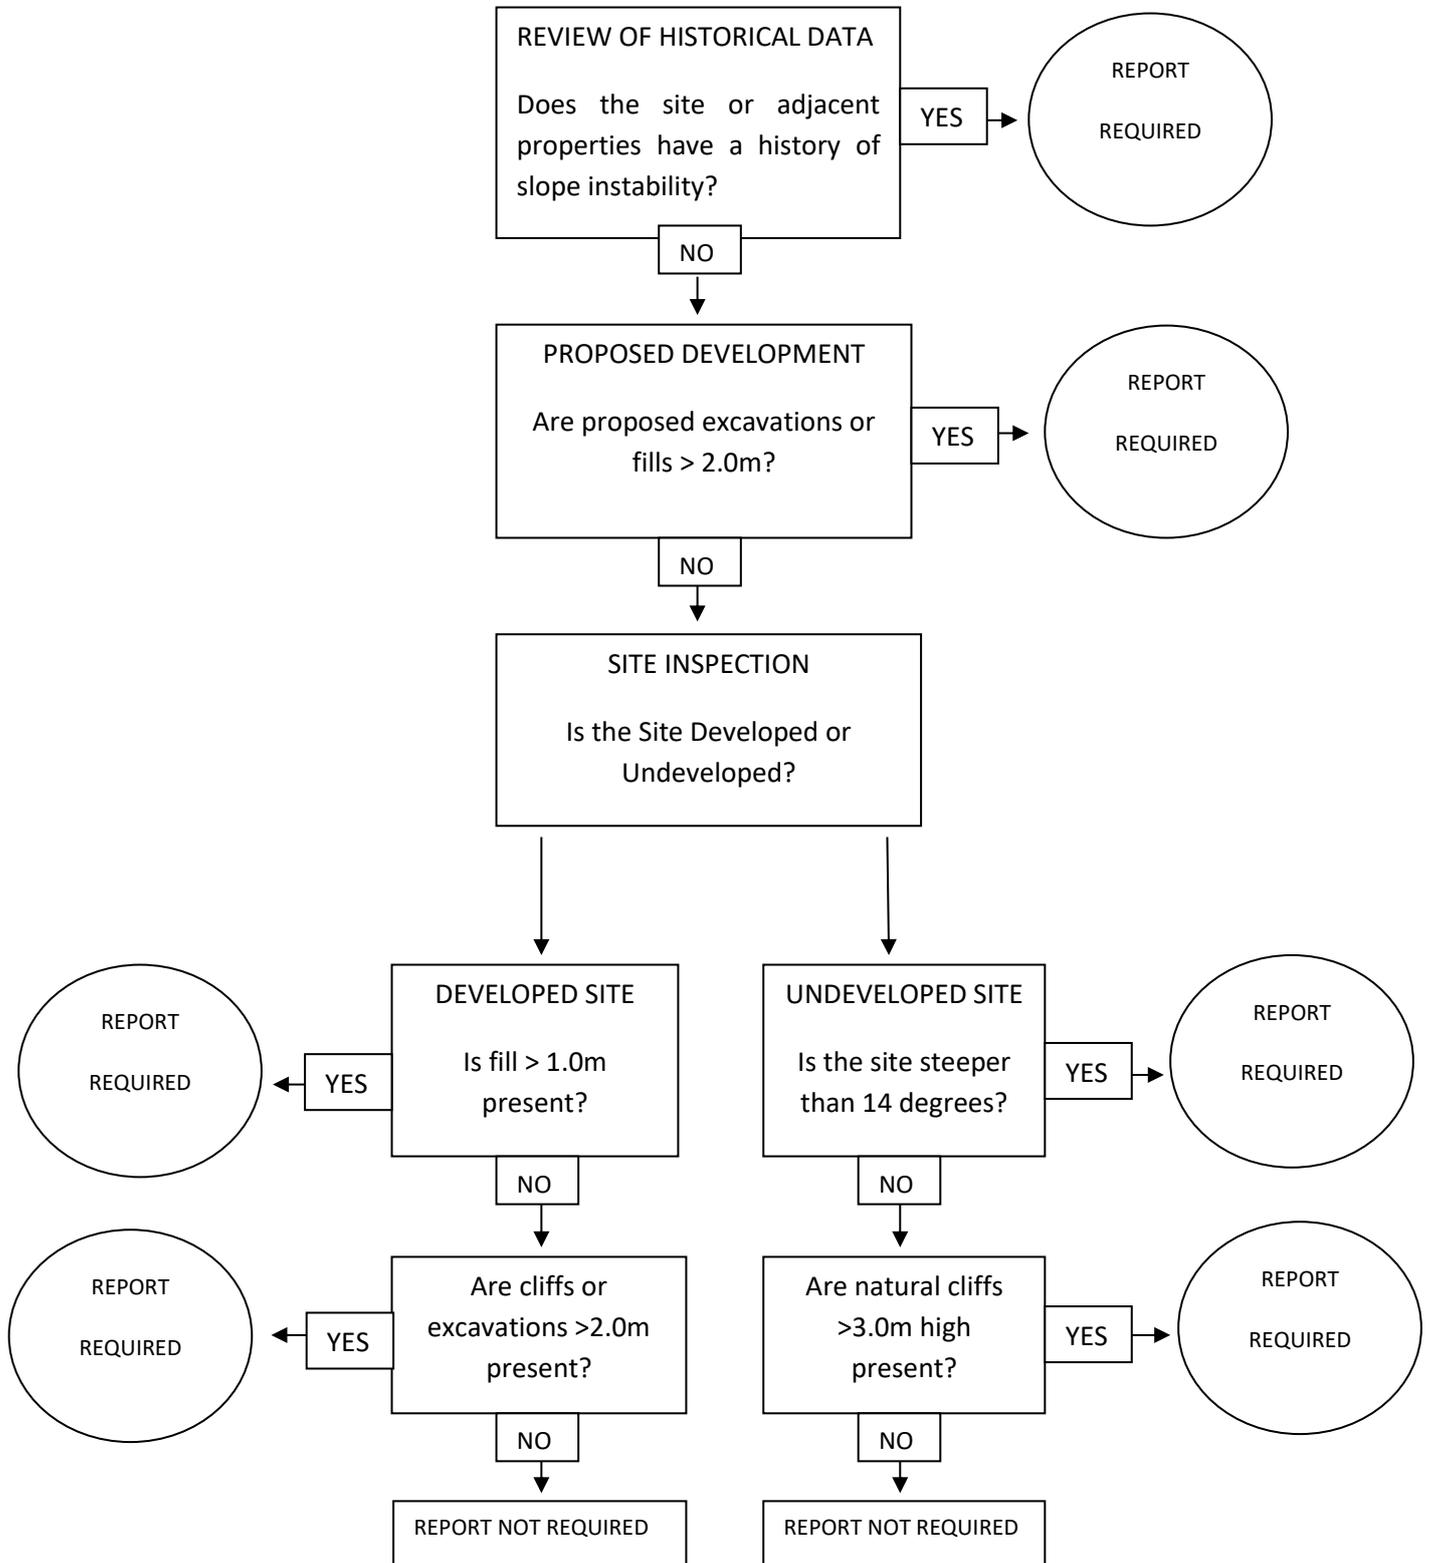
Preliminary Assessment Flow Chart – Northern Beaches Council (Warringah)

The proposed development and site conditions were considered and applied to the Council Flow Chart.
