AS2870-2011 SITE CLASSIFICATION

Icon Homes
P O Box 311
North Ryde BC NSW

No 3 Hill Street Fairlight
New South Wales

Our REF: AWT 69800

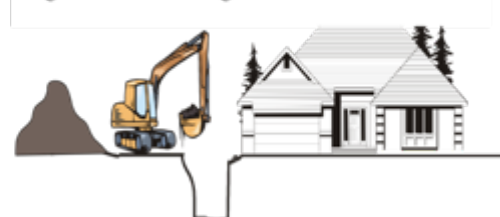
Fig. 11 De-stabilizing house foundations

- Ensuring that excavations are well supported or are dug to avoid collapses. (Fig. 11)
- Constructing well-compacted and retained 'soil aprons' around the building to stop erosion.

- Special considerations if any excavations are to be dug near adjoining structures. (Fig. 11)
- Sloping the soil and paths away from the building by the minimum amount required by the building regulations to prevent water flowing towards the building foundations. (Fig. 10 & 18)

- Running machinery over shallow drain pipes may break them causing leaks and subsequent foundation movements.
- Any excavations close to building footings can cause them to sink by disturbing the foundation material or by drying the foundation clay. (Fig 11)
