Geotechnical Investigation Report

Proposed Residential Development

**1130 Pittwater Road, Collaroy NSW
(Lot 1 on DP121939)**

Report No. R23146.Rev2

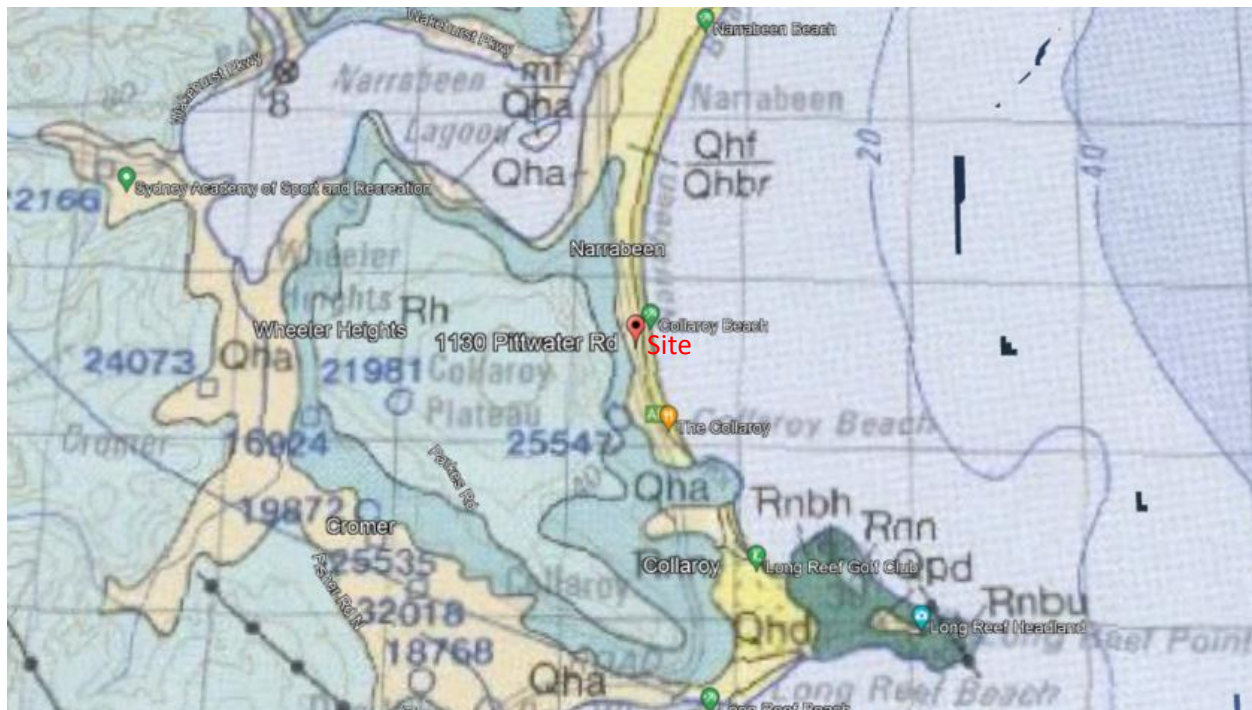
According to the Sydney 1:100 000 Geological Series Sheet, the site is underlain by the Quaternary age alluvial consist of sands and sandy muds.

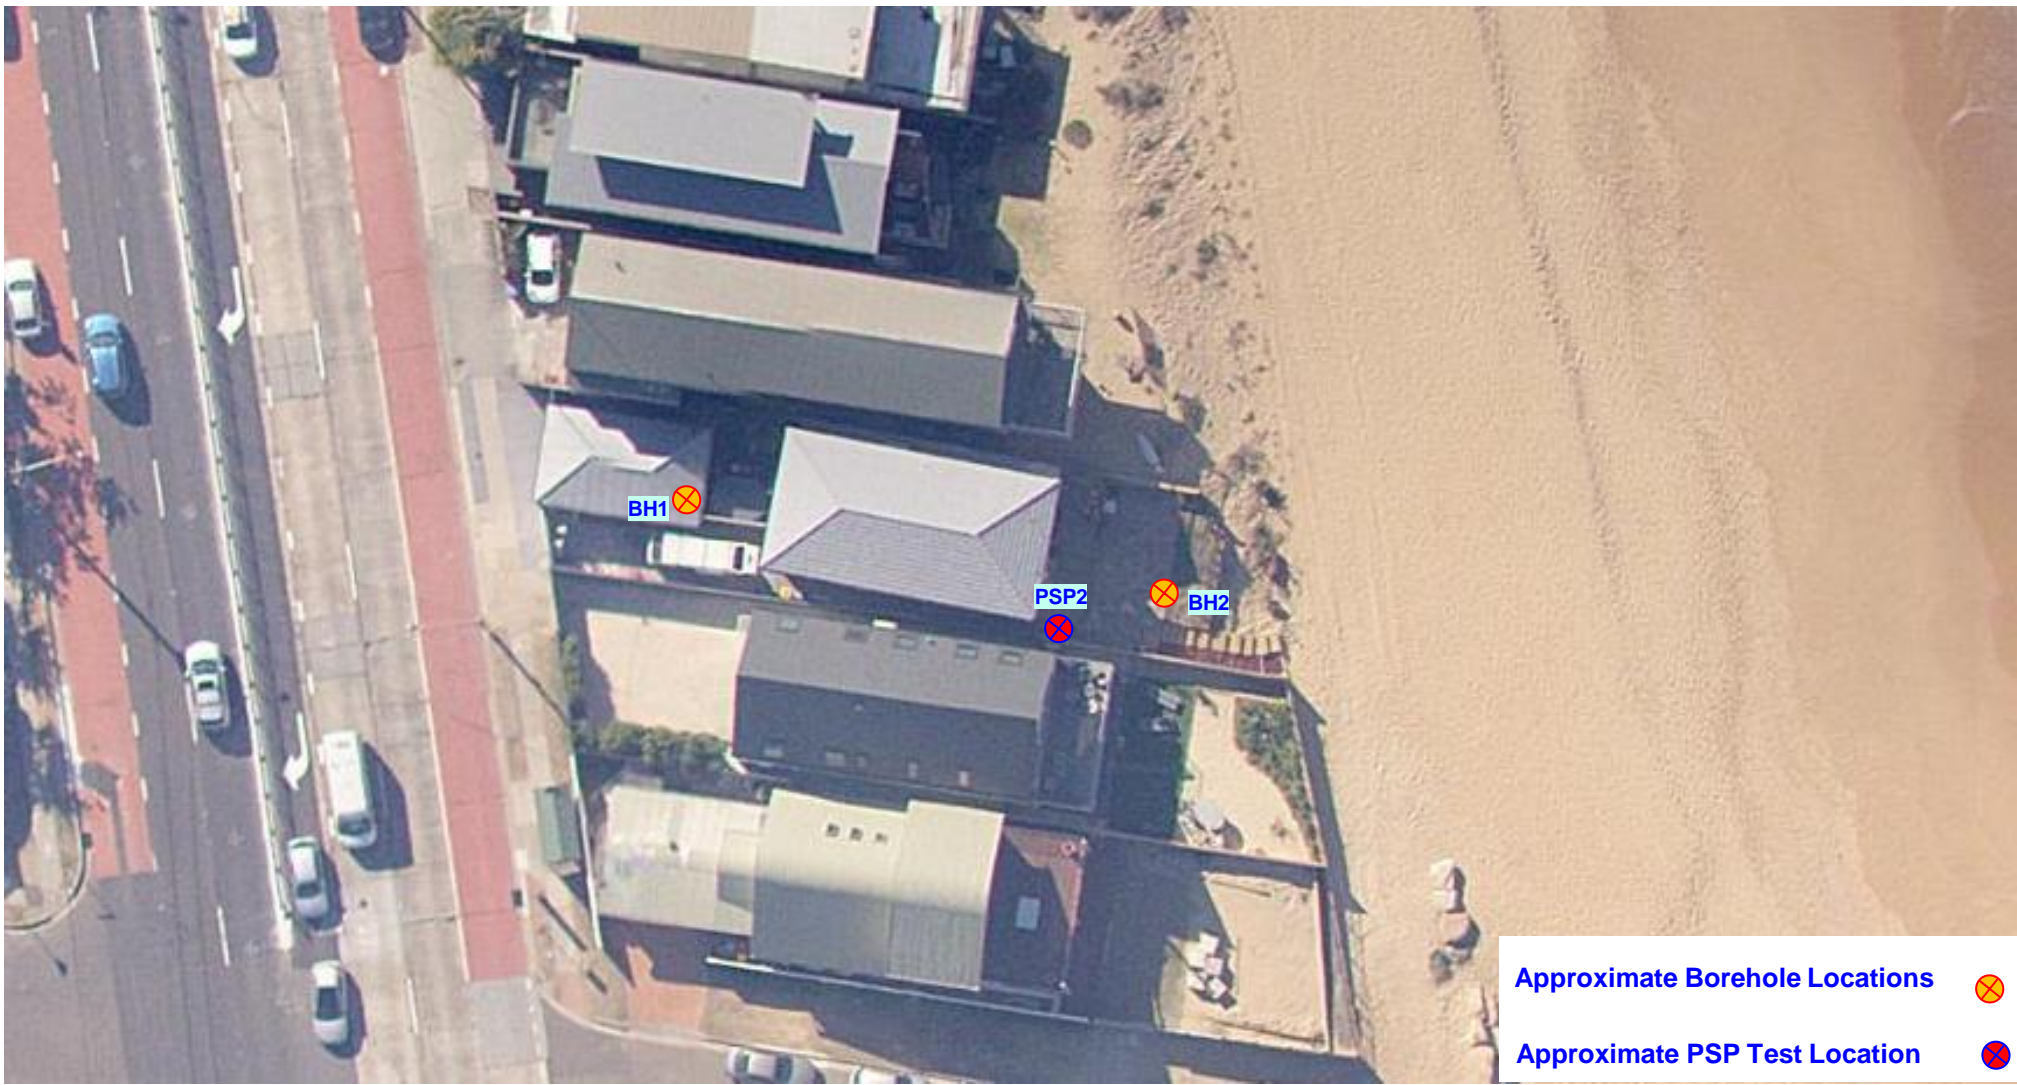
Approximate Borehole Locations

The field work comprised drilling of two auger boreholes (BH1 and BH2) across the site. BH1 was drilled in a garden bed at the front of the allotment and BH2 was drilled in the sandy material across the crest of the sea wall at the rear of the site. The boreholes were drilled using a Hilux mounted Christie Engineering drilling rig and continued to the maximum reach of the equipment, 9.0 m.

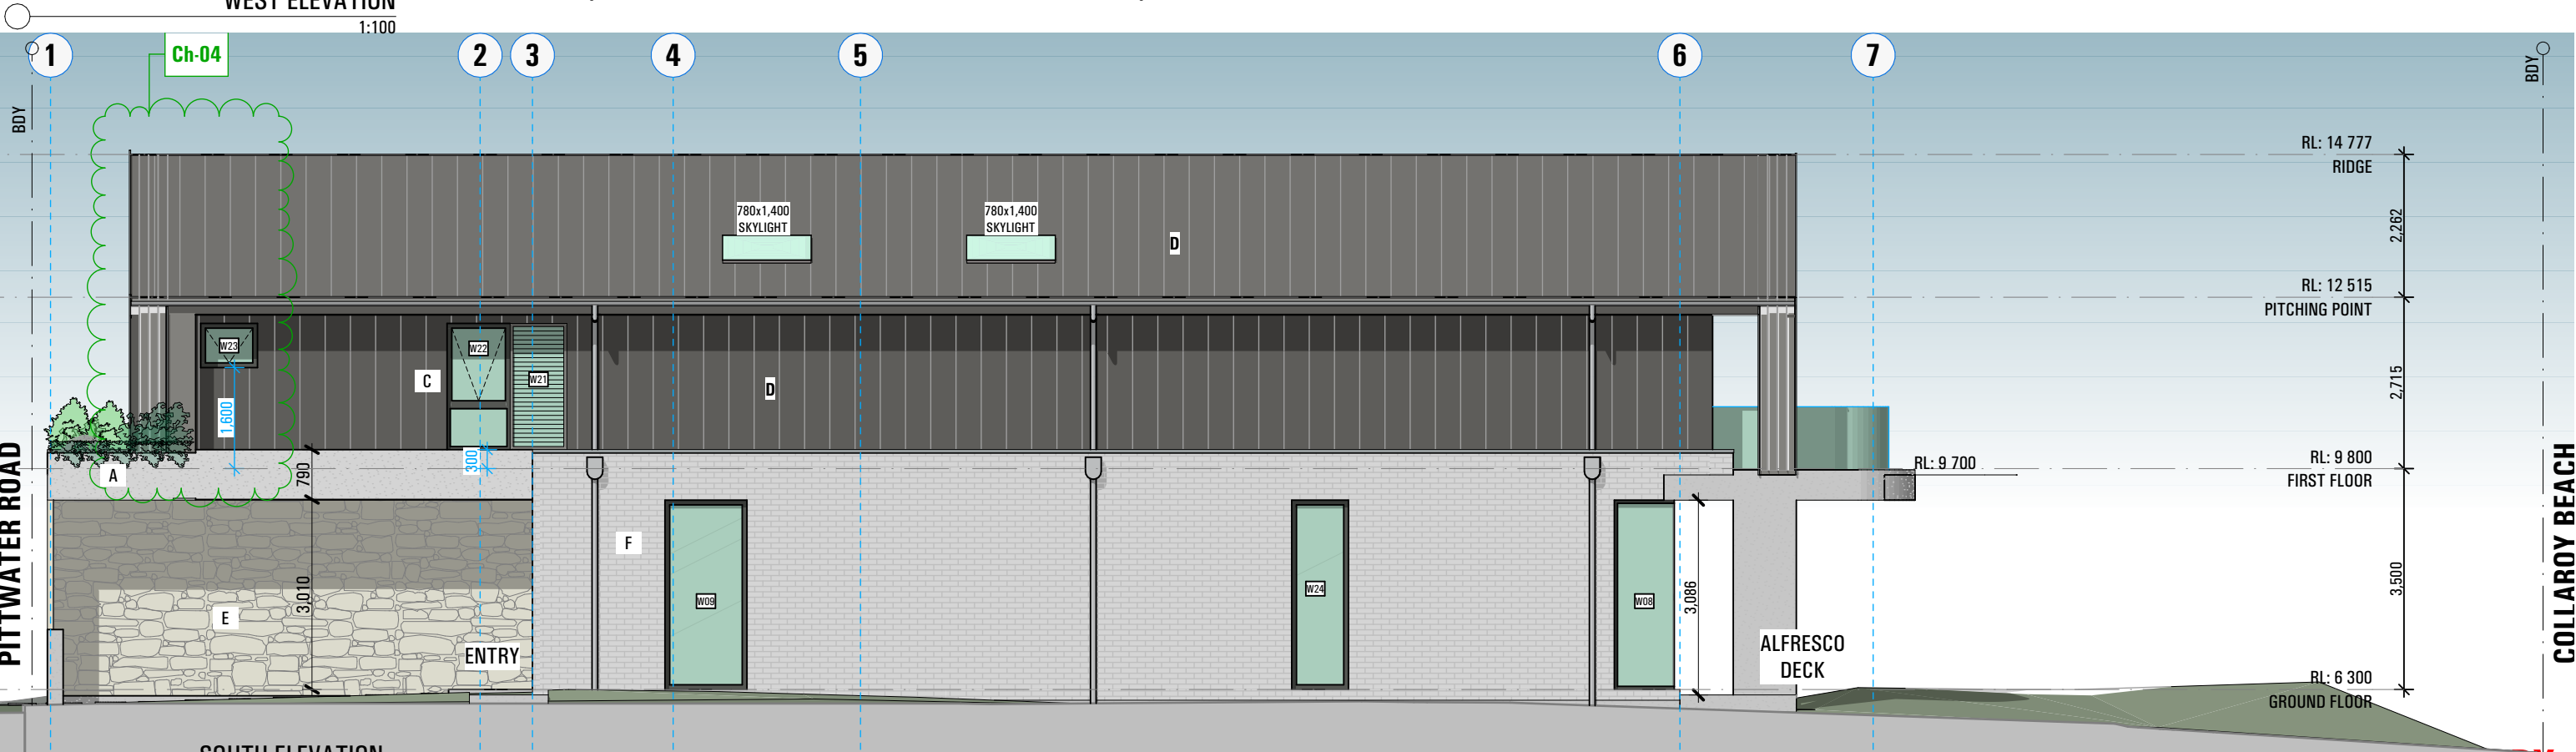
SOUTH ELEVATION
1:100

S4.55 MODIFICATIONS	
Change ID	Name
Ch-01	Courtyard wall moved into courtyard
Ch-02	Alfresco deck reshaped
Ch-03	New indow to first floor bathroom (W25)
Ch-04	Western wall in first floor moved forward by 650mm & Balcony removed
Ch-05	New window to ground floor Dining (W24)
Ch-06	W04 - Kitchen window size change
Ch-07	Skylights relocated from stairwell to hallway
Ch-08	Eastern balcony screen reduced in length

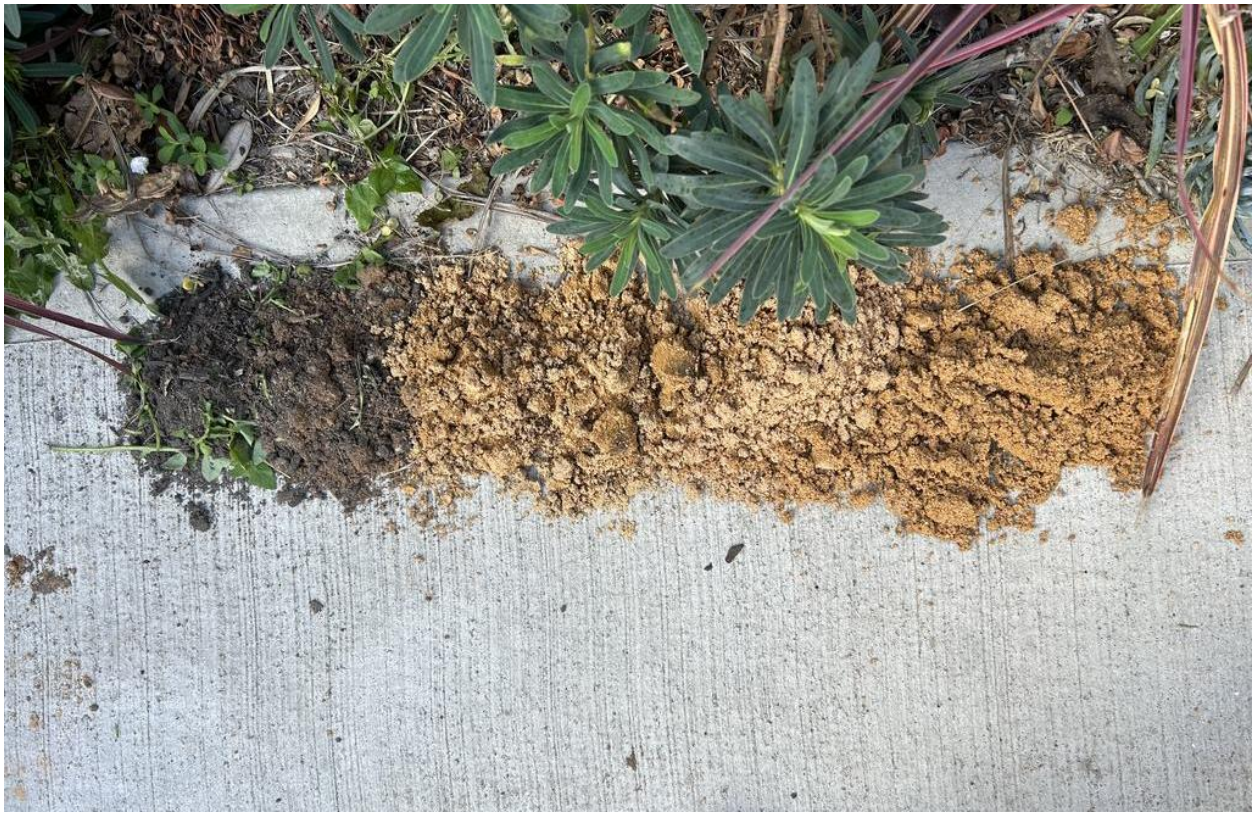
Samples of subsurface material - BH1

The subsurface material encountered in the boreholes comprised sands and silty sands in dry to moist conditions to the termination depth of boreholes. The subsurface sands included traces of shells fragments below approximate depth of 7 m in the boreholes. BH2 was drilled across the recently constructed seawall and fill material consisting of very loose sands continued to approximate depth of 2 m.

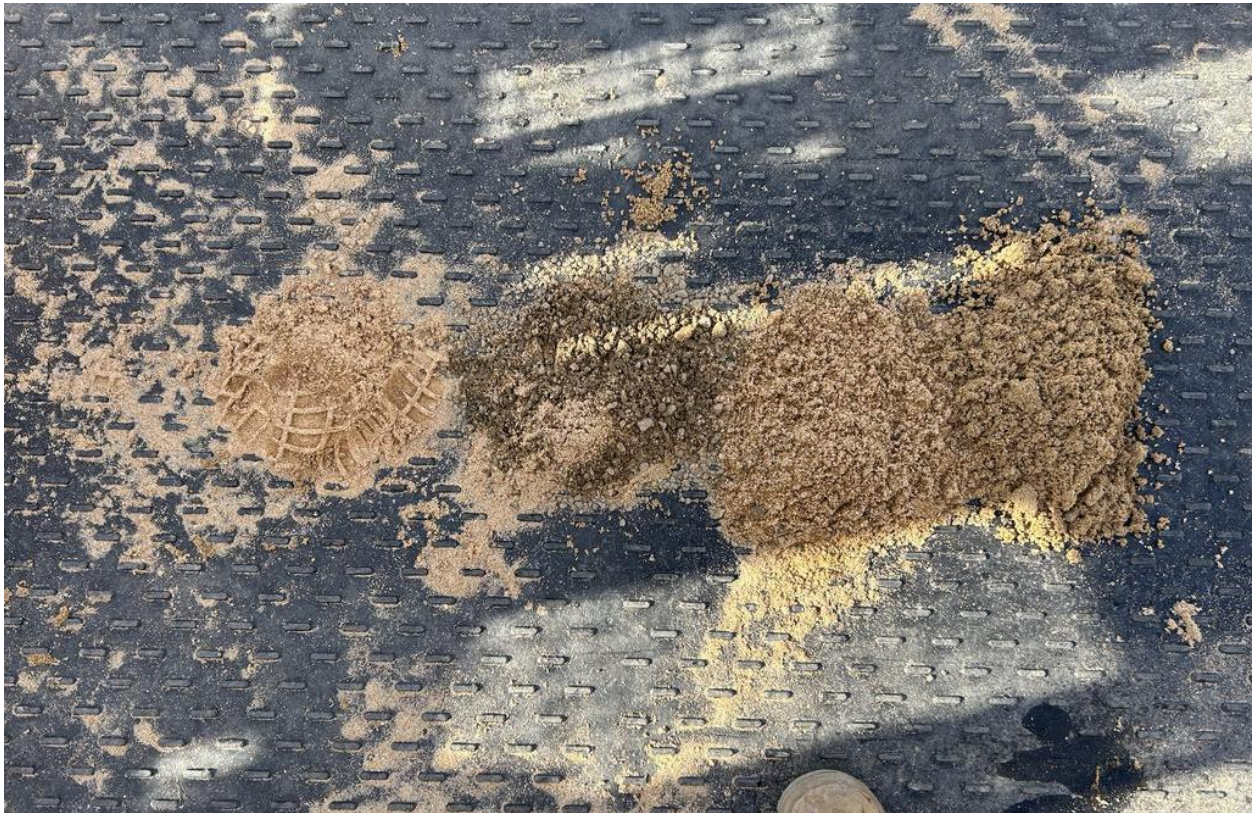
Samples of subsurface material – BH2

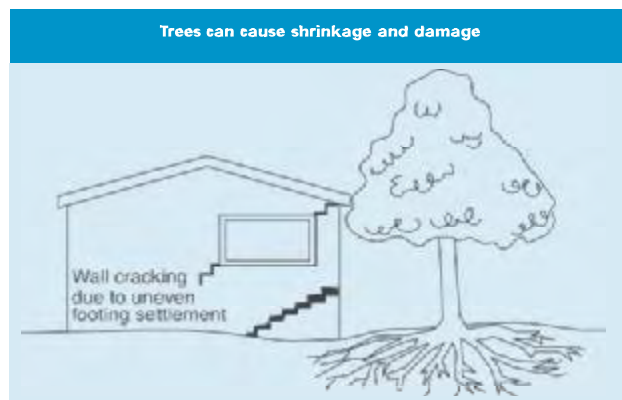
As the moisture absorption process completes its journey to the innermost areas of the building, the internal footings will rise. If the spread of moisture is roughly even, it may be that the symptoms will temporarily disappear, but it is more likely that swelling will be uneven, creating a difference rather than a disappearance in symptoms. In buildings with timber flooring supported by bearers and joists, the isolated piers will rise more easily than the strip footings or piers under walls, creating noticeable doming of flooring.

As the weather pattern changes and the soil begins to dry out, the external footings will be first affected, beginning with the locations where the sun's effect is strongest. This has the effect of lowering the external footings. The doming is accentuated and cracking reduces or disappears where it occurred because of dishing, but other cracks open up. The roof lines may become convex.
