Development Application for \_\_\_\_\_ Civia \_\_\_\_\_  
Name of Applicant  
Address of site \_\_ 1102 Barrenjoey Road, Palm Beach \_\_\_\_\_

REPORT TO  
**CIVIA**

ON  
**THREE-DIMENSIONAL (3D) NUMERICAL ANALYSIS**

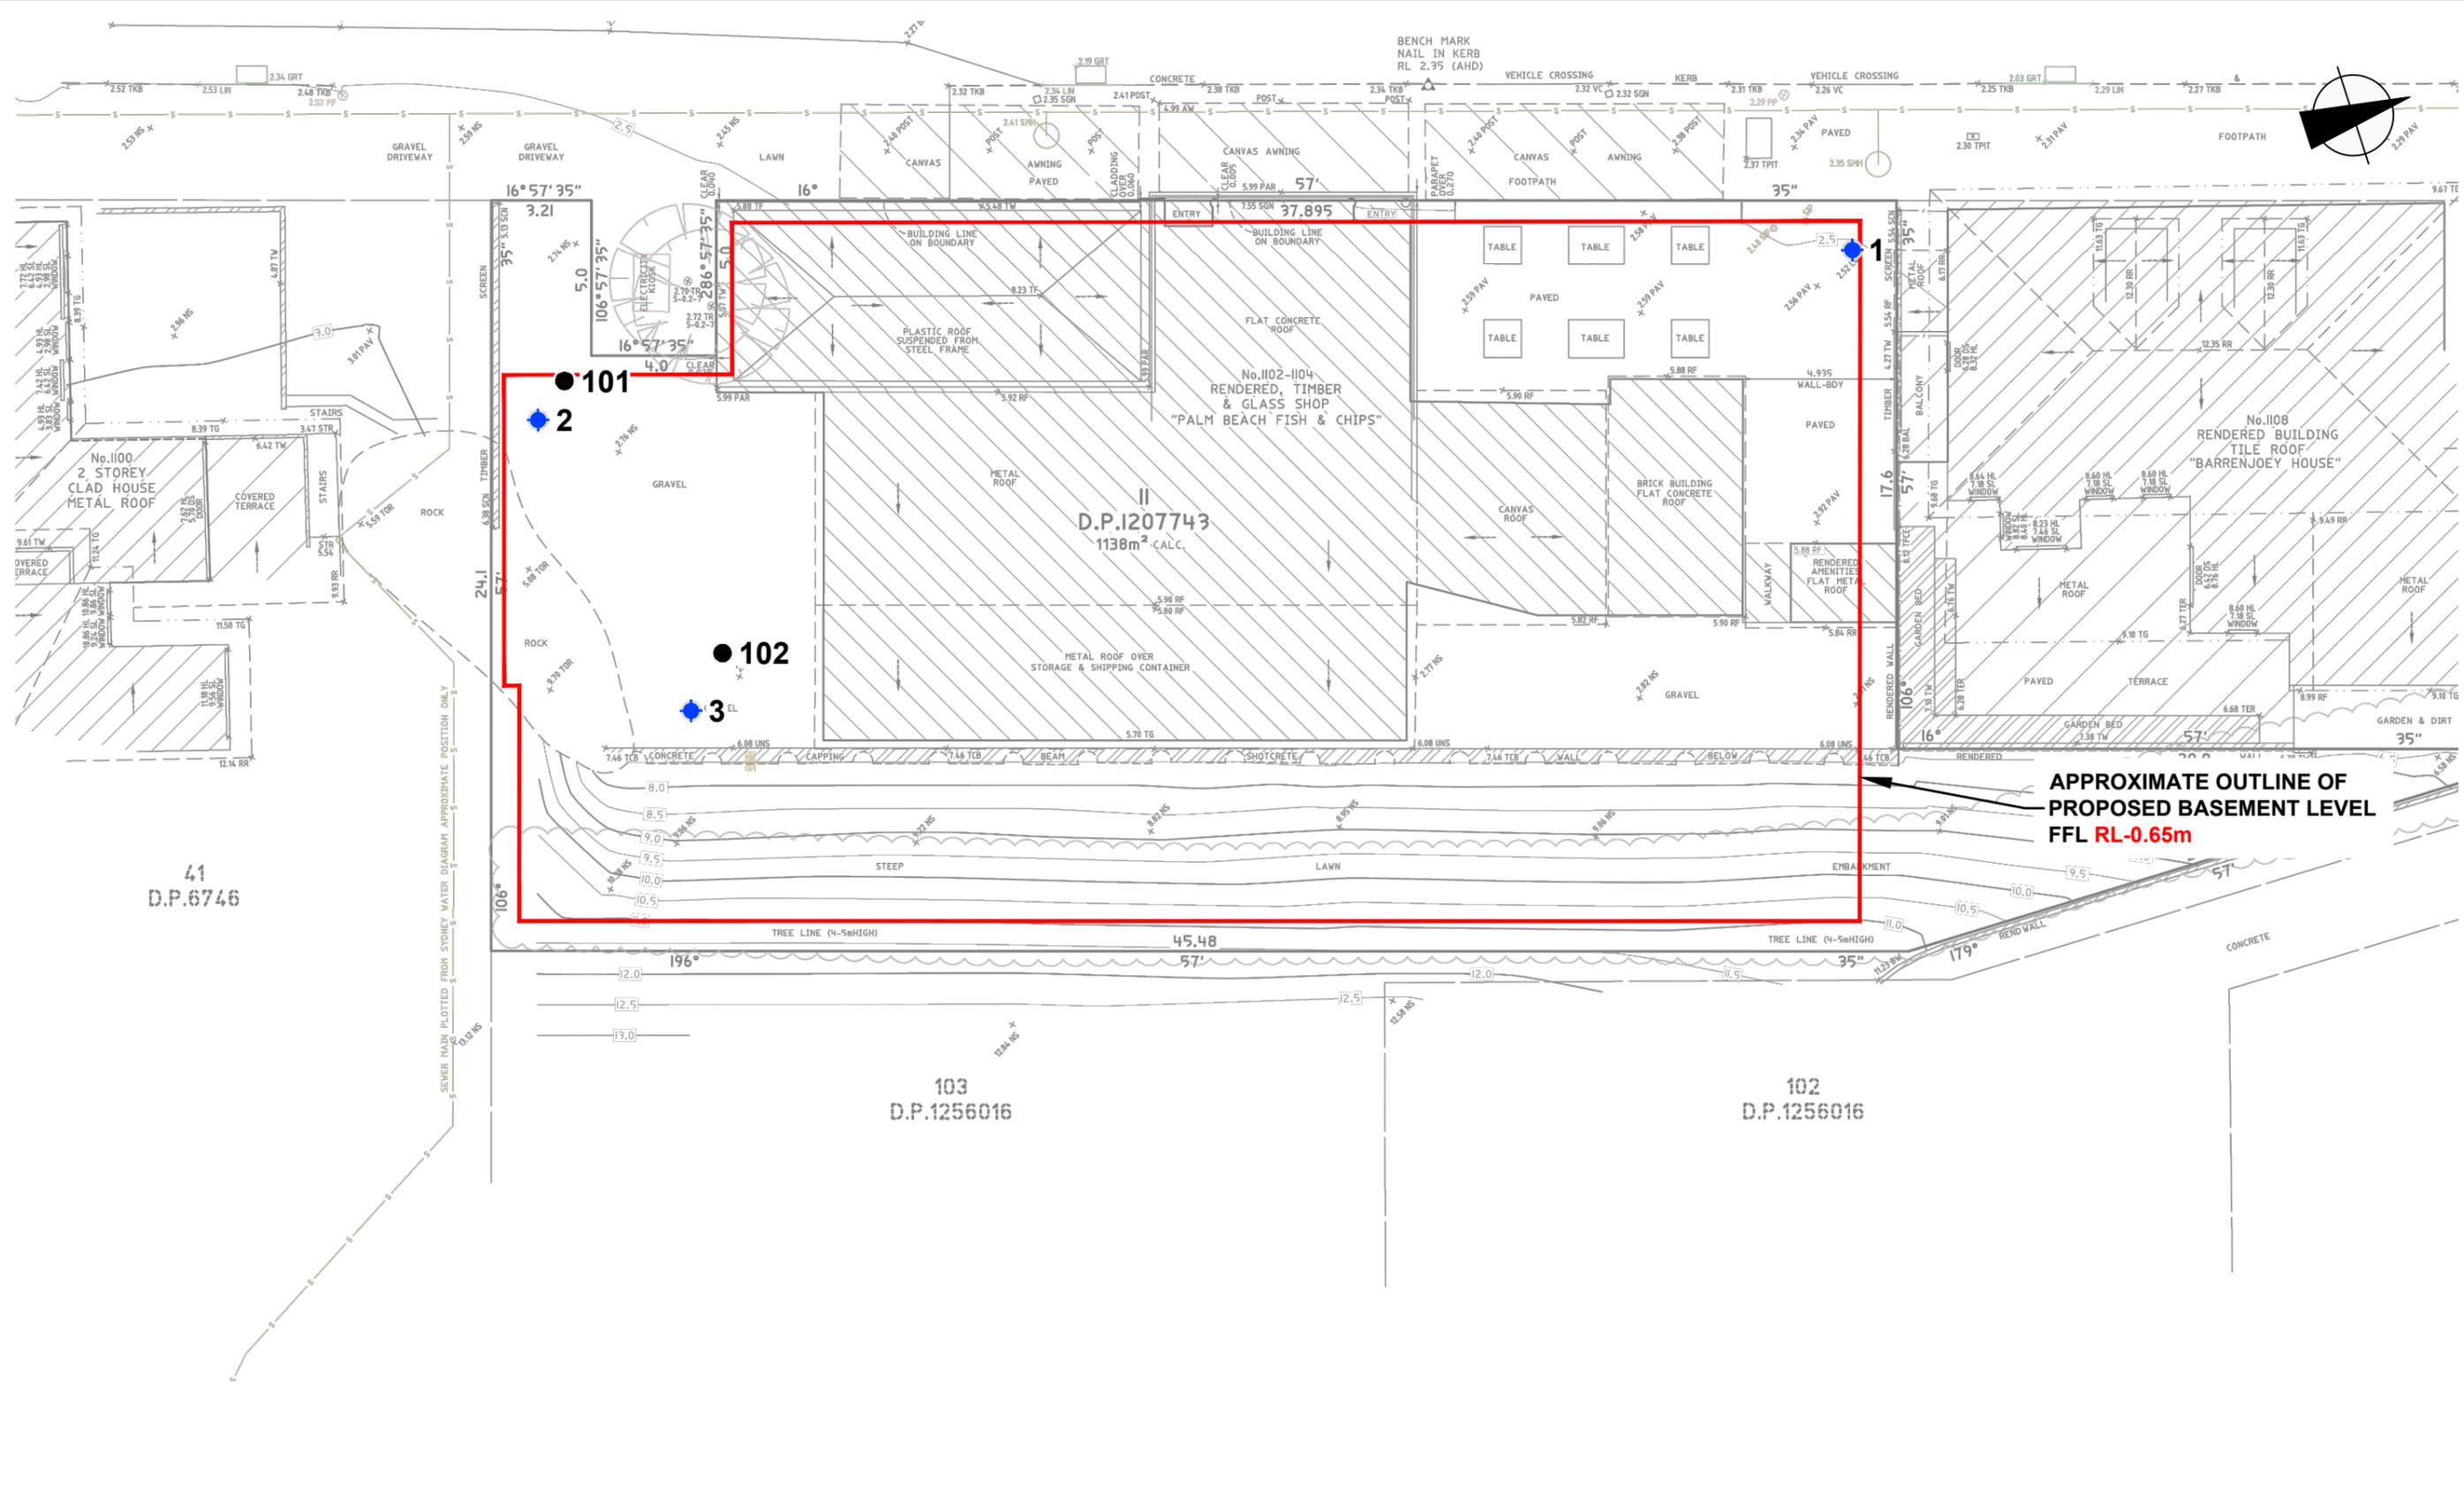
**APPROXIMATE OUTLINE OF PROPOSED BASEMENT LEVEL FFL RL -0.65m**

<p>Title:</p> <p><b>PROPOSED DEVELOPMENT FOOTPRINT</b></p>	
<p>Location: 1102 - 1106 BARRENJOEY ROAD, PALM BEACH, NSW</p>		<p>Report No: 33618YJrptrev4</p>	
<p>Figure No: 2</p>		<p><b>JKGeotechnics</b></p>

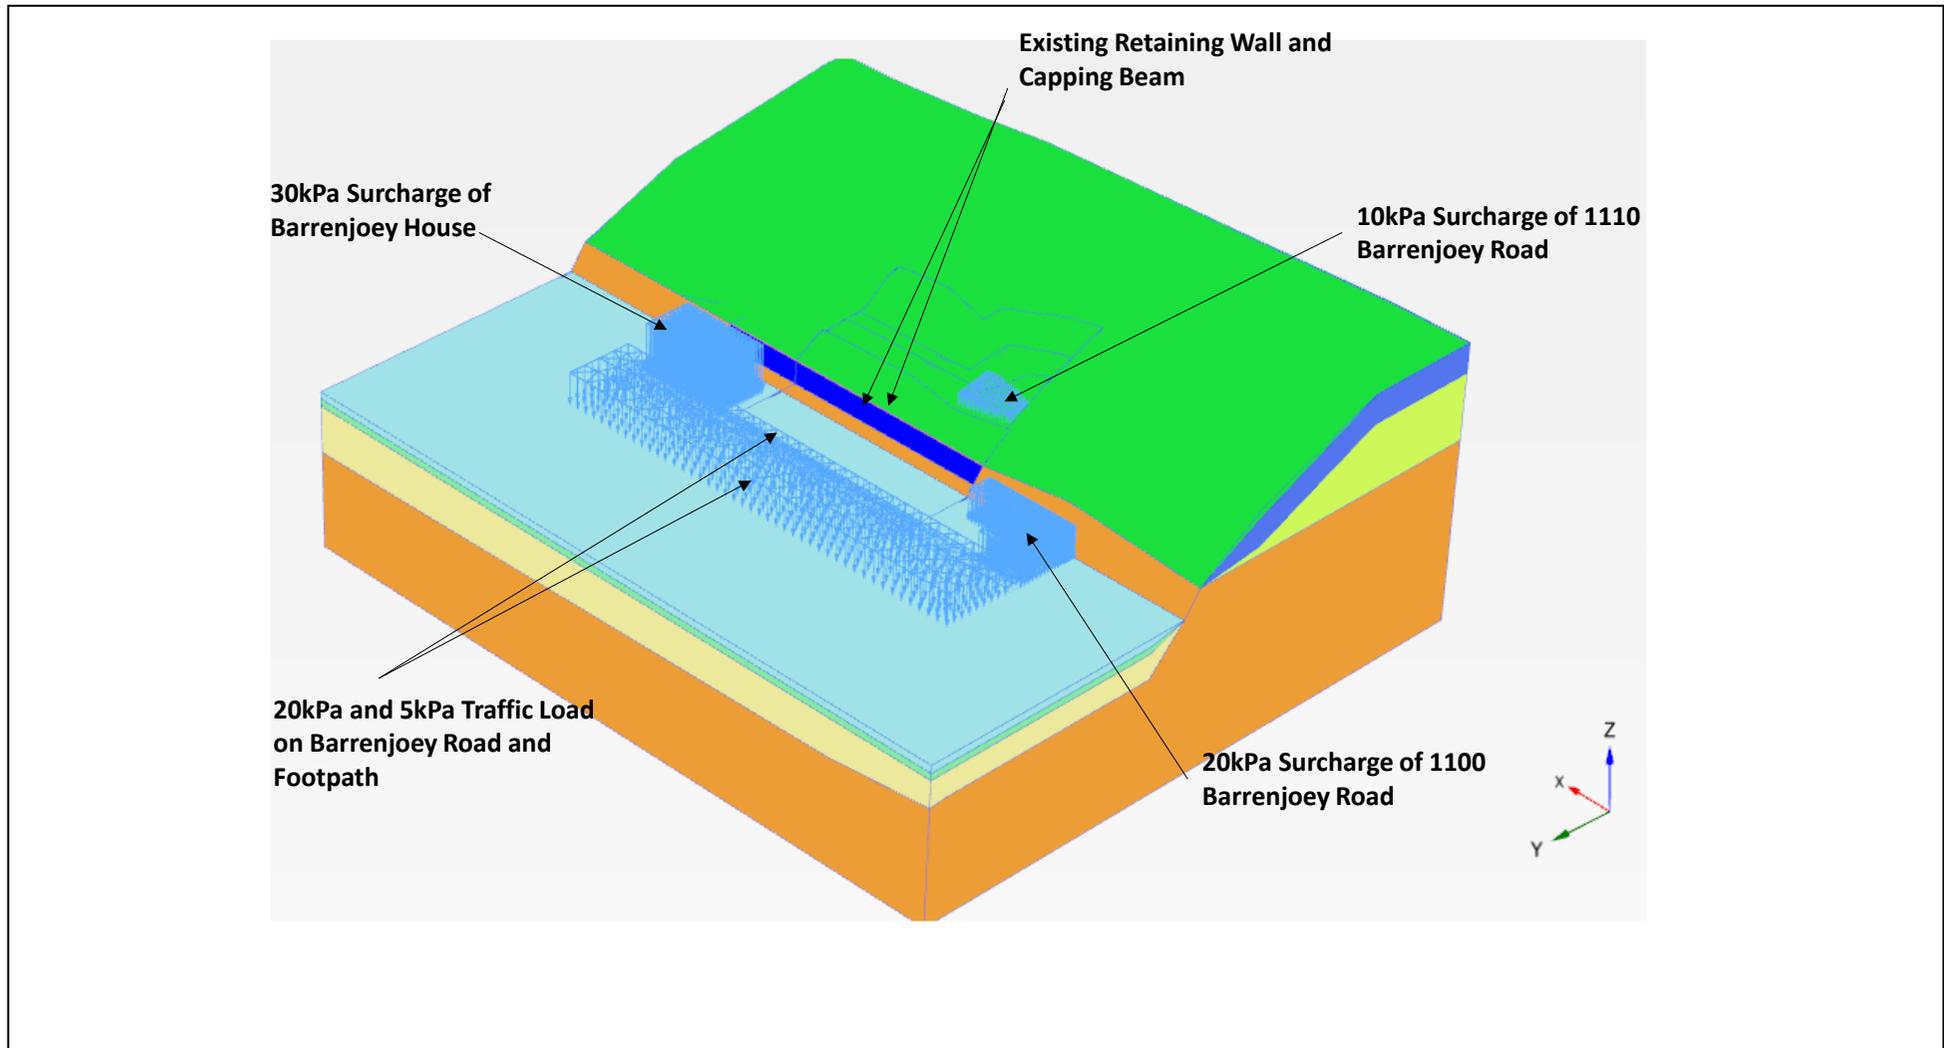
Existing Site Conditions

Figure 3: Existing Site Conditions

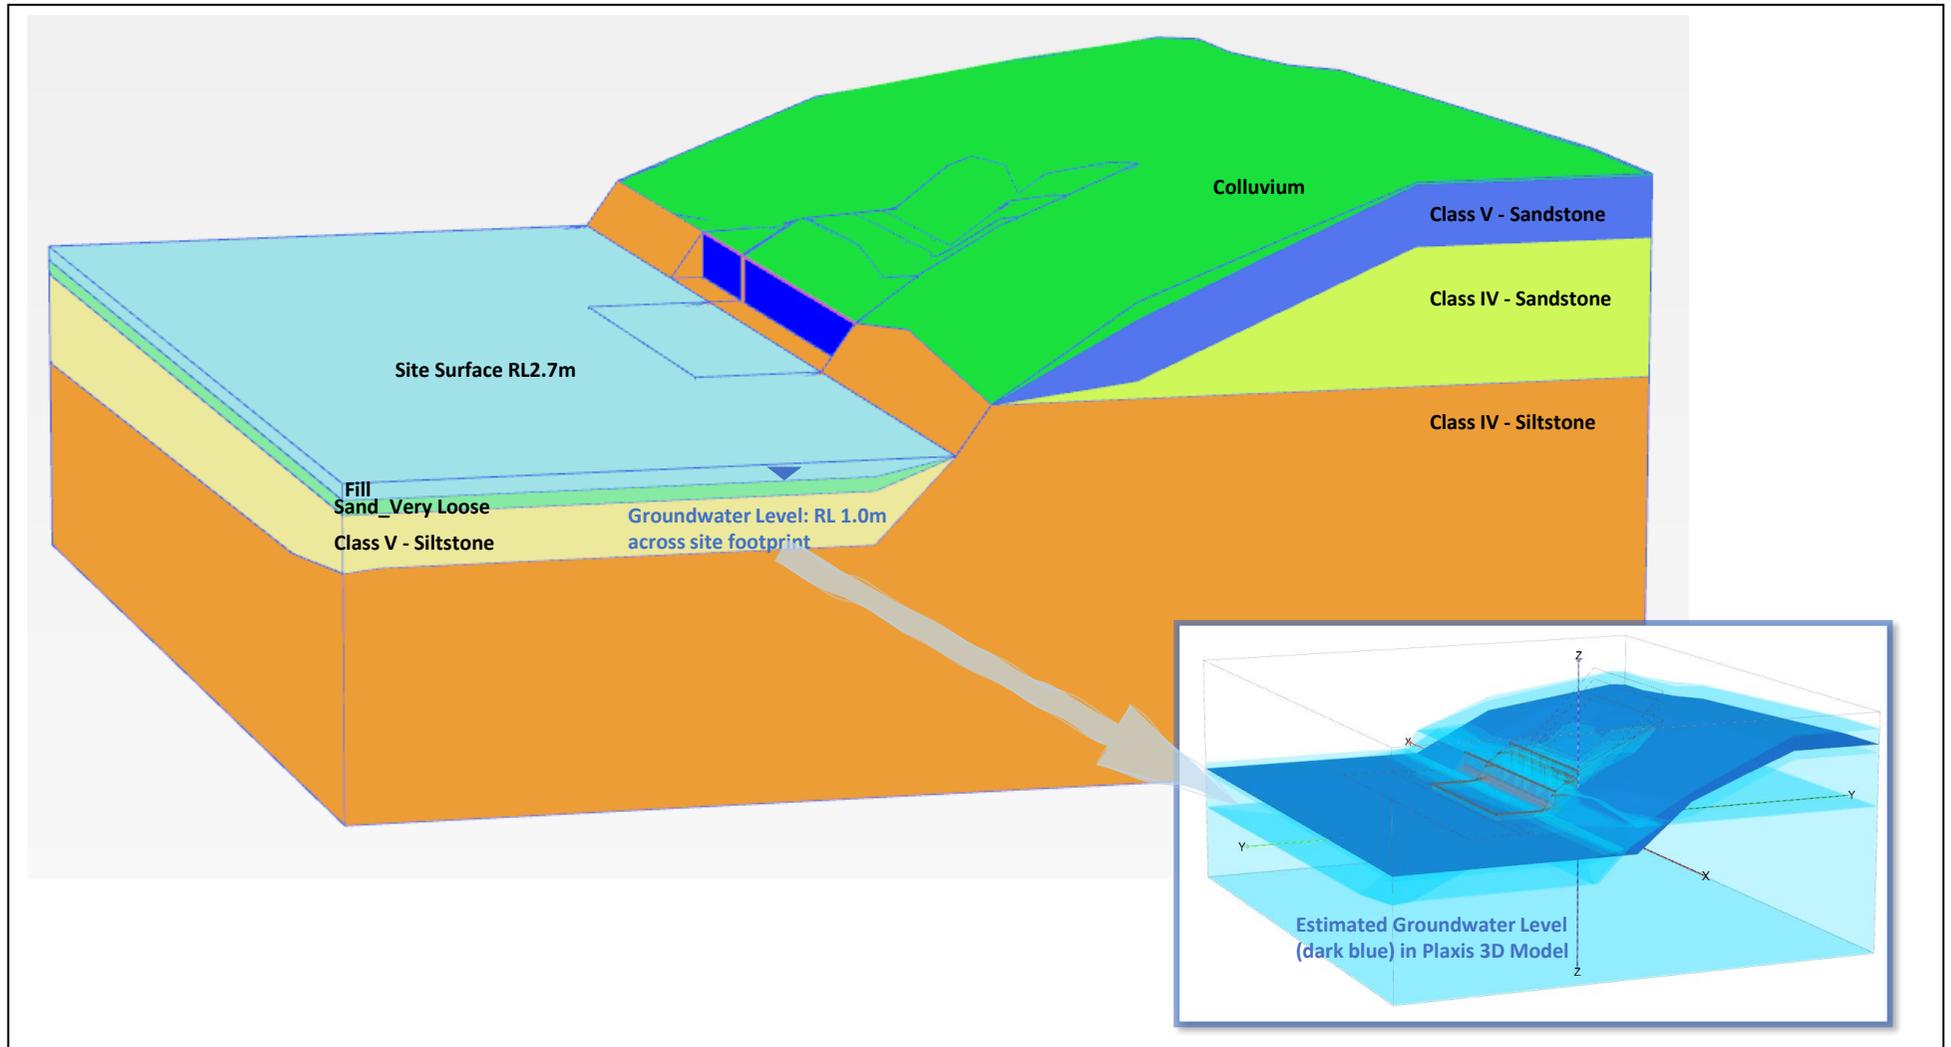
Assumed Topographical and Subsurface Profile

The subsurface profile was based on the results of the geotechnical investigations. Due to the limitations of 3D modelling, some generalisation of the profile was required to prevent numerical inaccuracies and computational difficulties occurring in the analysis due to thin and tapered soil layers formed due to linear interpolation between subsurface conditions nominated at inputted borehole locations.

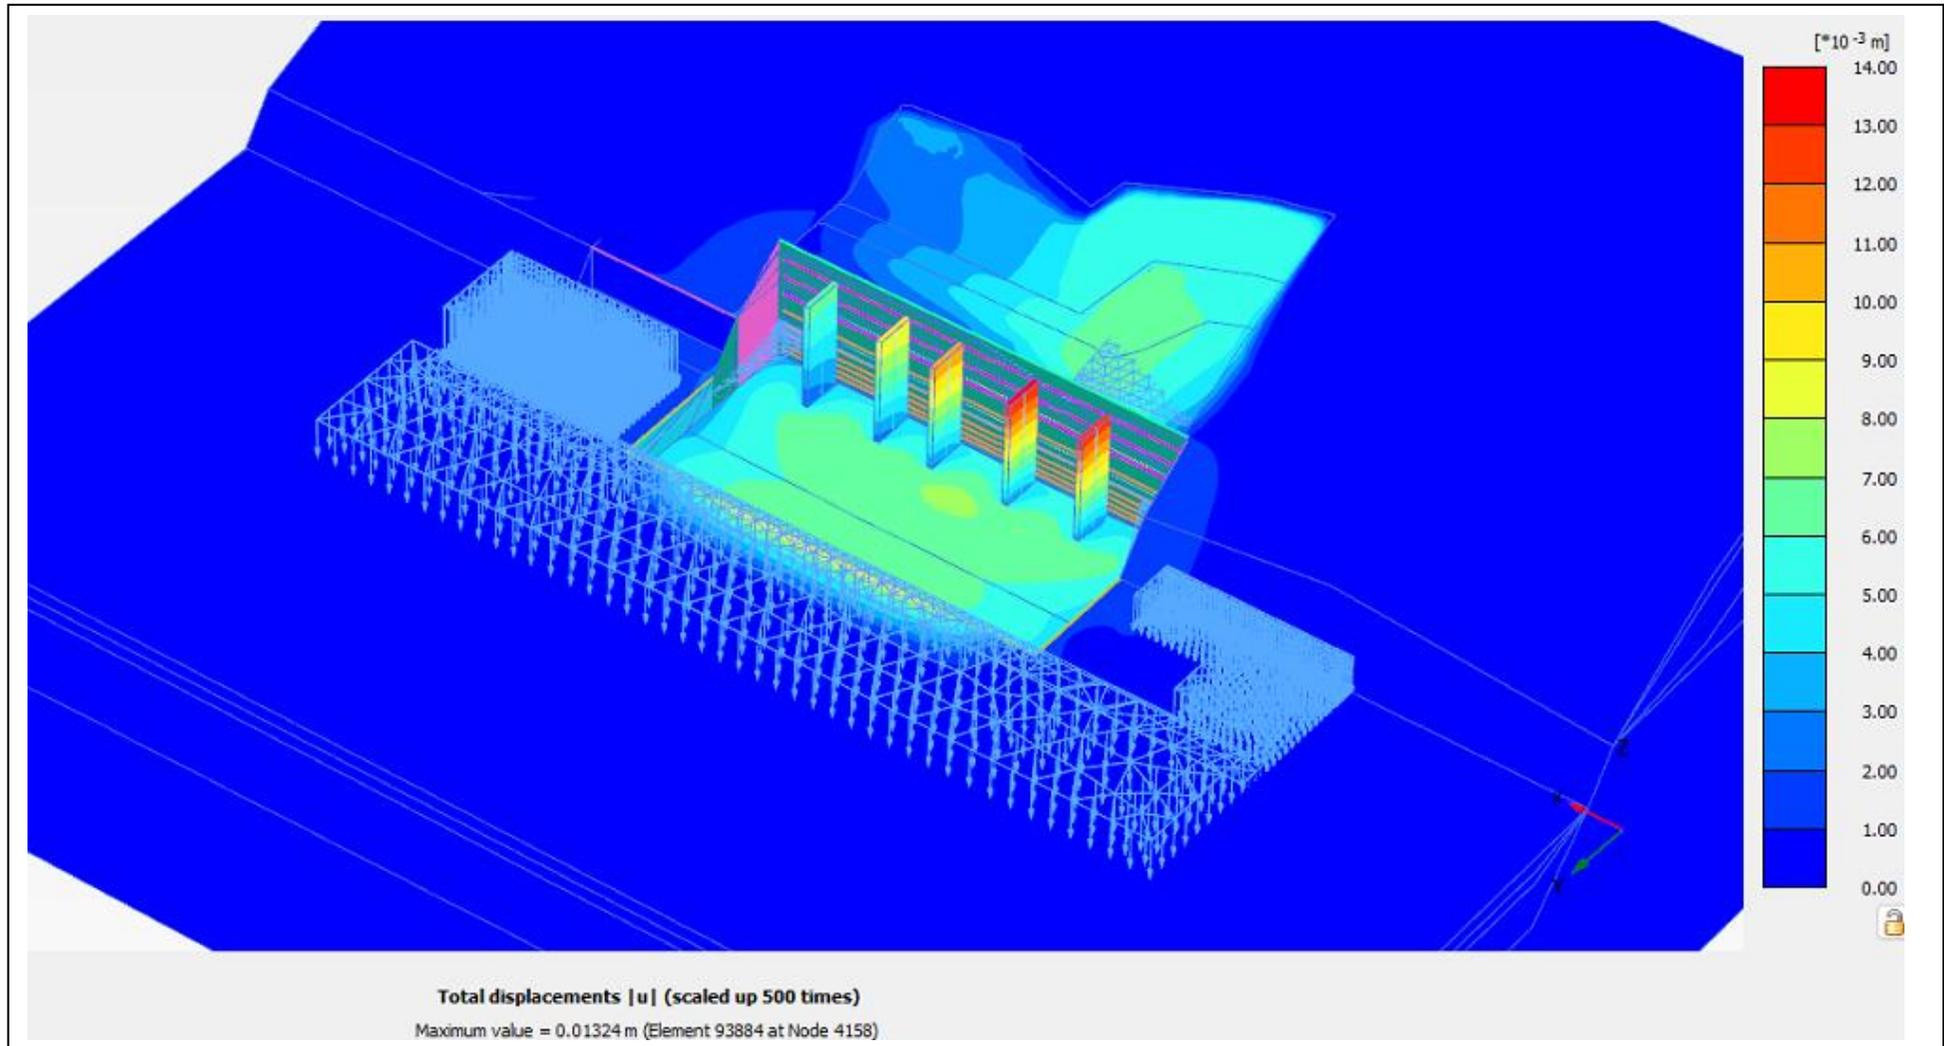
Maximum Displacements – Eastern and Northern Walls

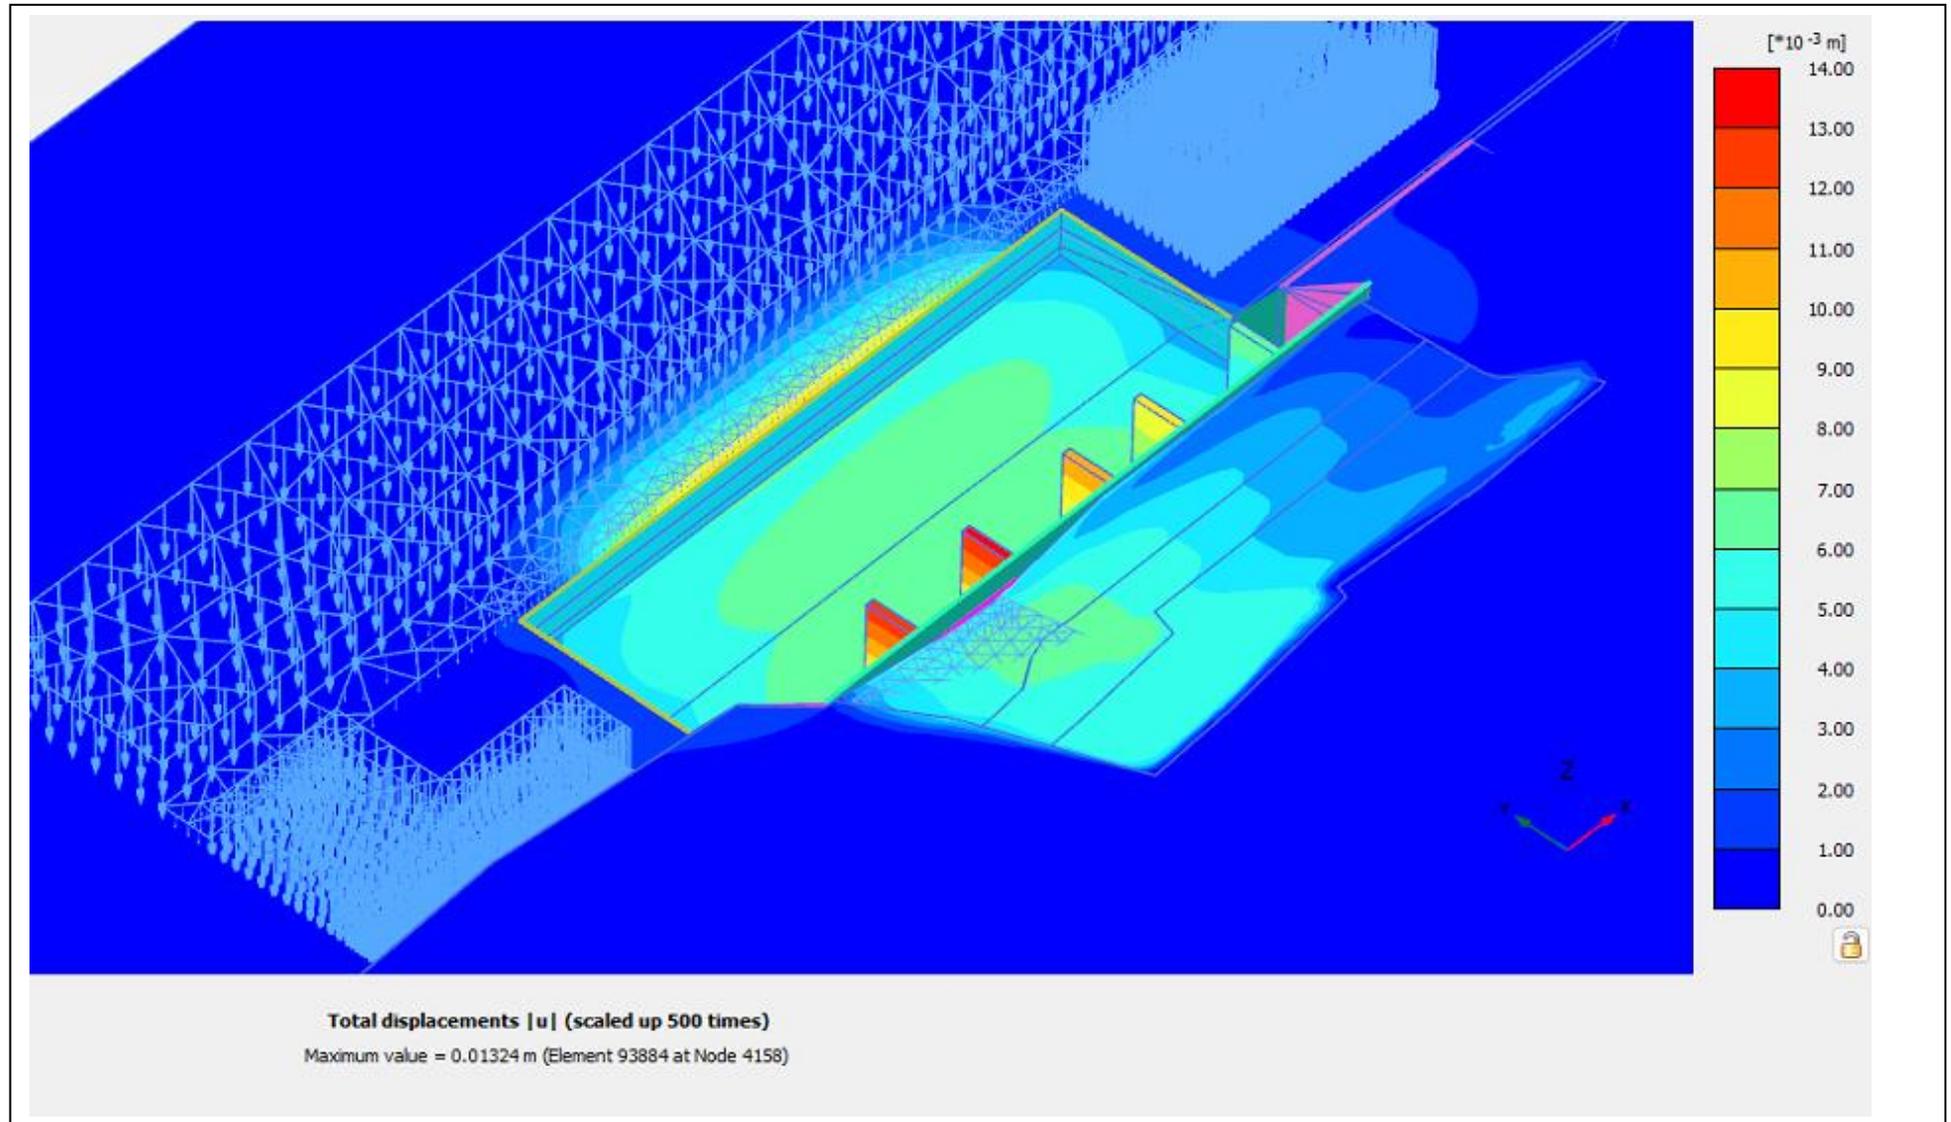
Maximum Displacements – Western and Northern Walls

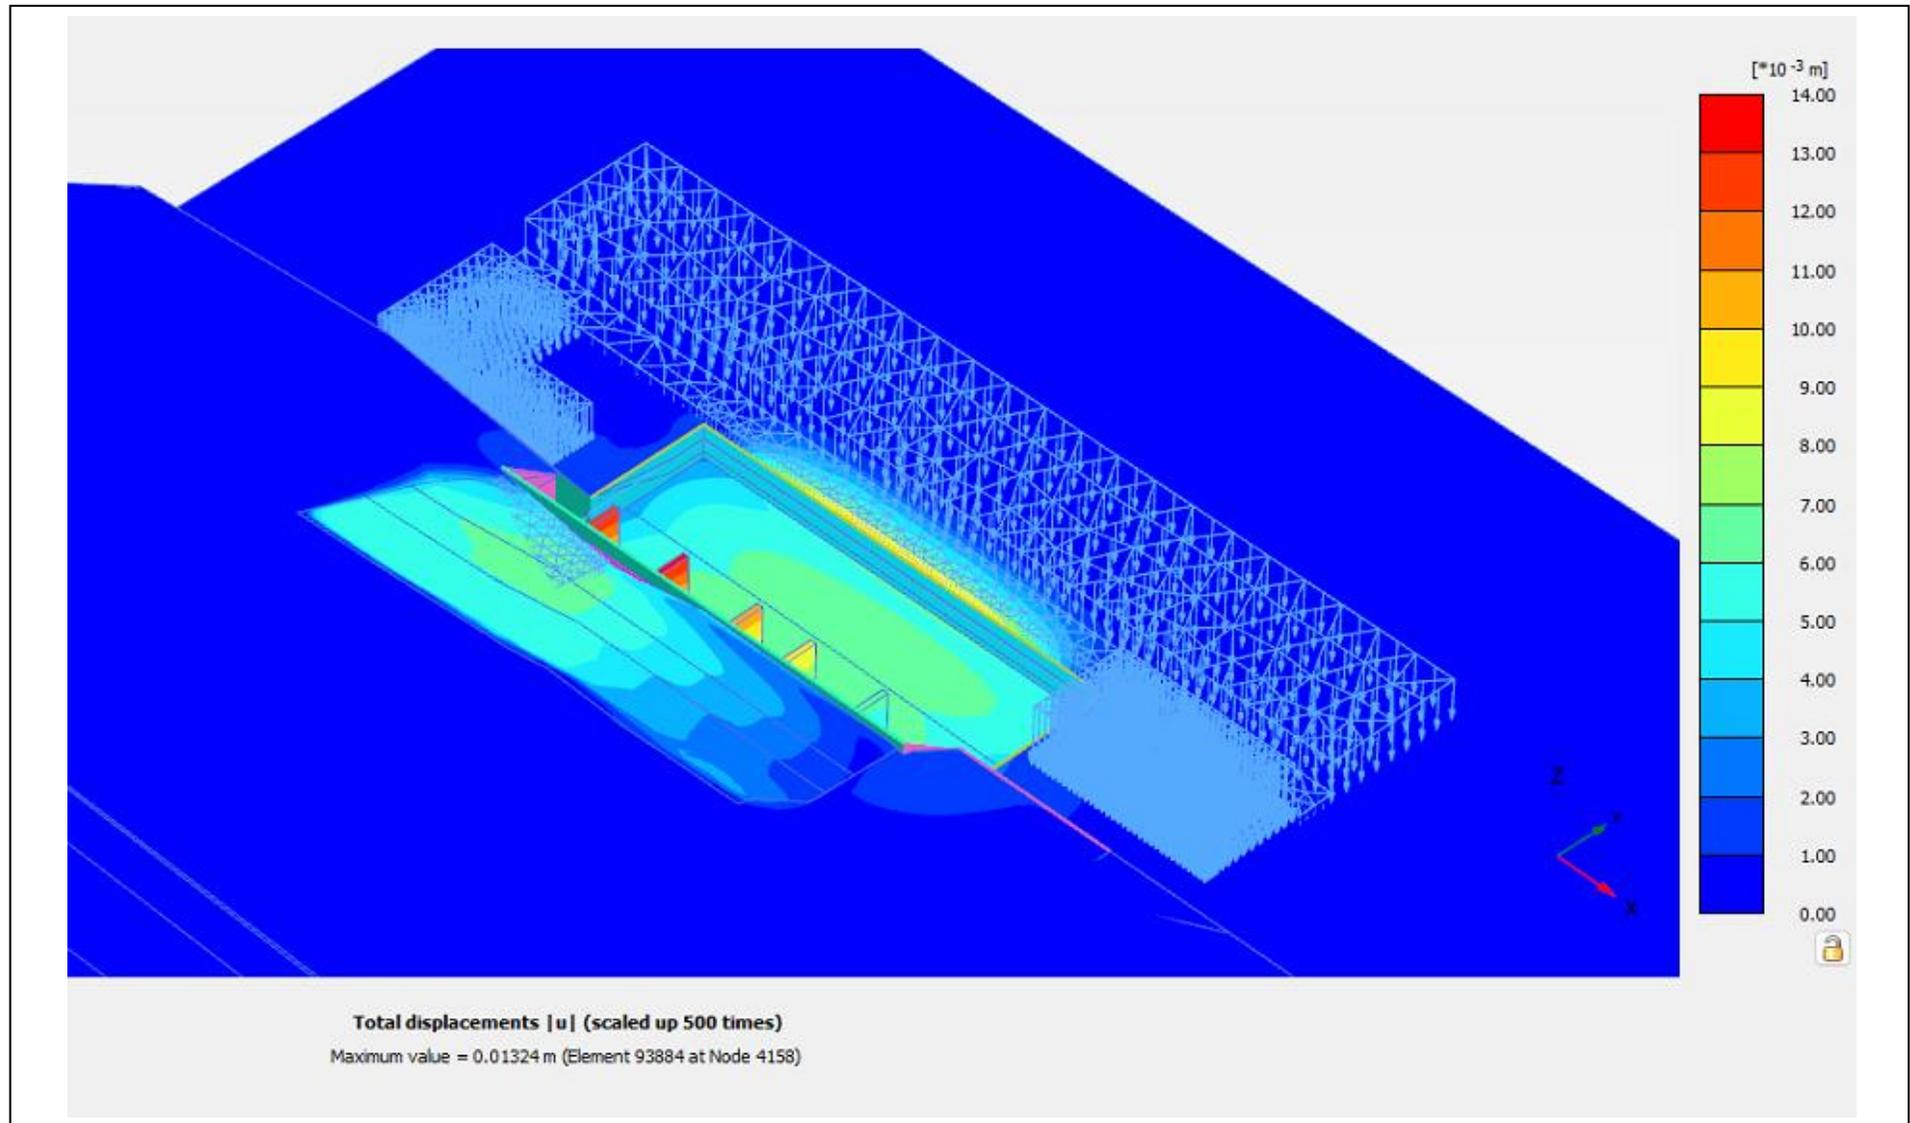
Maximum Displacements – Western and Southern Walls

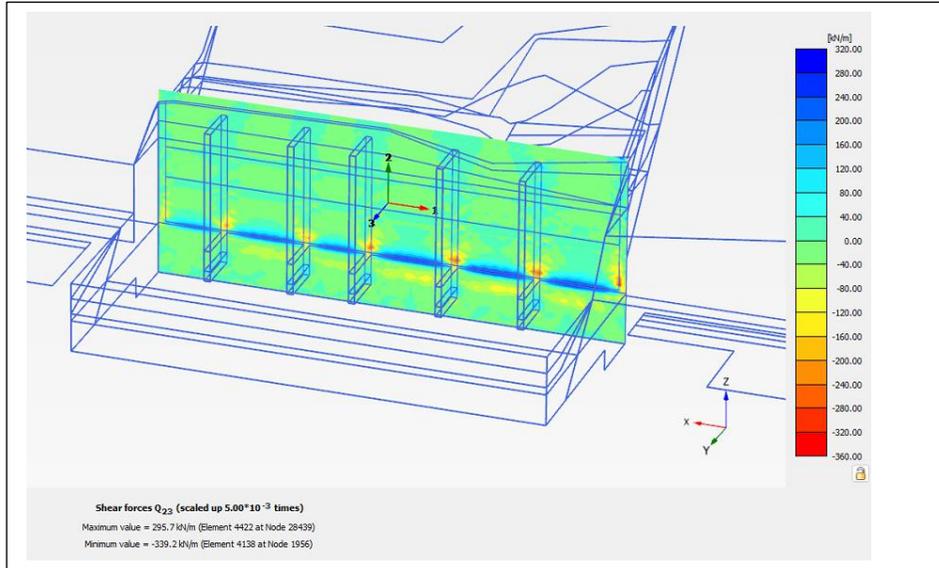
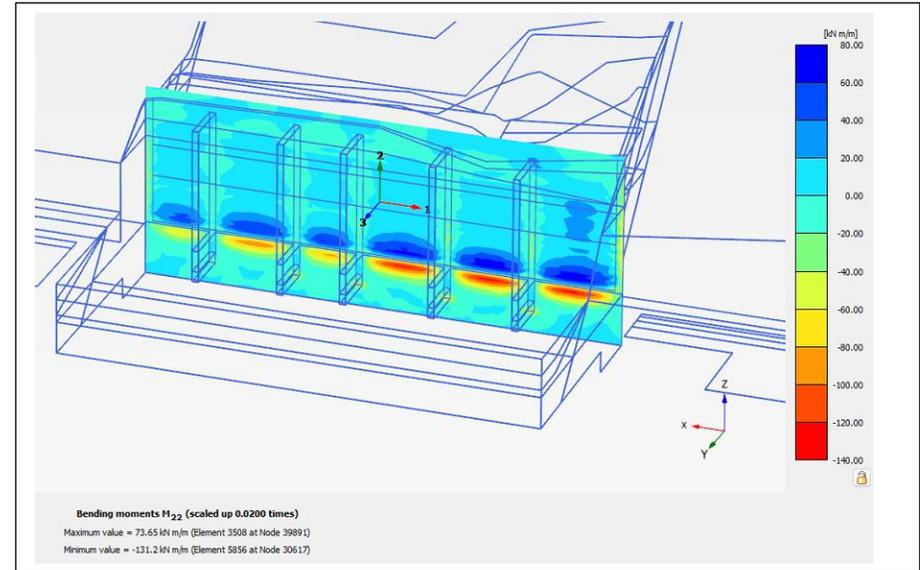
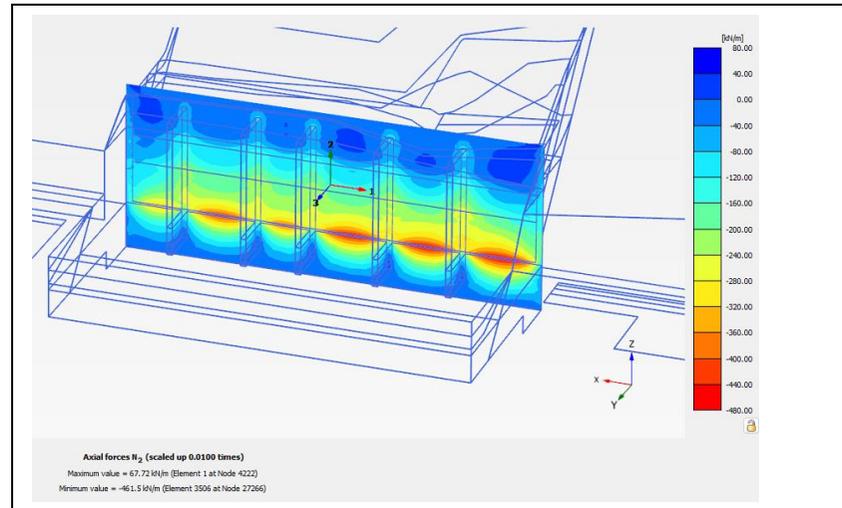
Axial and Shear Forces and Bending Moments – Eastern Wall

The following tables summarise the design axial forces (N), shear forces (Q) and bending moments (M). All values are based on working (serviceability) load cases. It should be noted that the values reported below are the maximum calculated values. However, these values may not be representative of the actual forces experienced by the structures and references should be made to the height maps when deciding the magnitude of design forces and moments to adopt. These results are also presented in Figures 8 to 19.

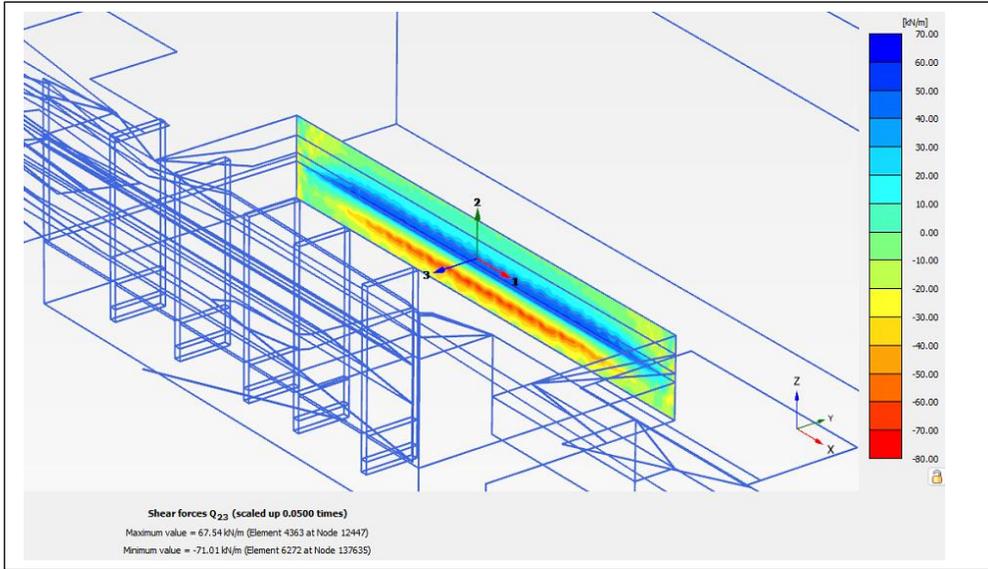
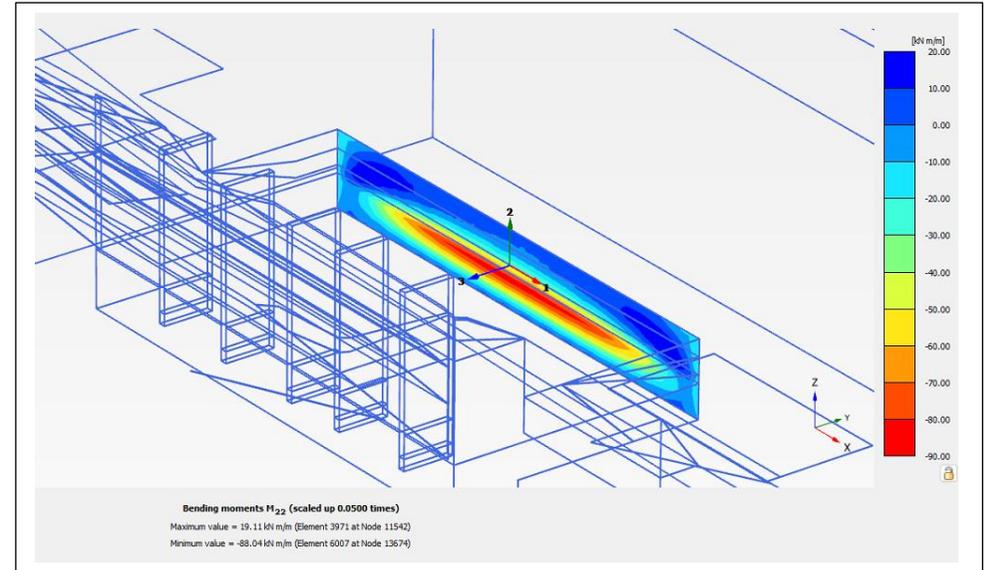
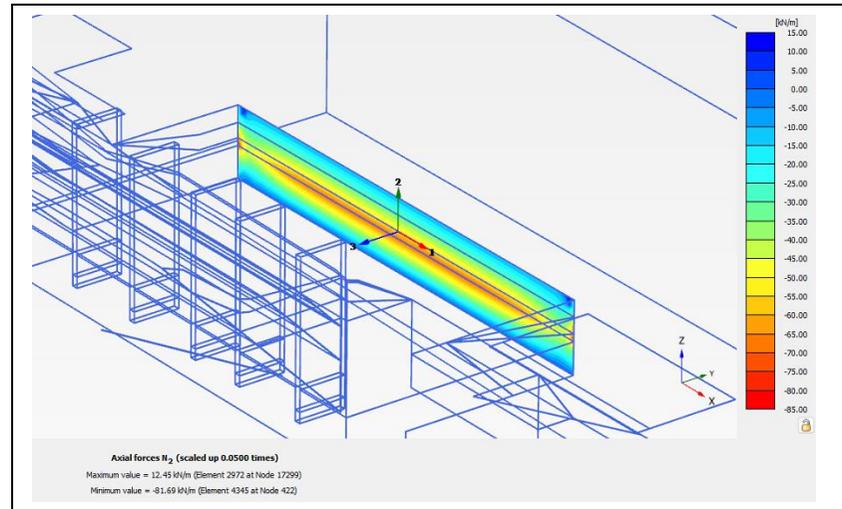
## Axial and Shear Forces and Bending Moments – Western Wall

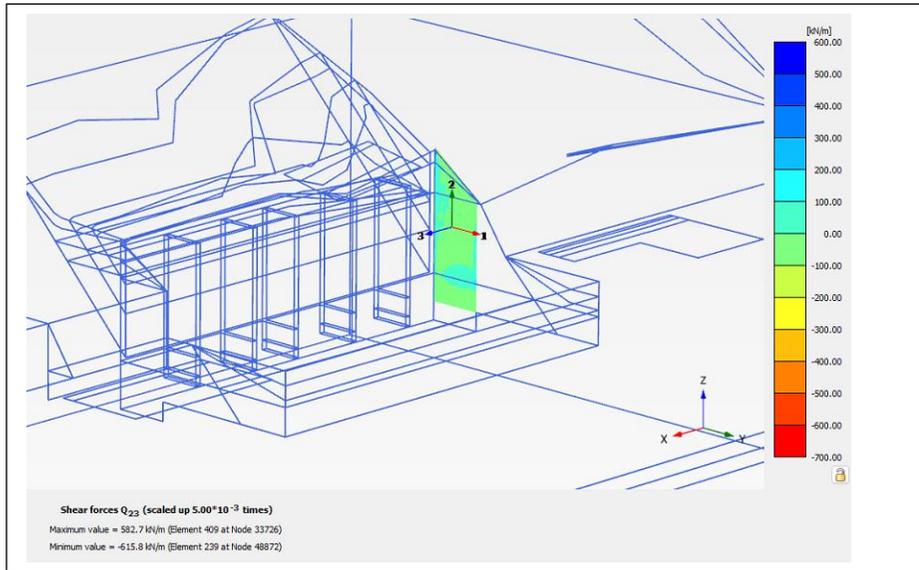
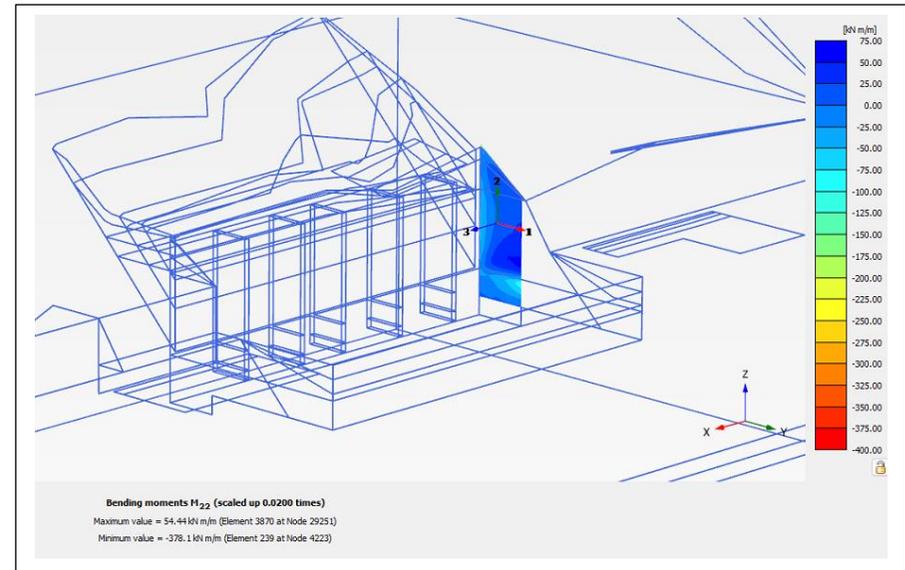
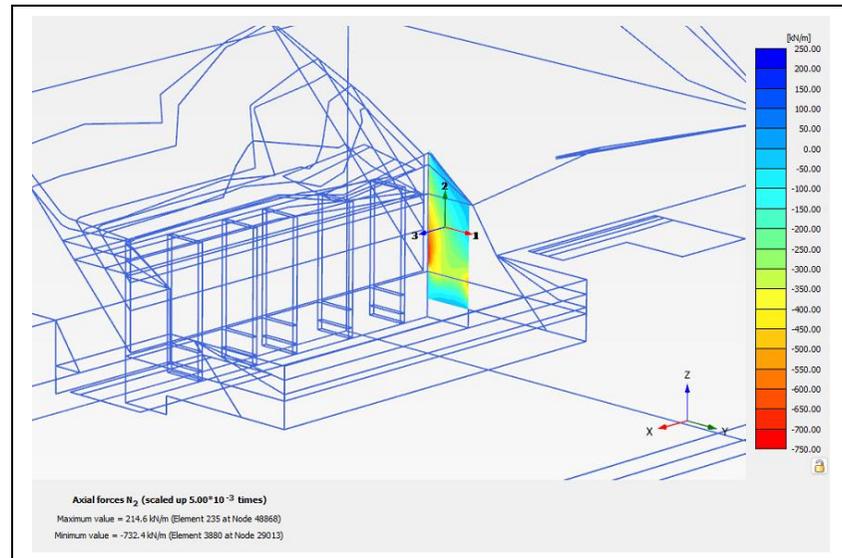
## Axial and Shear Forces and Bending Moments – Southern Buttress Wall

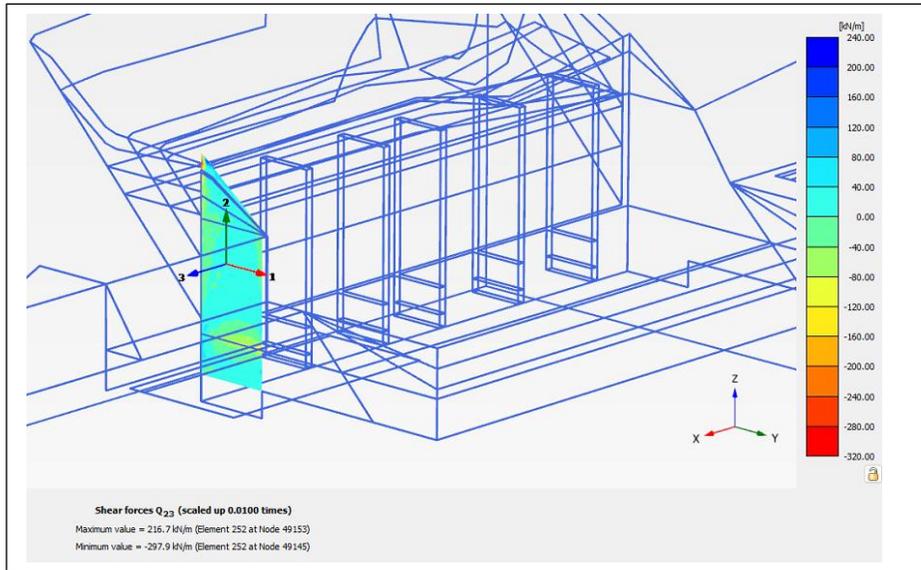
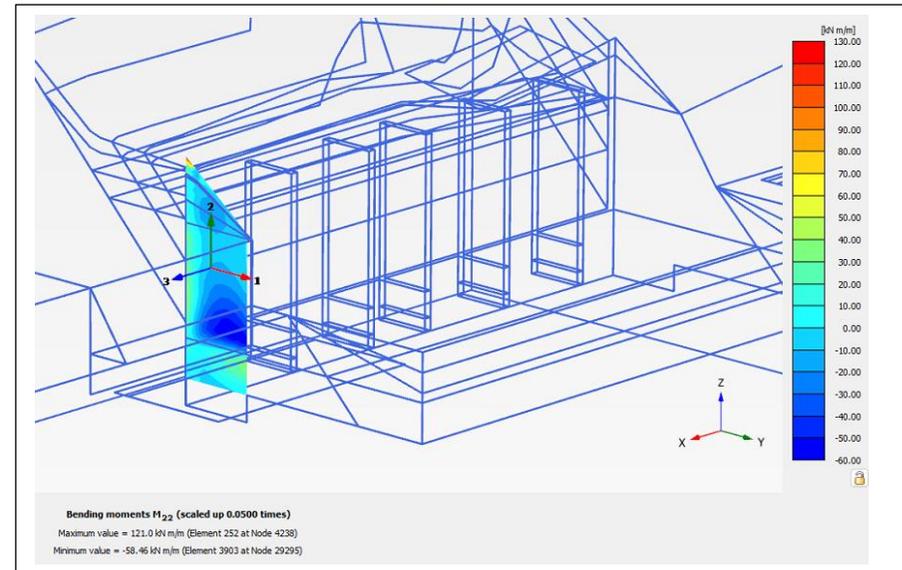
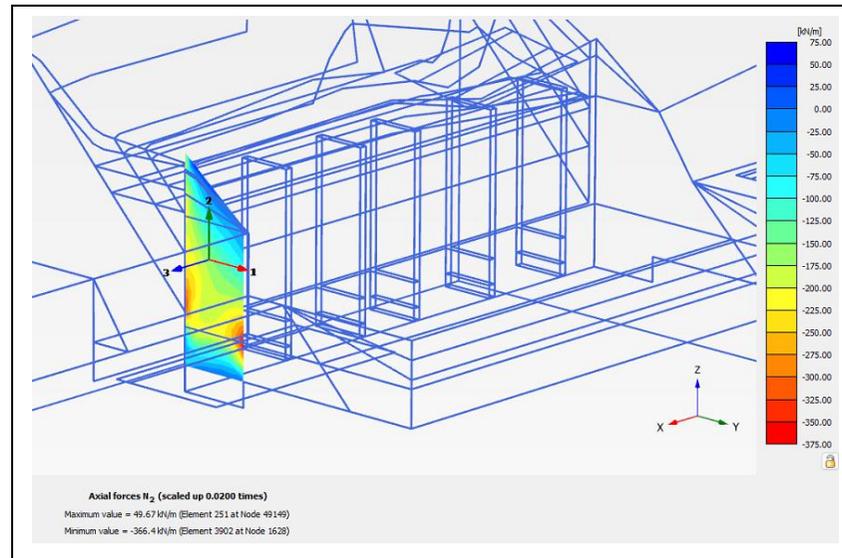
## Axial and Shear Forces and Bending Moments – Northern Buttress Wall

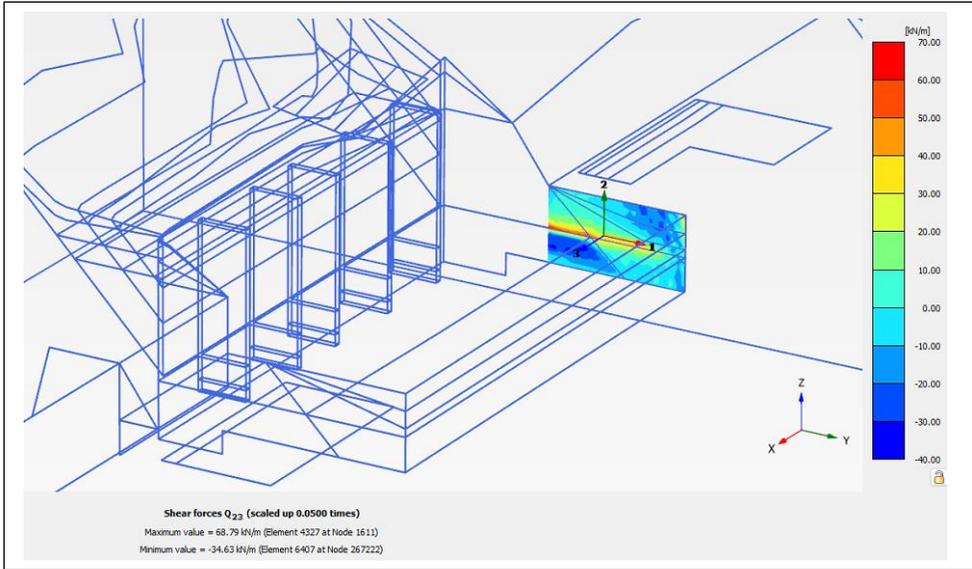
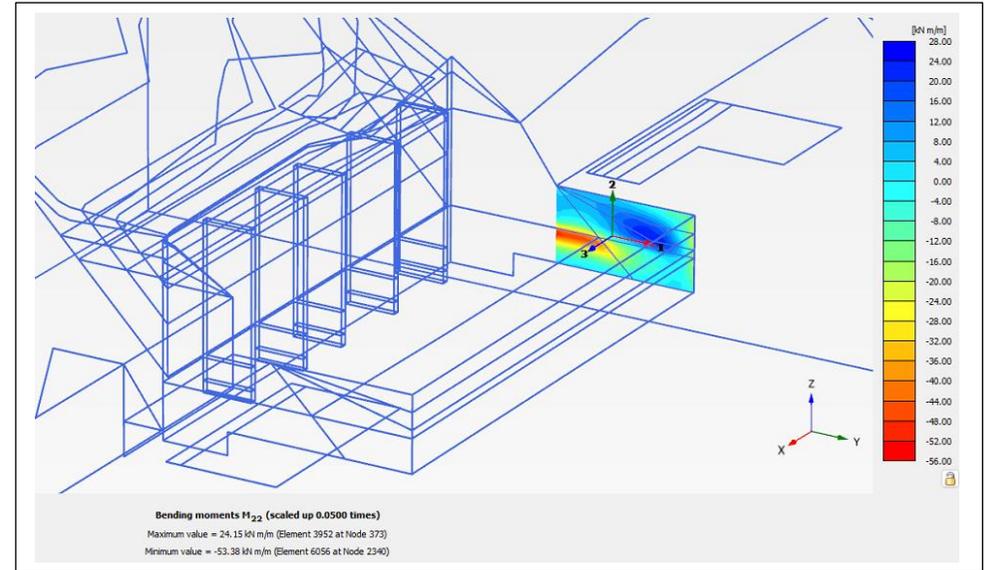
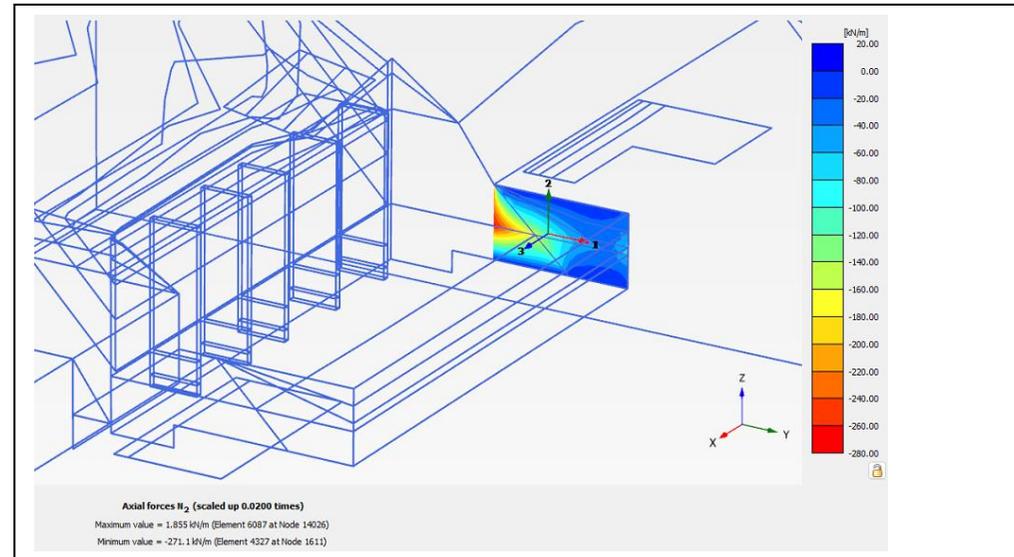
Axial and Shear Forces and Bending Moments – Southern Wall
