Development Application for \_\_\_\_\_ Civia \_\_\_\_\_  
Name of Applicant  
Address of site \_\_ 1102 Barrenjoey Road, Palm Beach \_\_\_\_\_

REPORT TO  
**CIVIA**

ON  
**THREE-DIMENSIONAL (3D) NUMERICAL ANALYSIS**

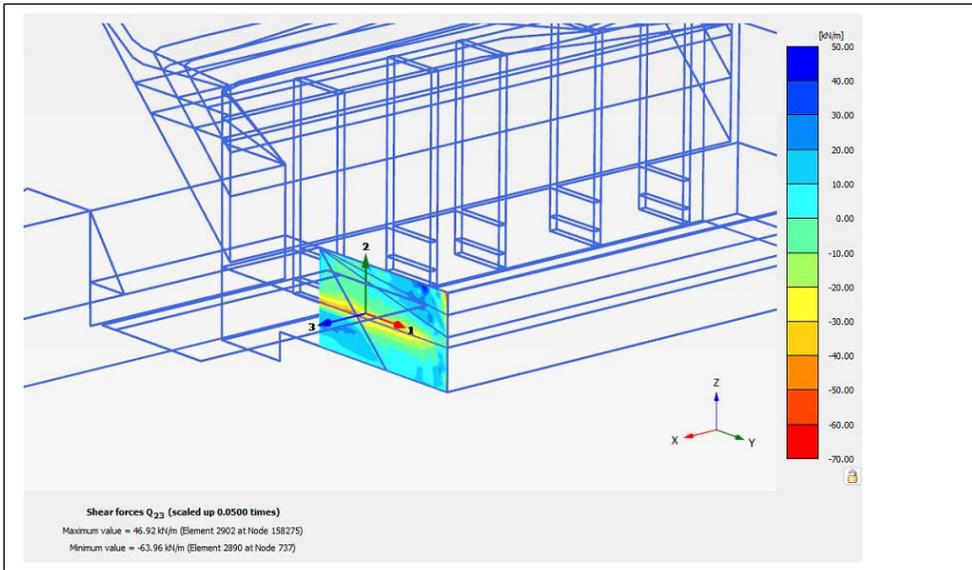
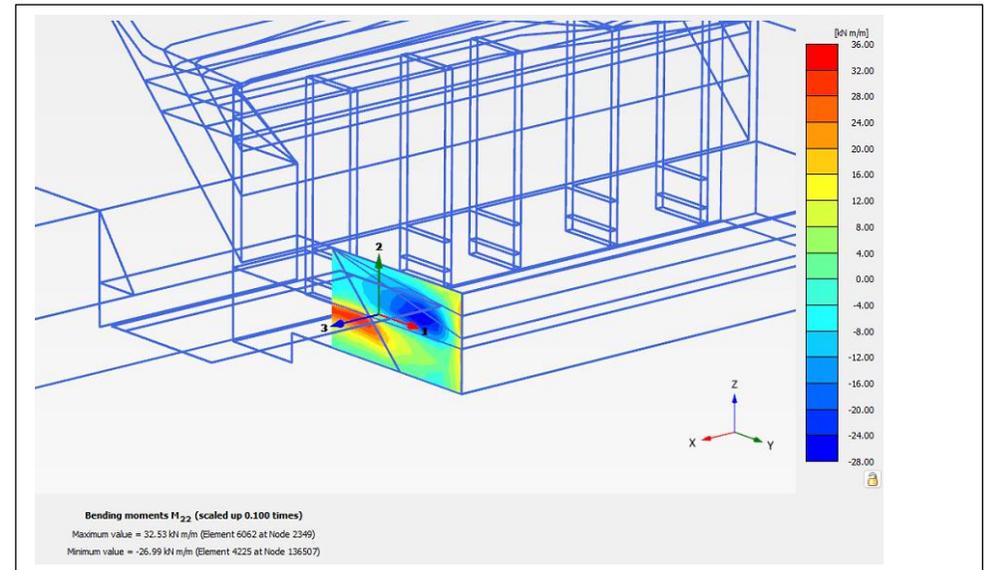
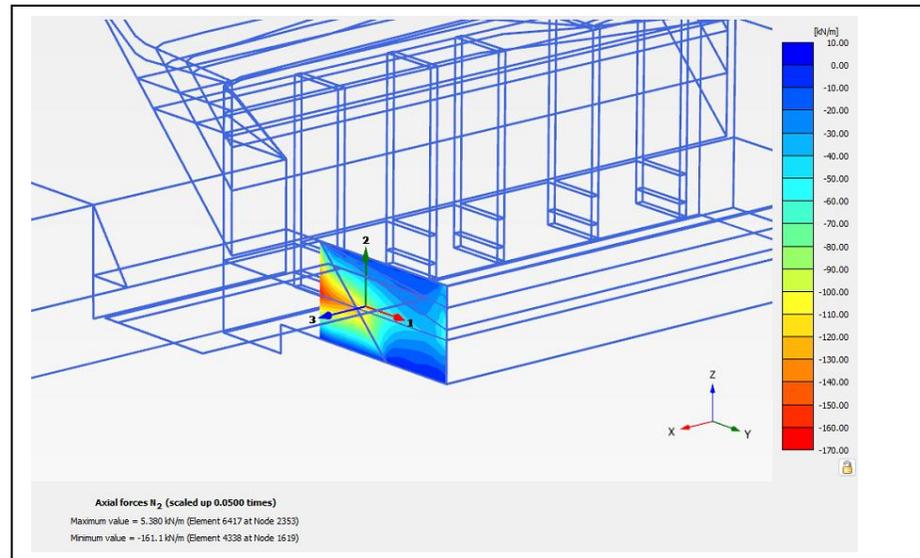
Axial and Shear Forces and Bending Moments – Northern Wall

The following tables summarise the design axial forces (N), shear forces (Q) and bending moments (M). All values are based on working (serviceability) load cases. It should be noted that the values reported below are the maximum calculated values. However, these values may not be representative of the actual forces experienced by the structures and references should be made to the height maps when deciding the magnitude of design forces and moments to adopt. These results are also presented in Figures 8 to 19.

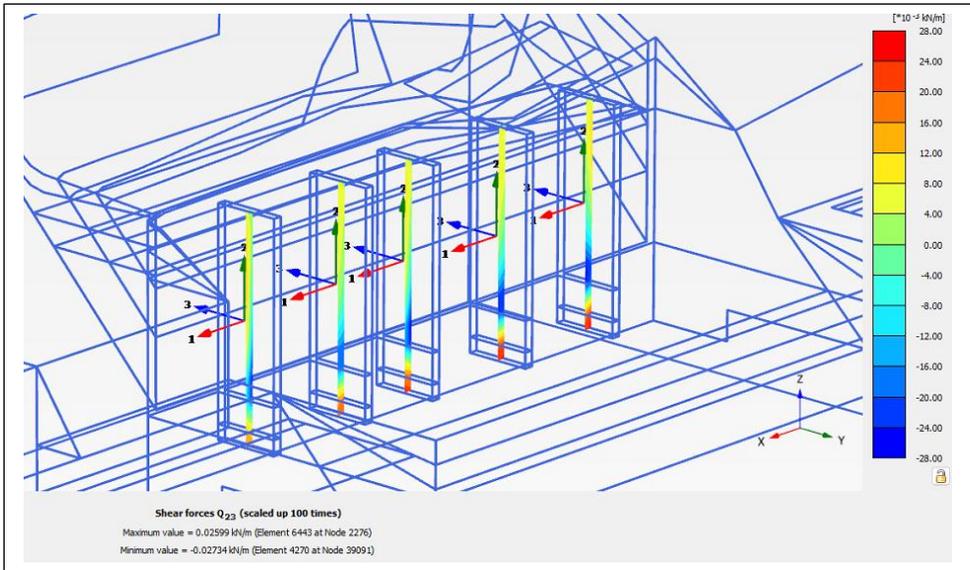
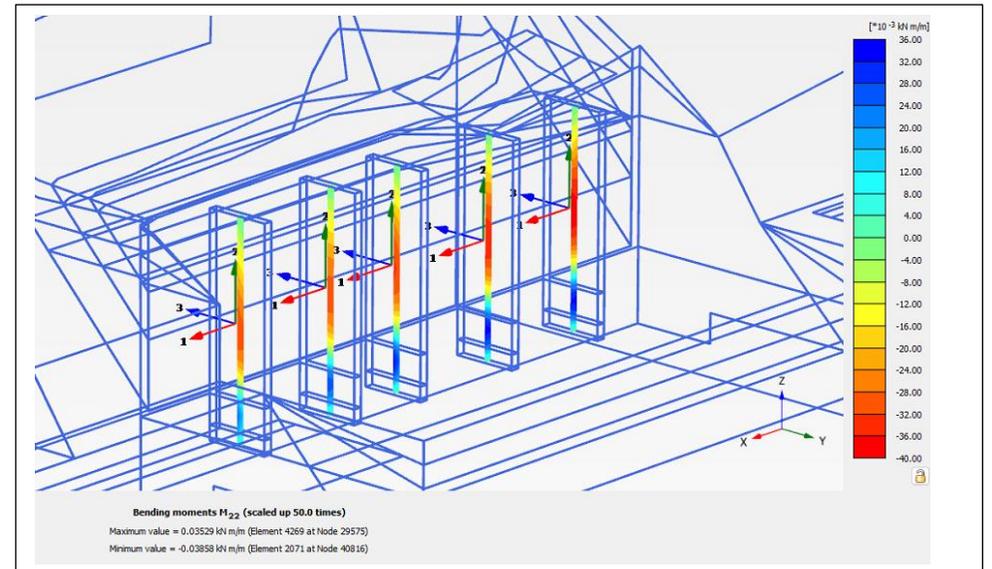
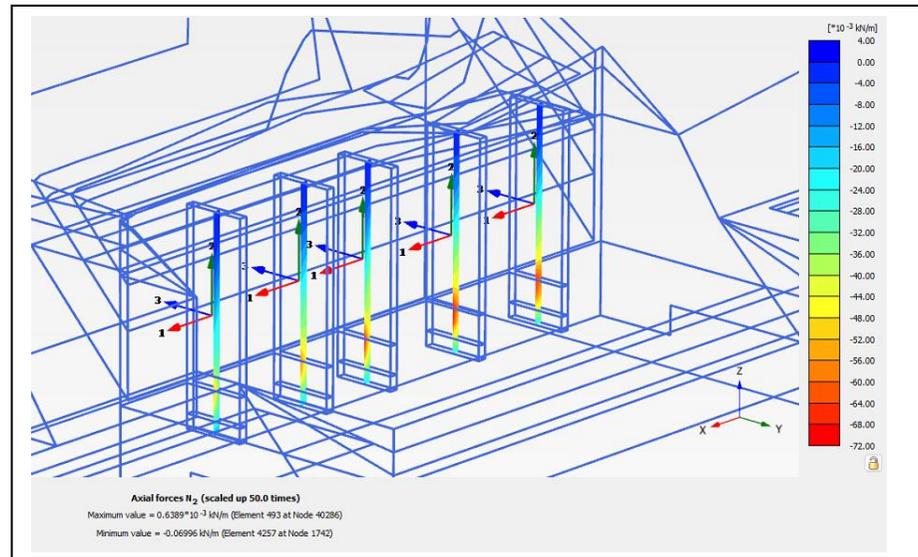
## Forces and Moments in Dummy Plates of Central Buttresses

(Values have been scaled up using the ratio of  $E_{real}/E_{dummy\ plate}$ )

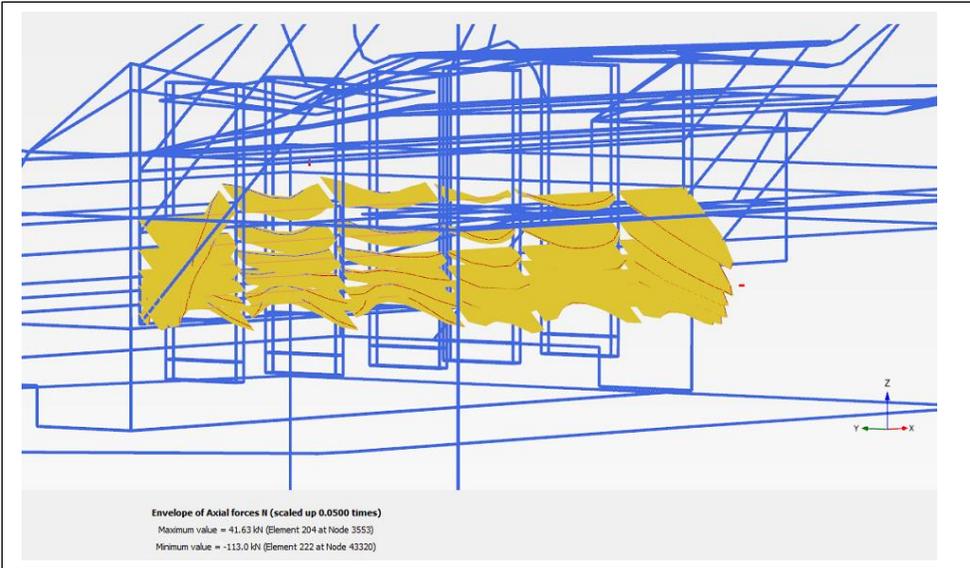
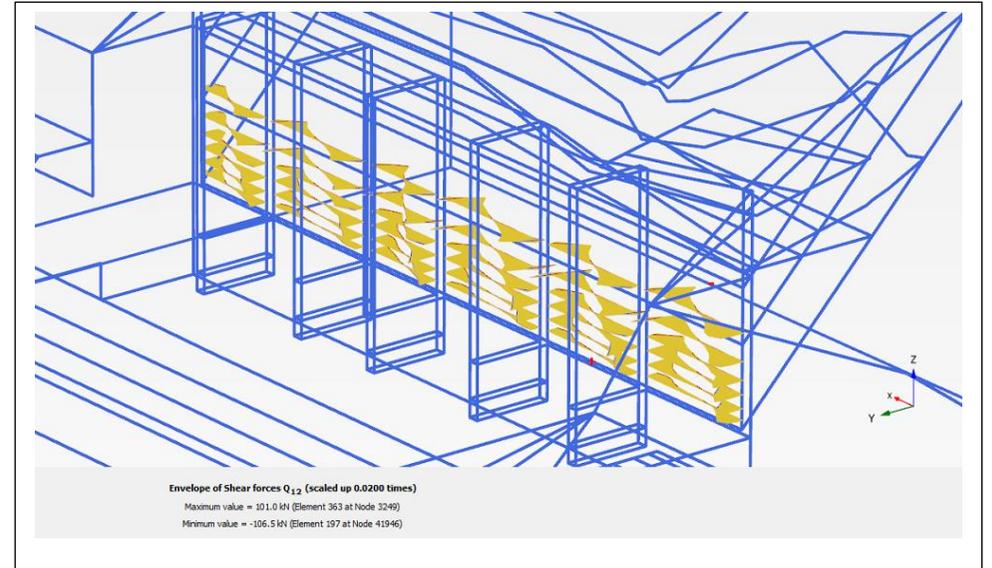
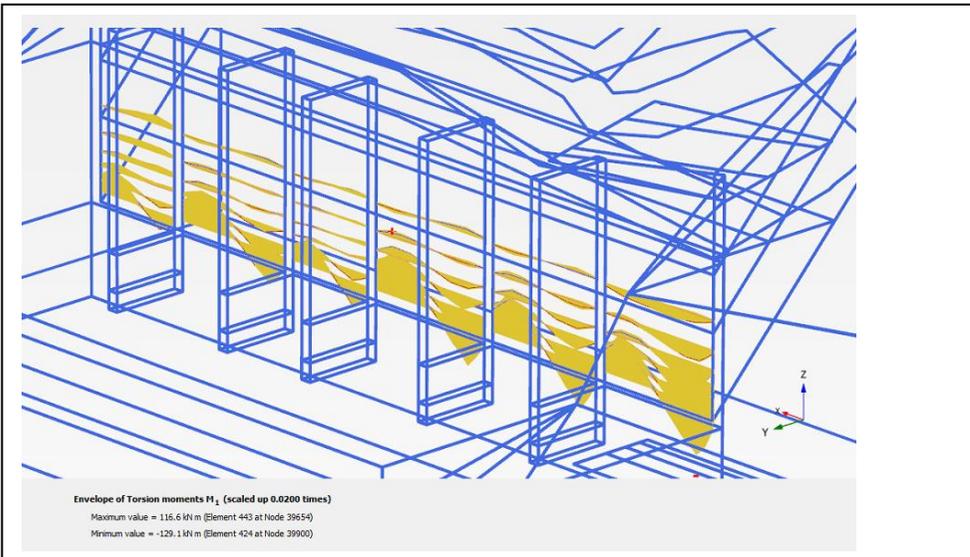
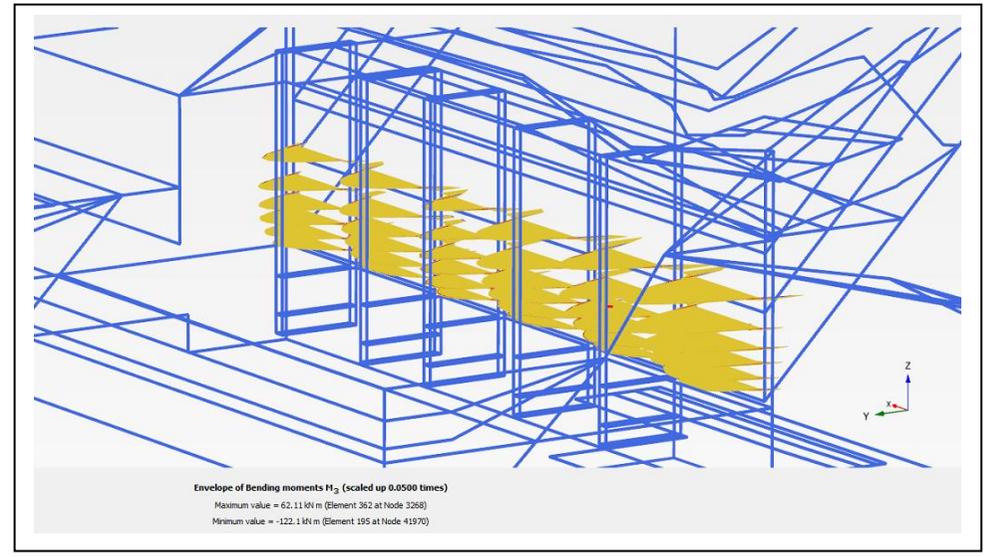
## Forces and Moment - WB1

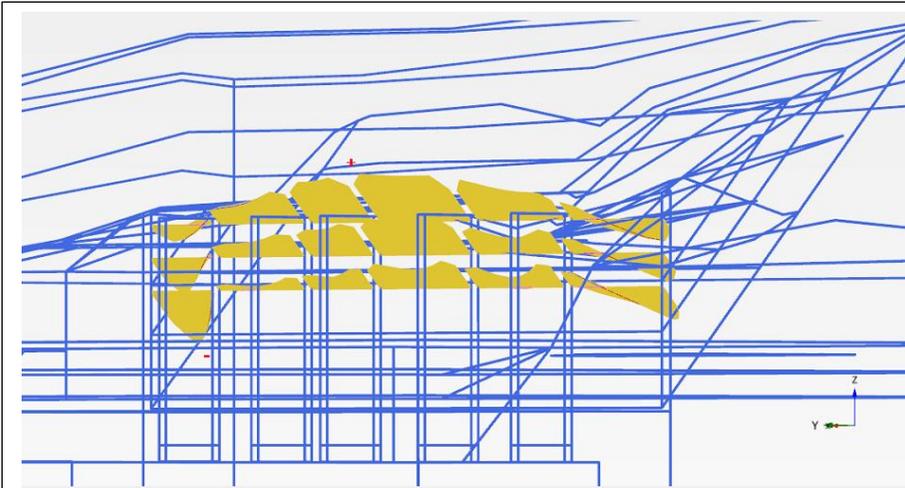
Envelope of Axial forces  $N$  (scaled up 0.0500 times)  
 Maximum value = 80.25 kN (Element 58 at Node 36261)  
 Minimum value = -88.98 kN (Element 189 at Node 43287)

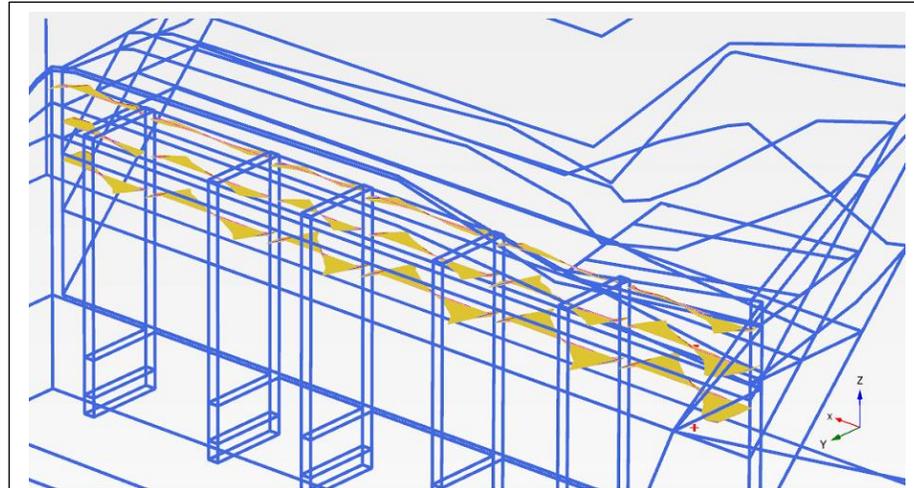
Envelope of Shear forces  $Q_{12}$  (scaled up 0.0500 times)  
 Maximum value = 50.18 kN (Element 148 at Node 42021)  
 Minimum value = -56.49 kN (Element 154 at Node 41979)

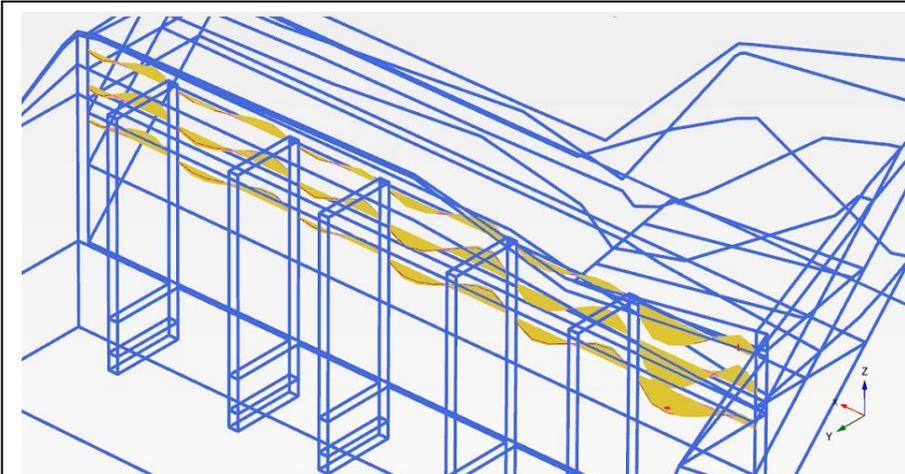
Envelope of Torsion moments  $M_1$  (scaled up 0.0500 times)  
 Maximum value = 23.27 kN m (Element 77 at Node 35070)  
 Minimum value = -40.09 kN m (Element 81 at Node 35058)

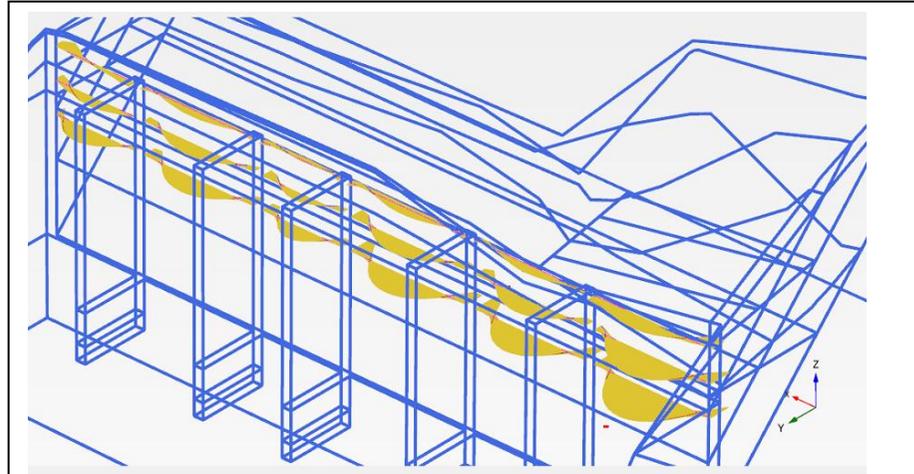
Envelope of Bending moments  $M_2$  (scaled up 0.0500 times)  
 Maximum value = 30.64 kN m (Element 162 at Node 3528)  
 Minimum value = -58.00 kN m (Element 151 at Node 42012)

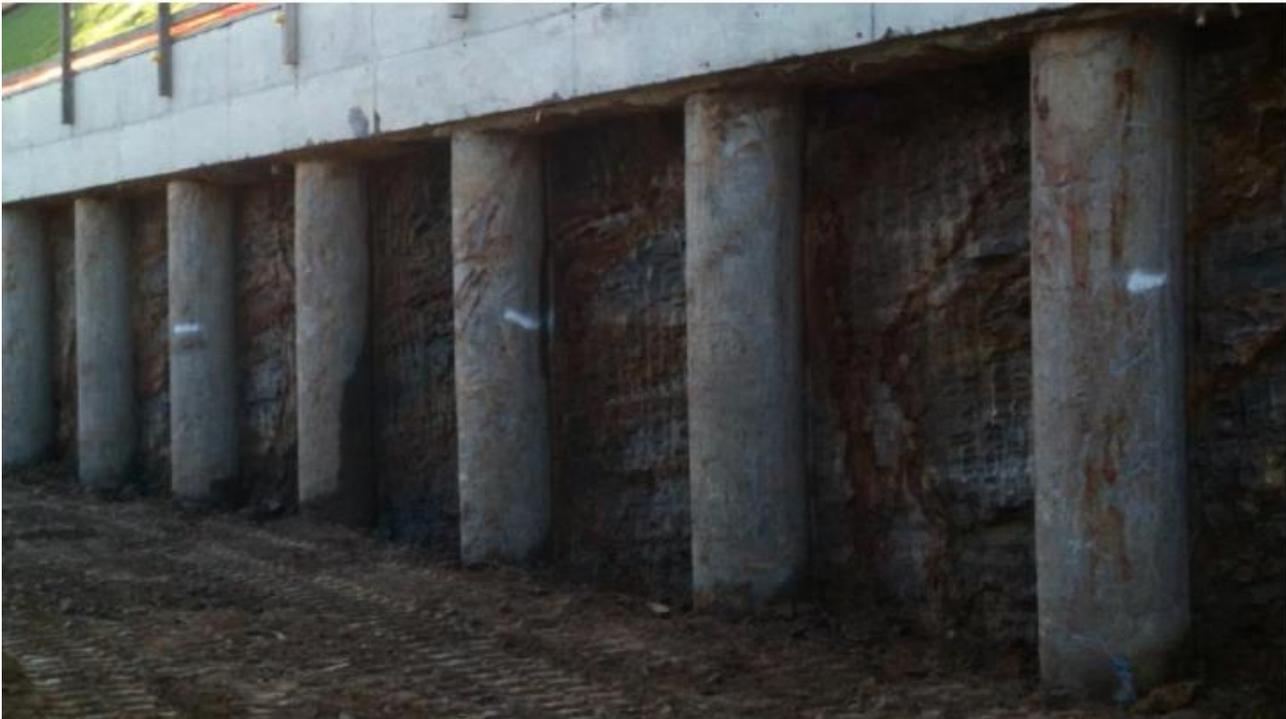
To the west of the soldier pile wall the site has been cut, is relatively level and has ground levels that vary between about RL2.5m and RL3m. This portion of the site is currently unoccupied. The soldier pile wall comprised 0.6m diameter piles spaced at about 2.5m, with mesh and shotcrete infill panels between the piles to about 0.8m to 0.9m above the base of the excavation. Mesh and shotcrete has not been placed here and the materials exposed were assessed to comprise moderately weathered siltstone of low to medium strength. Water seepage was observed in this face, both over the siltstone cut face and through the shotcrete panels. Some cracks varying from 'hairline' to 2mm in width were observed in the shotcrete panels but overall, the soldier pile wall appeared to be in good condition. At the top of the piles was a concrete section that was about 1.1m high and appears to be the capping beam. Above the capping beam was a mesh fence about 1m high. The architectural section drawing by Mills Architecture & Interiors (Ref: Drawing No. DA.01) details the base of the soldier piles at RL-0.25m. We have extracted a photograph from the Witt geotechnical investigation report, as shown below in Plate 1, of the soldier pile wall prior to being shotcreted. It appears the portion below the capping beam comprises weathered rock.

**Plate 1: Photograph of Soldier Pile Wall Prior to being Shotcreted (Figure 3 from Witt Report)**

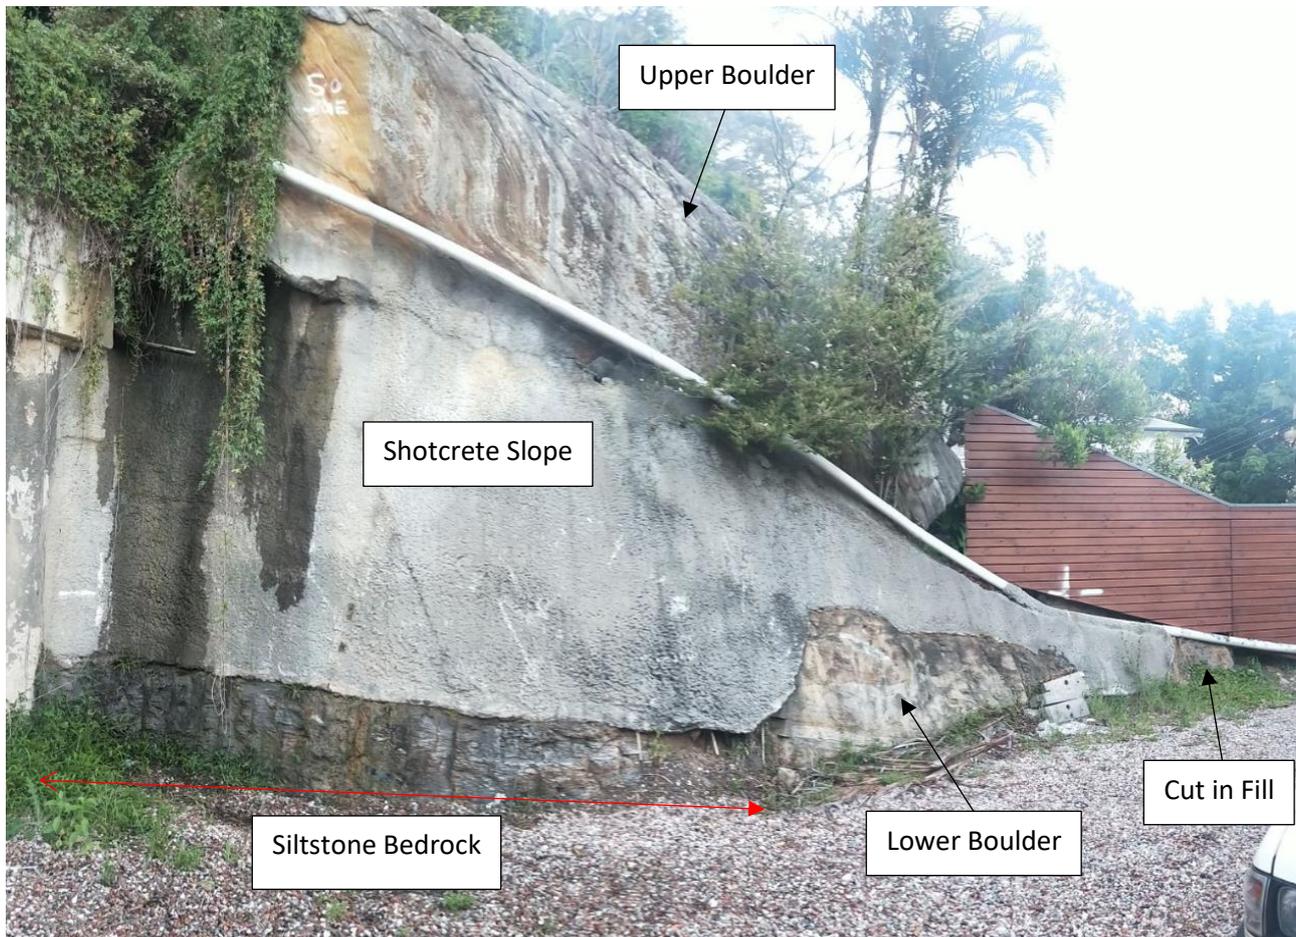
The site description that follows should be read in conjunction with Plate 2, which includes a photograph of the southern boundary area. Extending into the site near the southern boundary is a large sandstone boulder. This boulder is located in the upper portion of the profile and where excavation has extended below it the cut face has been protected with shotcrete. The boulder is approximately 2m to 3m high and extends for a length of about 7.5m. The shotcreted cut has a maximum height of approximately 3.5m and extends for a length of about 10.5m. The boulder overhangs the eastern end of the cut by about 1m to 1.5m over a length of 1.5m. Water seepage was observed below the boulder along the eastern 2m length of the shotcrete facing. A second sandstone boulder is exposed below the western end of the upper boulder. This boulder extends for a length of about 2.5m over the lower 0.7m to 1.3m of the cut. Between the eastern soldier pile wall and this lower boulder, siltstone bedrock was exposed below the shotcrete for a length of about 6m to 7m over the lower 0.8m of the cut. The siltstone bedrock was assessed to be moderately weathered and of low to medium strength. A 0.8m high vertical cut in fill was observed over a length 1m at the westernmost end of the southern cut.

**Plate 2: Photograph 1 of Large Boulders and Shotcreted Cut Face At/Near Southern Boundary (Facing South)**

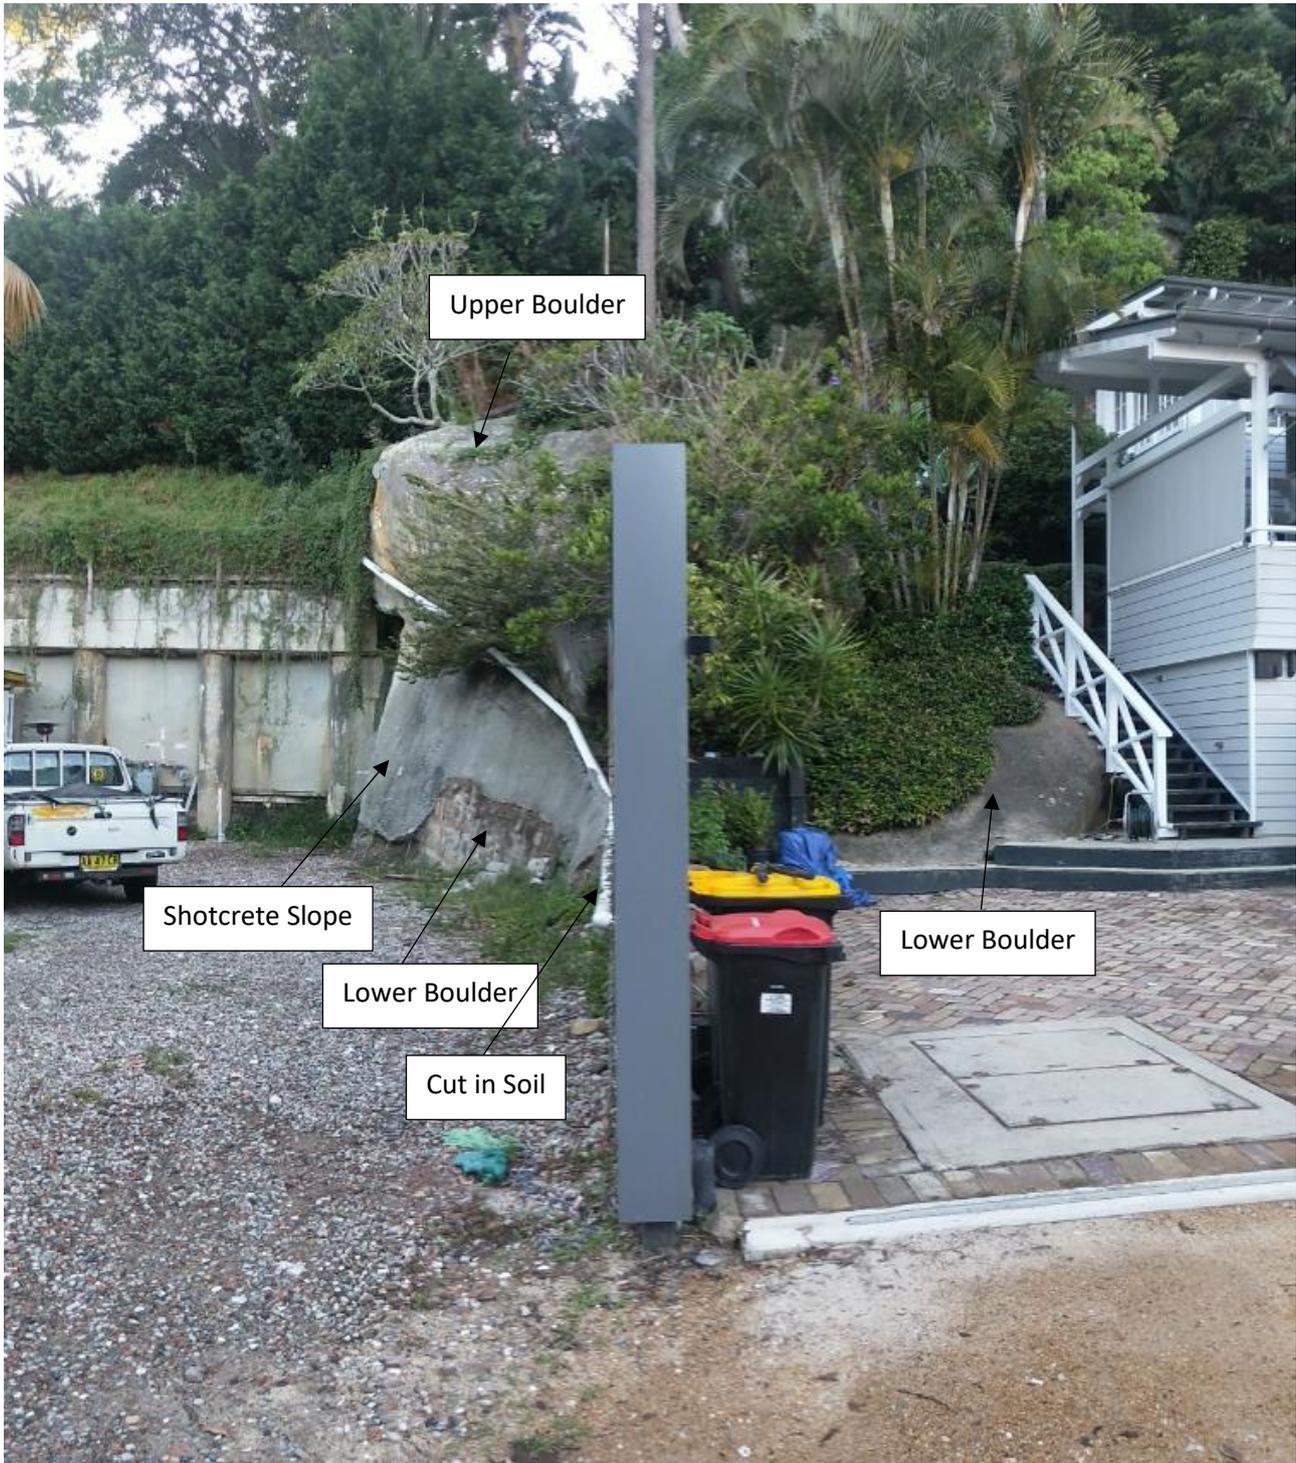
The site is bounded by residential development to the south (1100 Barrenjoey Road). It appears that the upper boulder visible in the southern cut face extends an additional 2.5m to the south and overlies another large boulder that extended further to the south. This can be seen below in Plate 3. While this lower boulder appears to be one boulder, investigation by Davies Geotechnical Consulting Engineers has established that this lower boulder is actually two discreet boulders that are positioned adjacent to one another with the southern (lower) boulder located entirely within 1100 Barrenjoey Road. Beyond these boulders is a two-storey timber clad house. To the east of the site is a flat grass area (driveway) and then a single-storey shed. To the north is a one and two storey rendered building ('Barrenjoey House', which is heritage listed) while Barrenjoey Road bounds the site to the west. All adjoining structures appeared in good condition when viewed from the site.

Plate 3: Photograph 2 of Large Boulders and Shotcreted Cut Face At/Near Southern Boundary (Facing East)

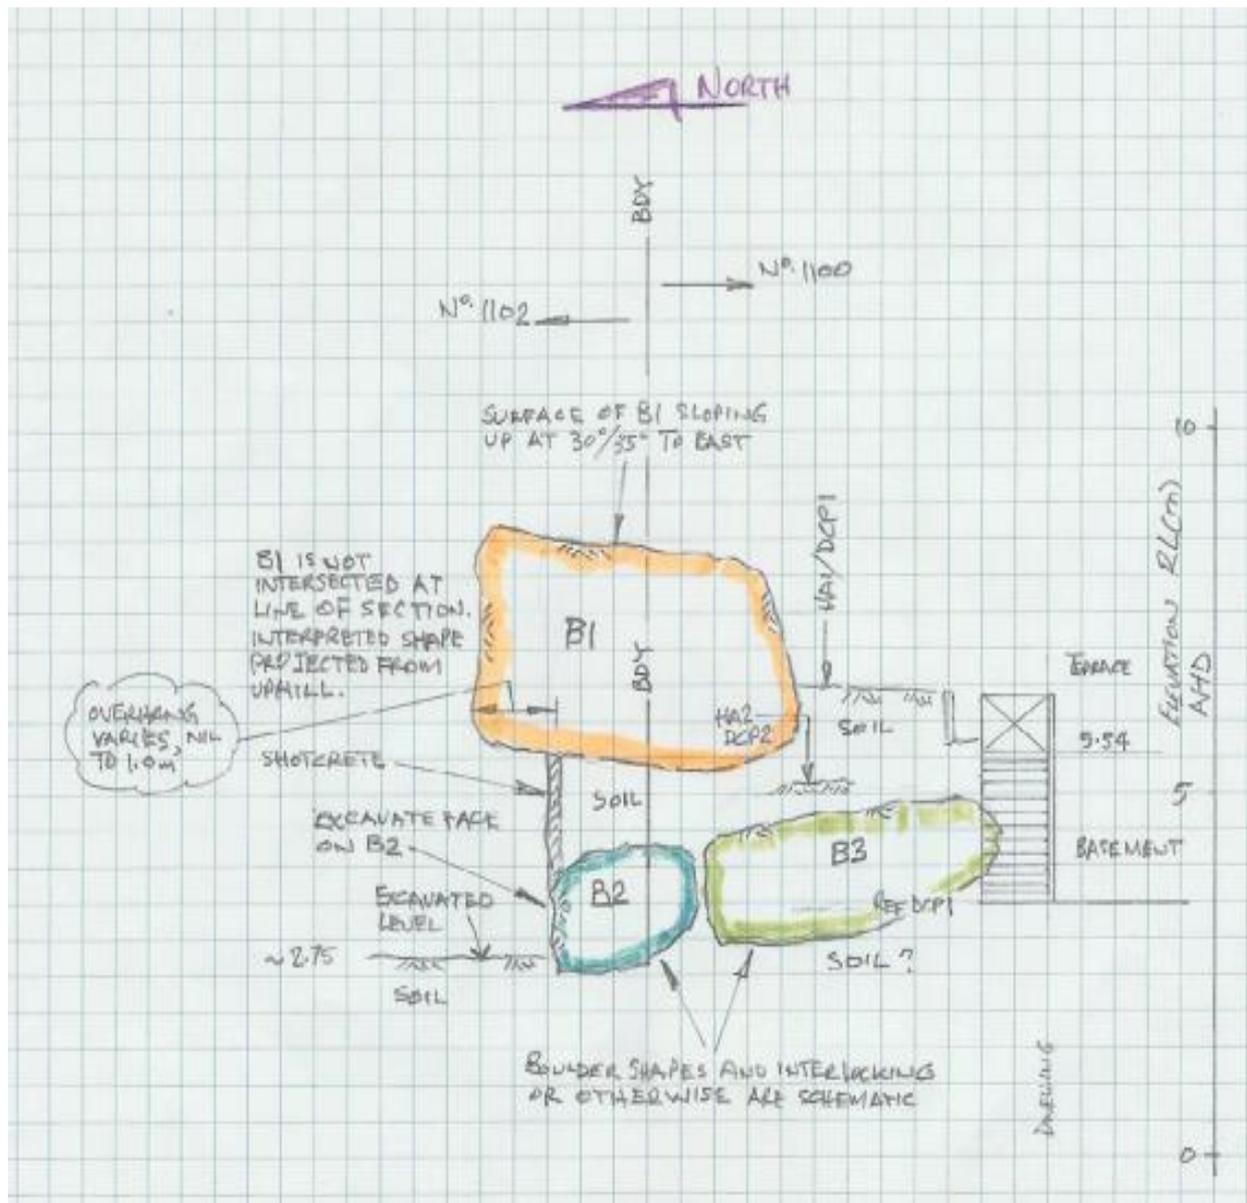
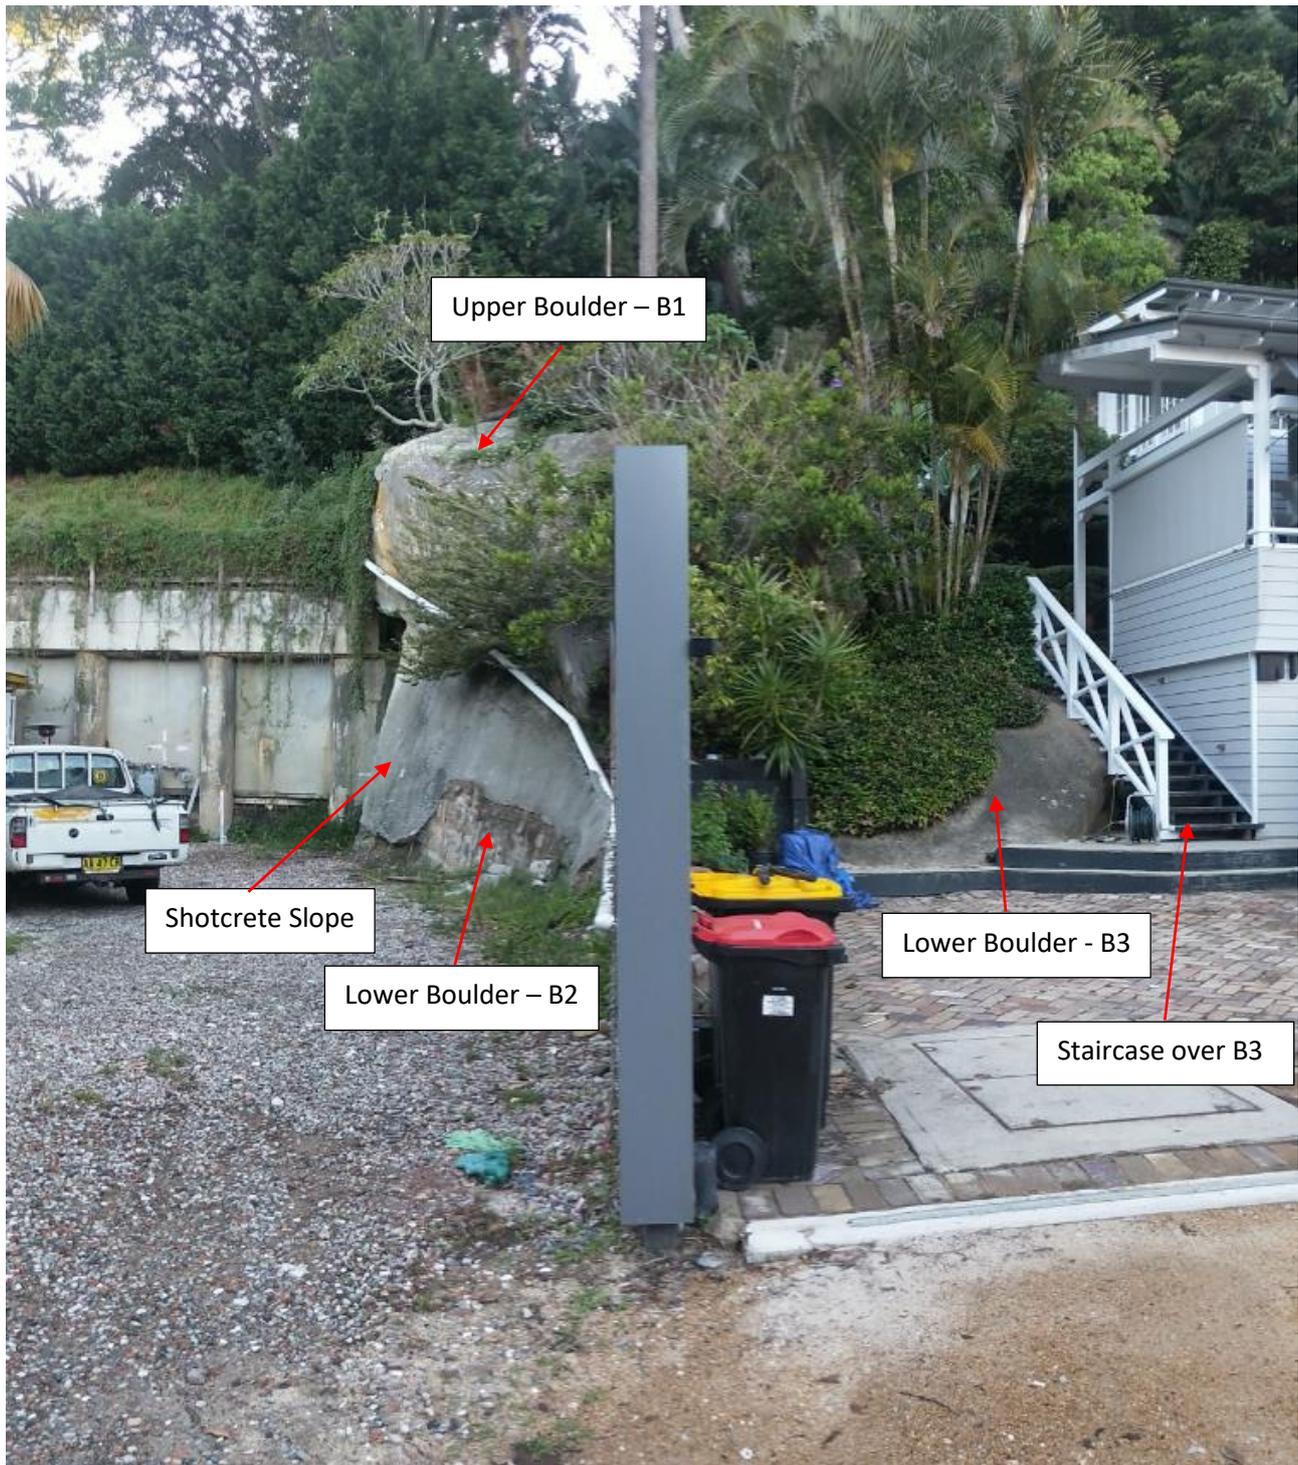
In a report prepared by Warwick Davies of eiaustralia (Ref: P21153.01\_DRAFT, dated 16 January 2023), Warwick Davies has provided a review of a memo that he prepared in 2021 when he worked for Davies Geotechnical Consulting Engineers (DG) (Ref: 21-019.C\_rev1, dated 327 October 2021). In that memo, an investigation was undertaken to confirm the extent of the boulders present along the boundary. The results of this investigation and the location of these boulders, as extracted from that report are shown below and indicate that three boulders are present; two of which are located on the boundary and span both 1100 and 1102-1106 Barrenjoey Road (B1 and B2) while the third boulder (B3) is located wholly within 1100 Barrenjoey Road and is at roughly the same level as the lower of the two boulders on the boundary. None of these boulders extend below the residence at 1100 Barrenjoey Road nor is this building founded on these boulders, although the timber staircase does span across and run over the top of B3. To provide more context to these sketches we have also included an annotated photo that shows the conditions across the boundary.

At the heart of the comments prepared by eiaustralia is the expression of concern that the proposed development poses an unacceptable risk to two boulders that span the boundary between 1100 and 1102- 1006 Barrenjoey Road. To understand the risk posed by these boulders it is necessary to understand their location and how they may interact with one another and adjoining structures.

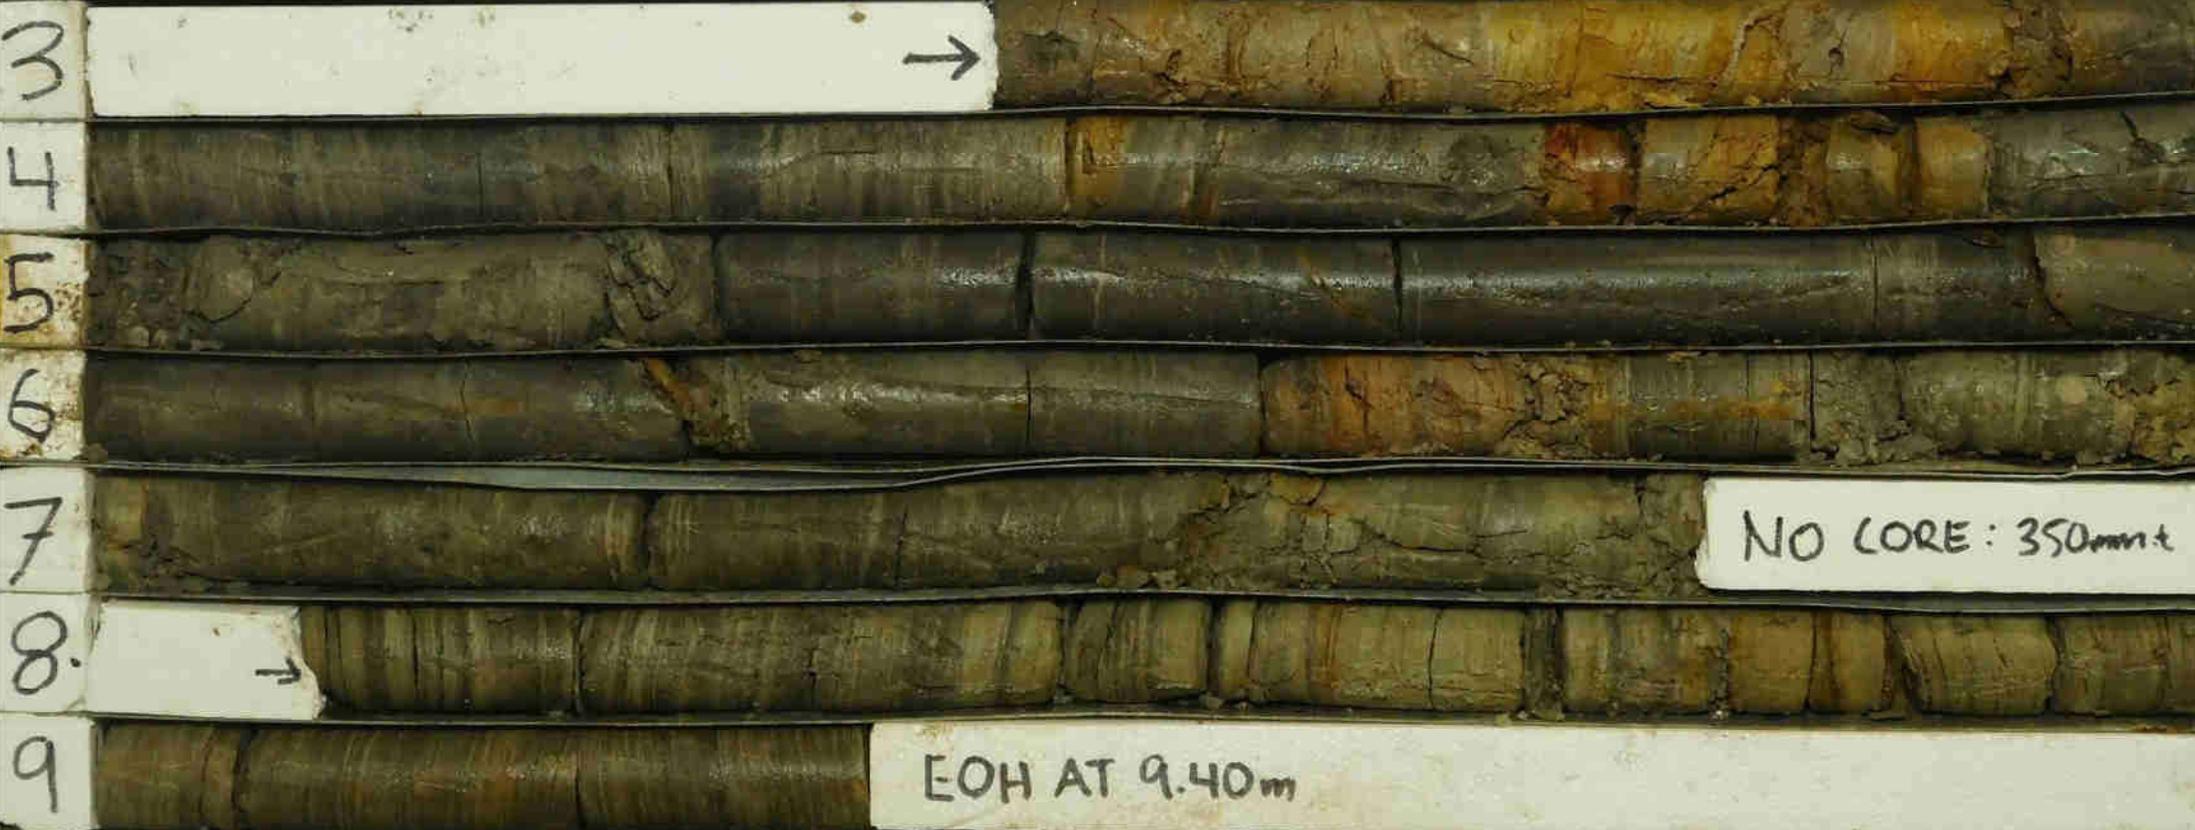
Job No: 33618YJ  
Borehole No: BH101  
Depth: 3.42m - 9.40m

33618YJ BH101 CORING STARTS AT 3.42m

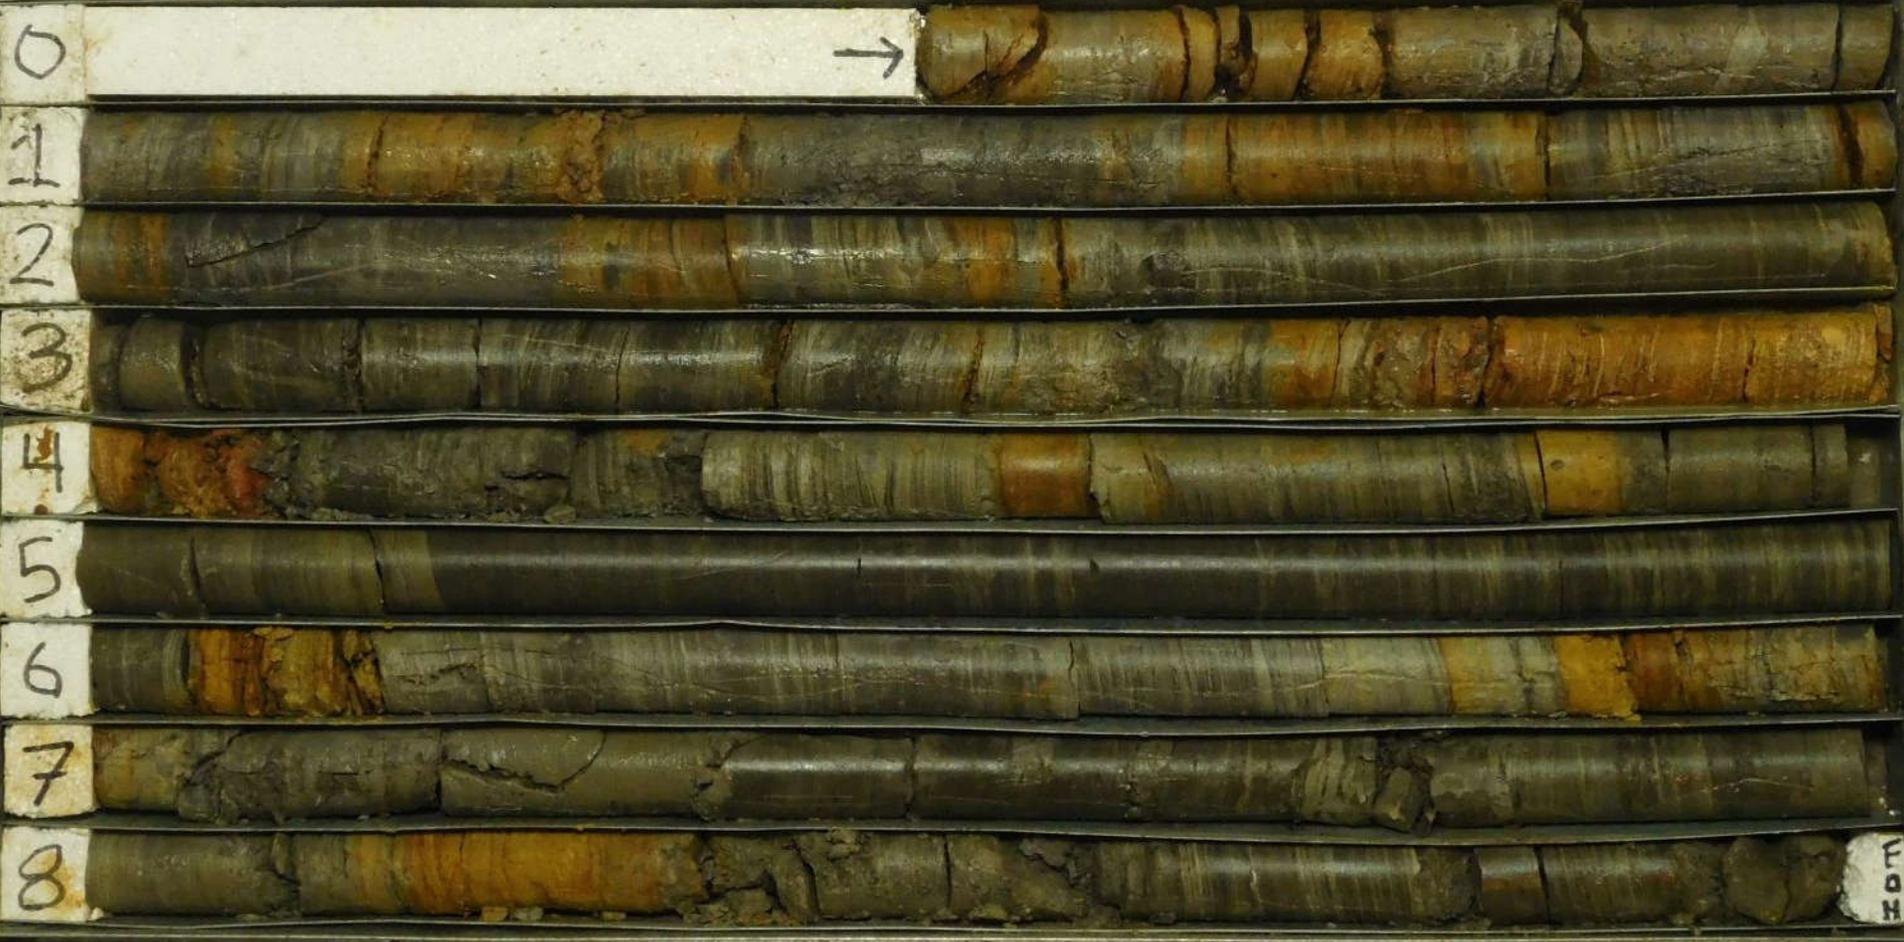
Job No: 33618YJ  
Borehole No: BH102  
Depth: 0.46m - 8.98m

33618YJ BH102 CORING STARTS AT 0.46m

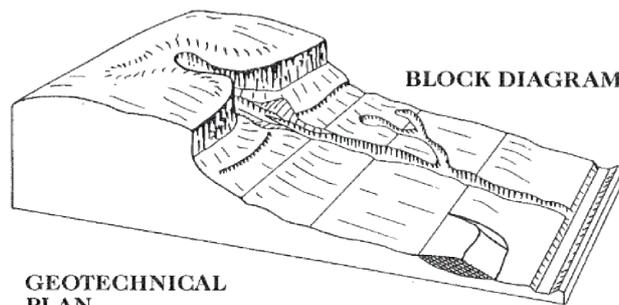
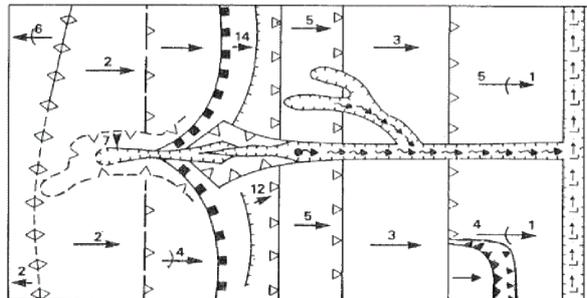
GEOTECHNICAL PLAN

### EXAMPLE OF USE OF TOPOGRAPHIC SYMBOLS:

Title: <b>GEOTECHNICAL MAPPING SYMBOLS</b>	
Location: 1102 - 1106 BARRENJOEY ROAD, PALM BEACH, NSW	
Report No: 33618YJ	Figure No: 6
<b>JKGeotechnics</b>
