Development Application for \_\_\_\_\_ Civia \_\_\_\_\_  
Name of Applicant  
Address of site \_\_ 1102 Barrenjoey Road, Palm Beach \_\_\_\_\_

REPORT TO  
**CIVIA**

ON  
**THREE-DIMENSIONAL (3D) NUMERICAL ANALYSIS**

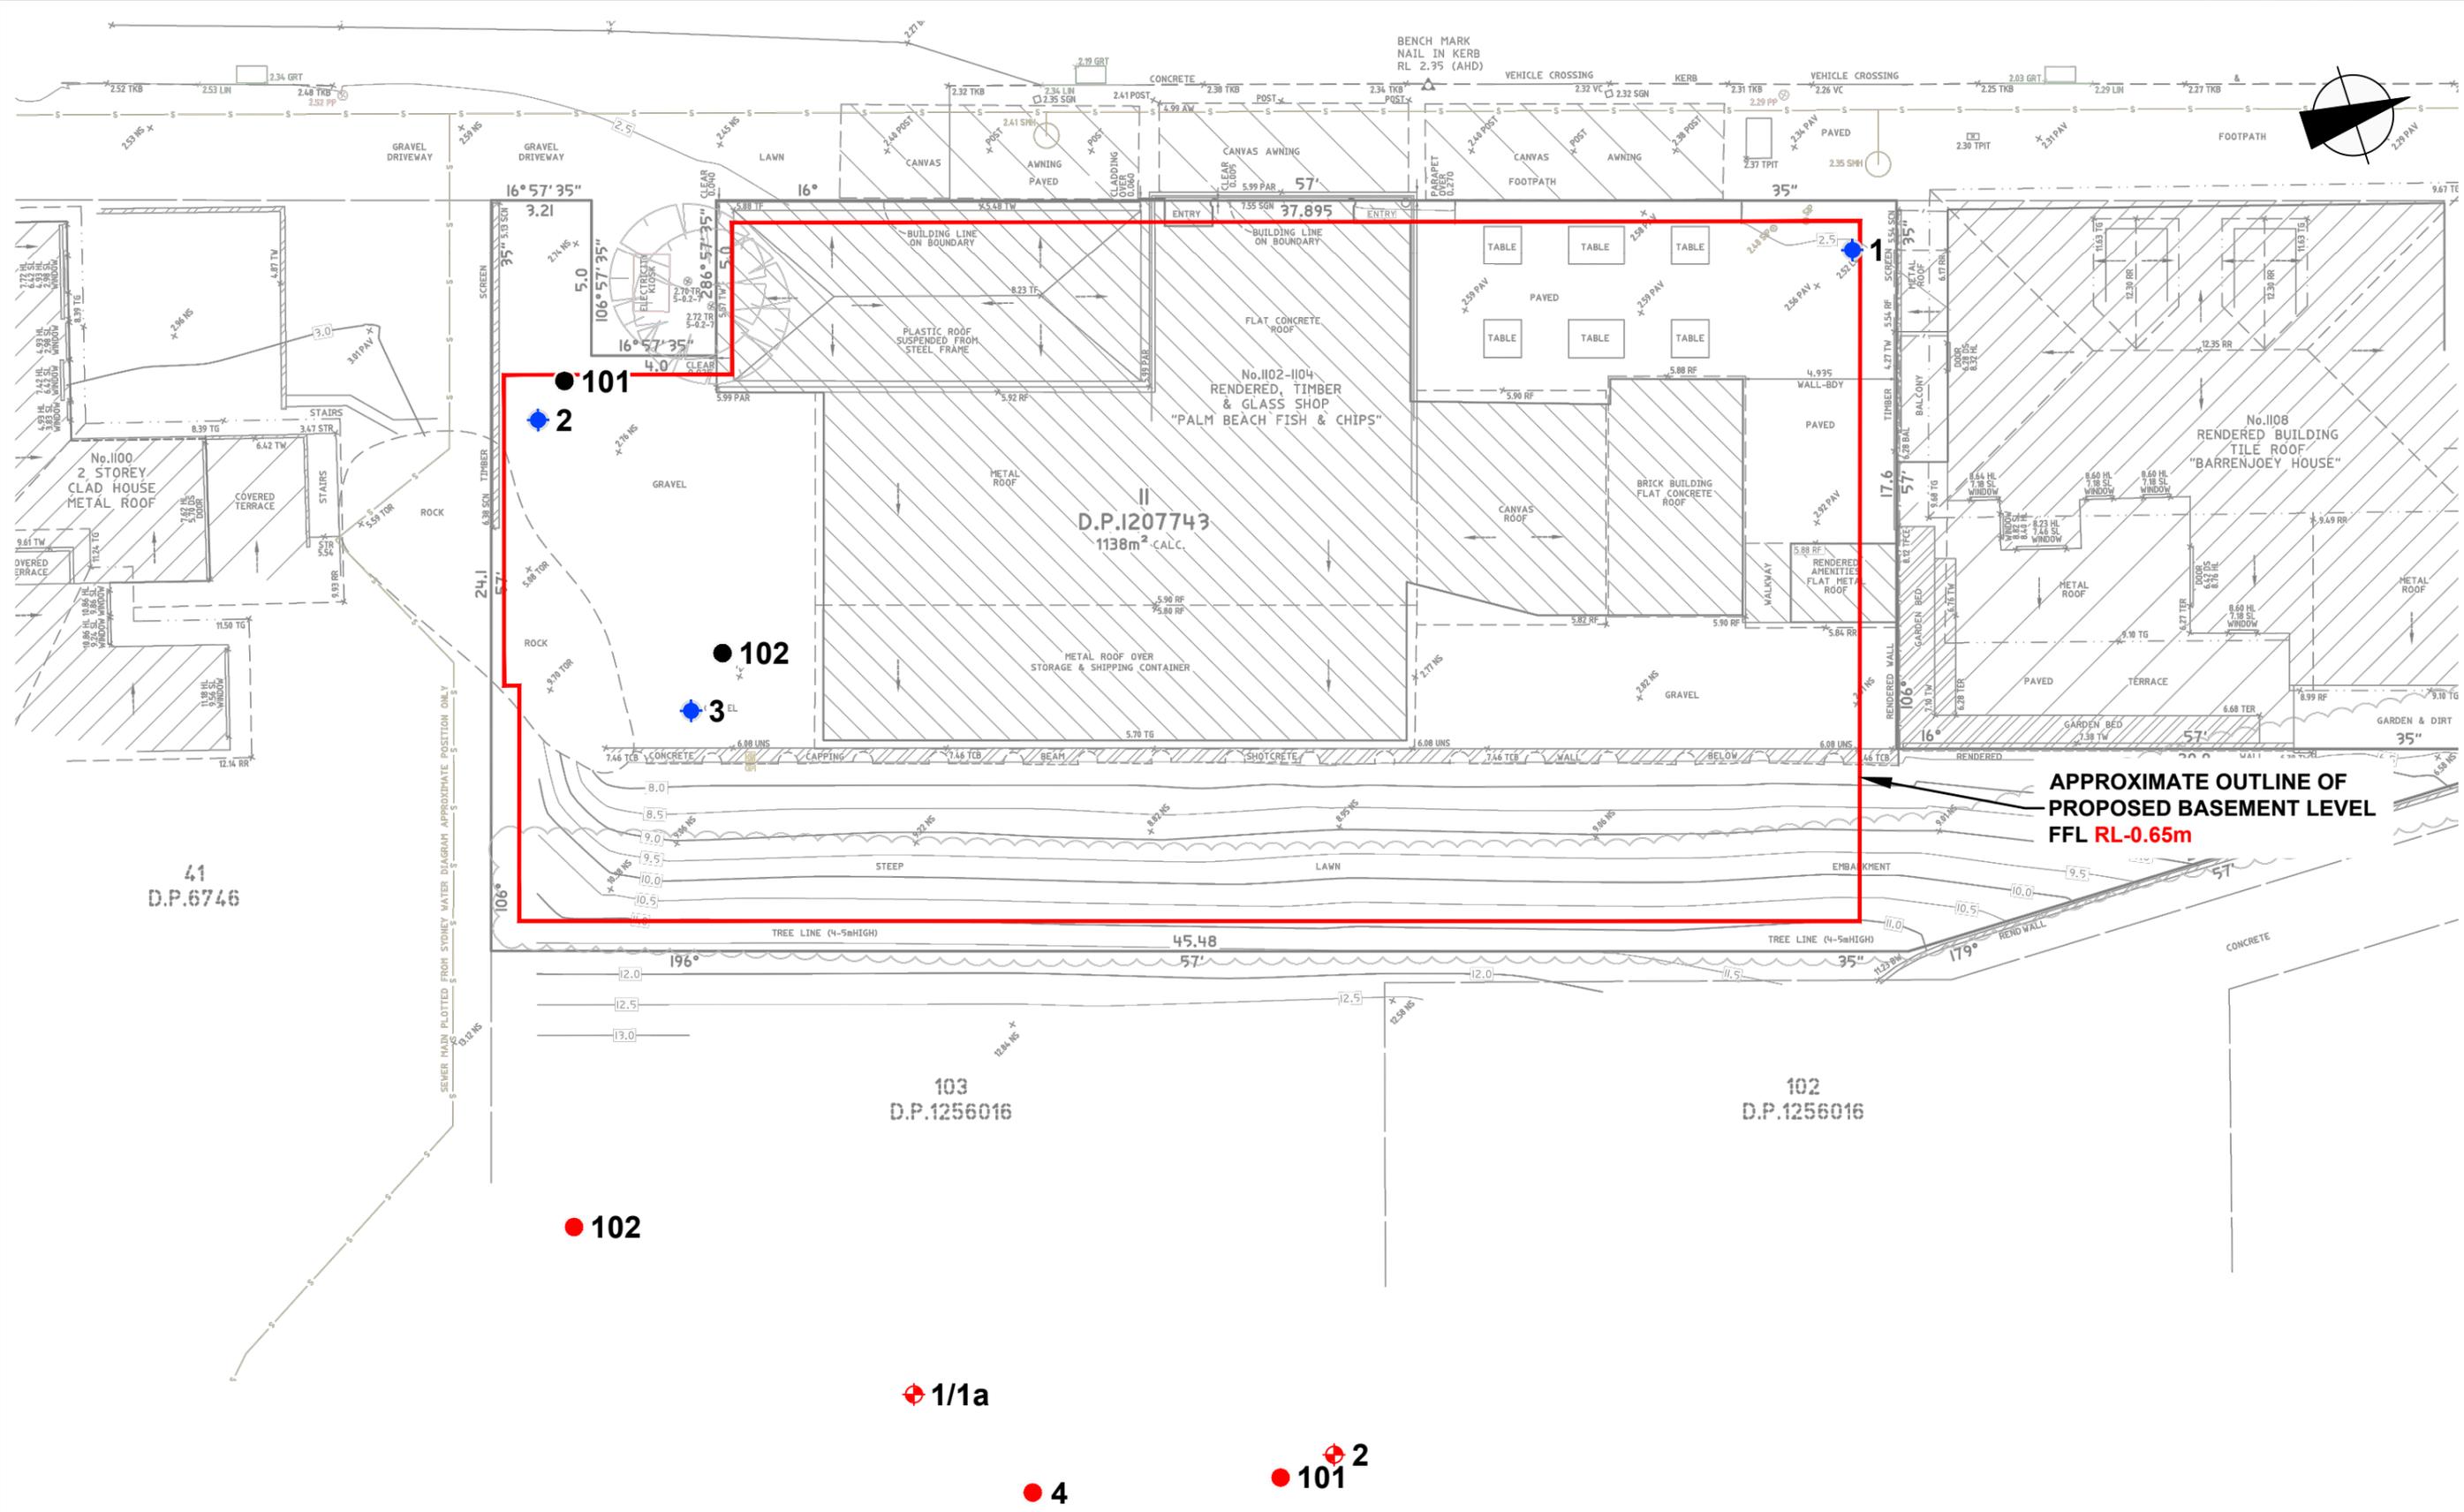
APPROXIMATE OUTLINE OF  
PROPOSED BASEMENT LEVEL  
FFL RL -0.65m

Title: <b>BOREHOLE LOCATION PLAN</b>	
Location: 1102 - 1106 BARRENJOEY ROAD, PALM BEACH, NSW	
Report No: 33618YJrptrev4	Figure No: 2
<b>JKGeotechnics</b>

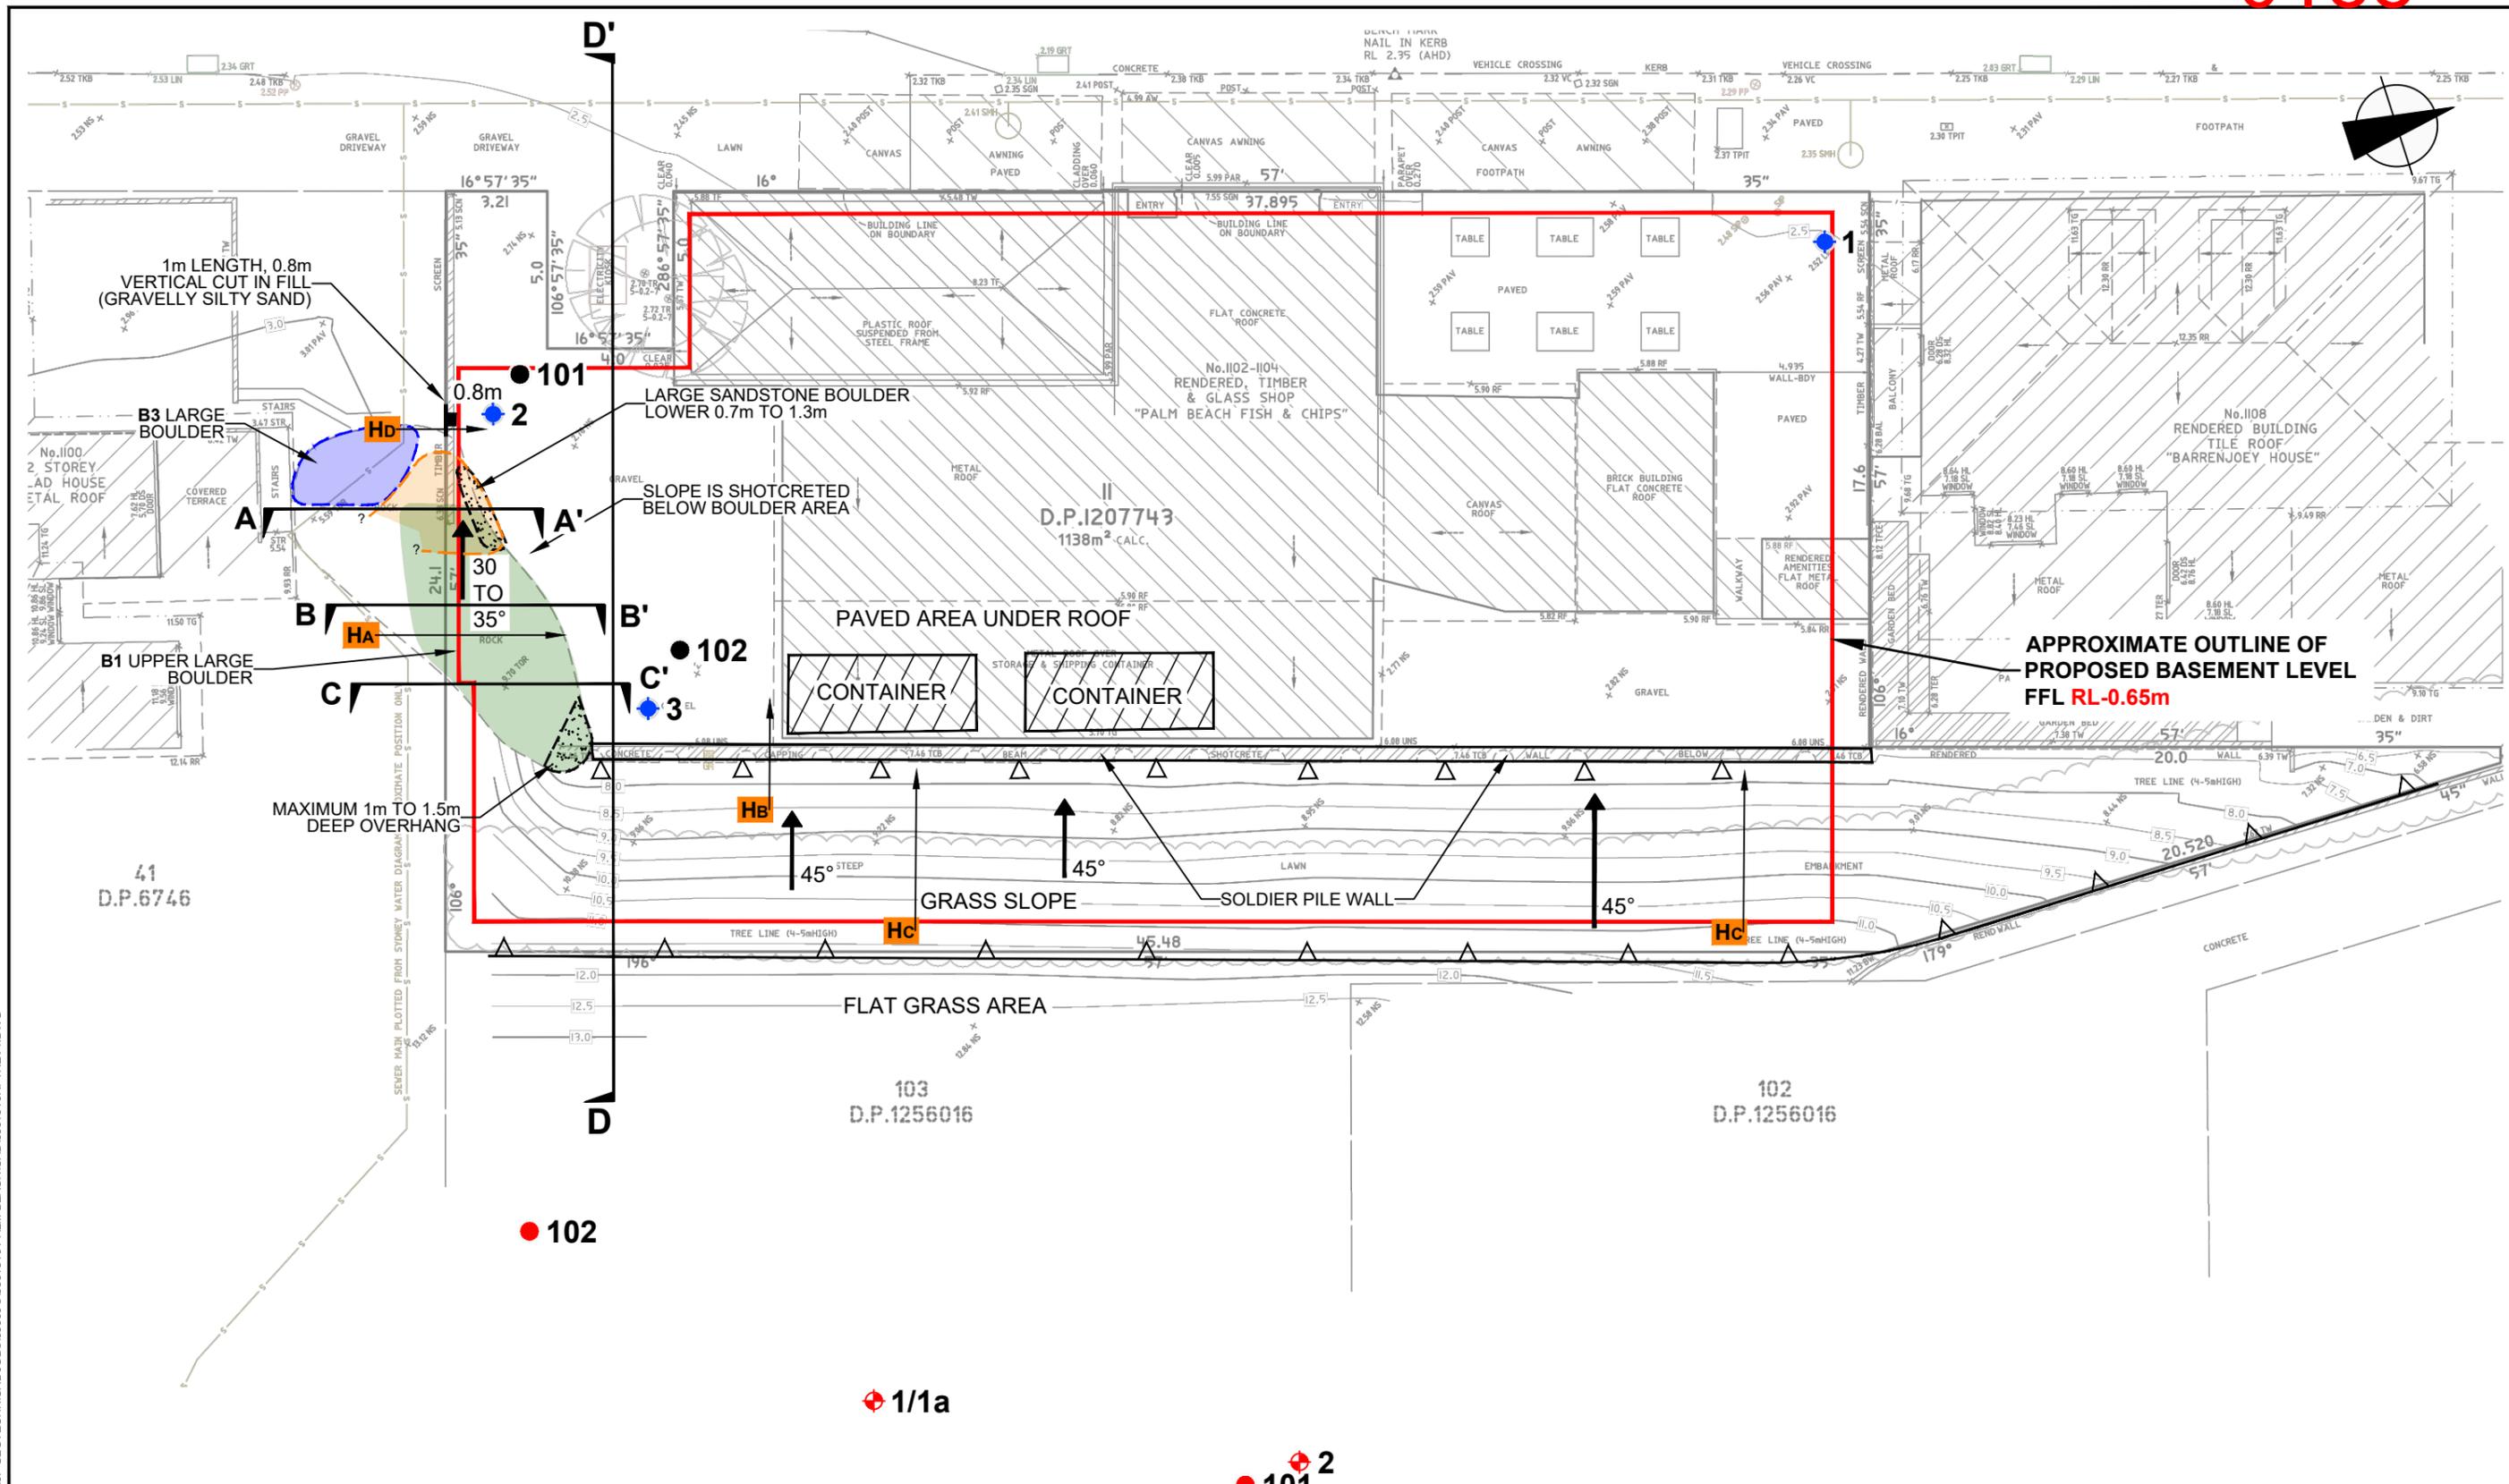
<b>Title: PLAN OF NOTABLE GEOTECHNICAL FEATURES + GEOTECHNICAL HAZARDS</b>	
	<b>Location: 1102 - 1106 BARRENJOEY ROAD, PALM BEACH, NSW</b>	
Report No: 33618YJrptrev4	Figure No: 3

The attached Figure 3 presents a plan showing notable geotechnical site features and geotechnical hazards. Figure 3 is based on the survey plan prepared by CMS Surveyors Pty Ltd (CMS, Ref: Drawing No. 19783detail, Issue 1, date of survey as 3 November 2020). We also received an older survey plan by Adam Clerke Surveyors Pty Ltd (Ref: 20688L, dated 26 April 2012), which we used to review former levels at the site. Additional features on Figure 3 have been measured by hand held clinometer and tape measure techniques and hence are only approximate. Should any of the features be critical to the proposed development, we recommend they be located more accurately using instrument survey techniques. Figure 6 defines the geotechnical mapping symbols adopted and used in Figure 3. Figures 4 and 5 present typical cross-sections (Sections A-A' and B-B', respectively) through the site based on the survey data augmented by our mapping observations. These sections include potential landslide hazards.

We recommend that the summary of observations which follows be read in conjunction with the attached Figure 1 (Site Location Plan) and Figure 3 (Plan of Notable Geotechnical Features and Geotechnical Hazards).

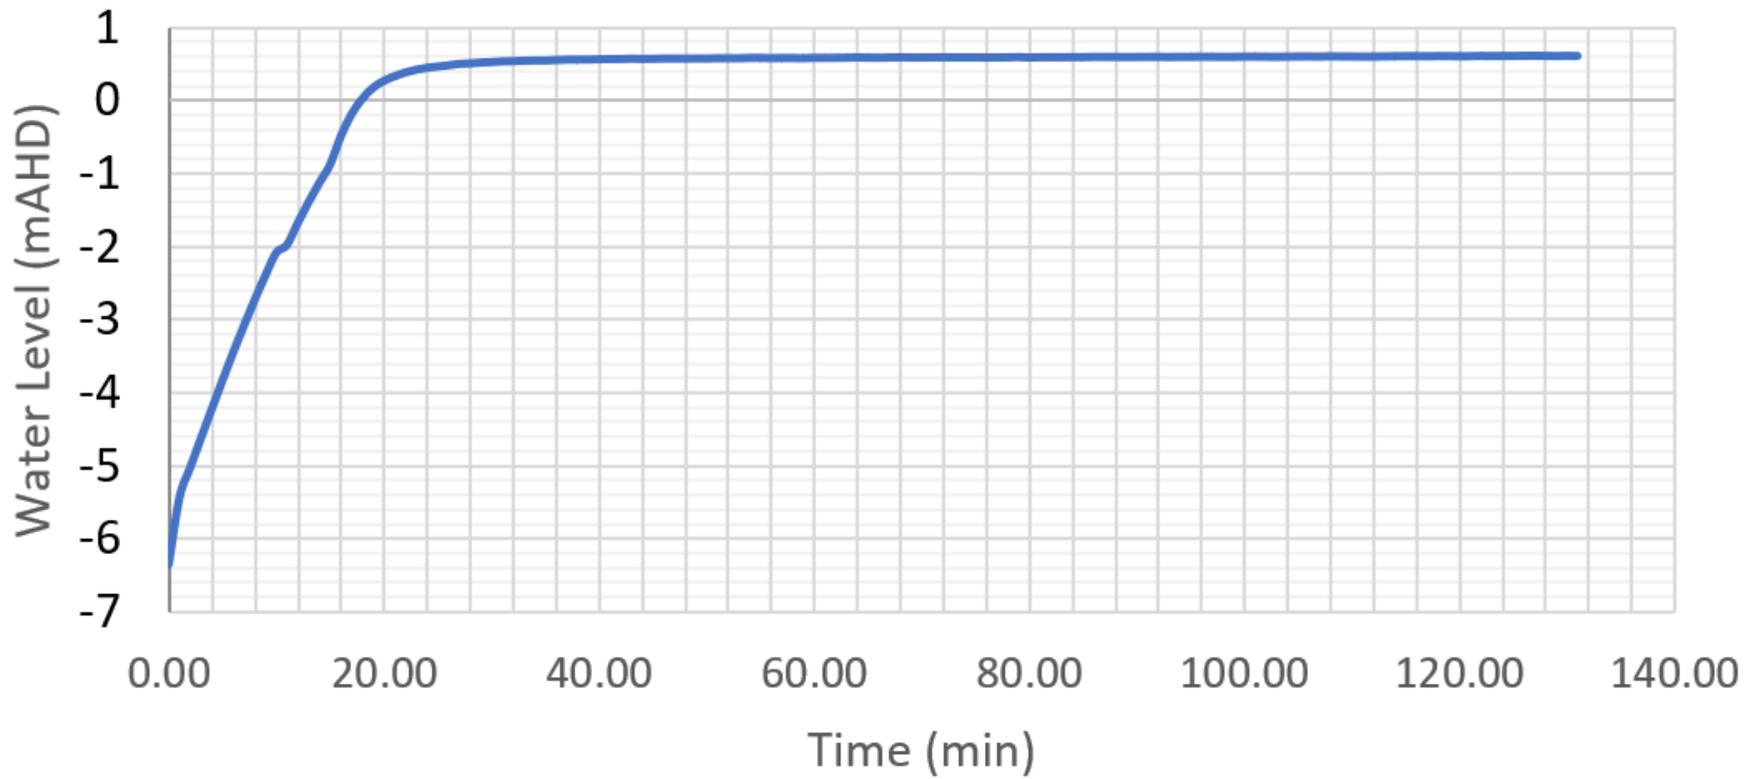
### PUMP-OUT RECOVERY TESTING VS TIME PLOT – BH101

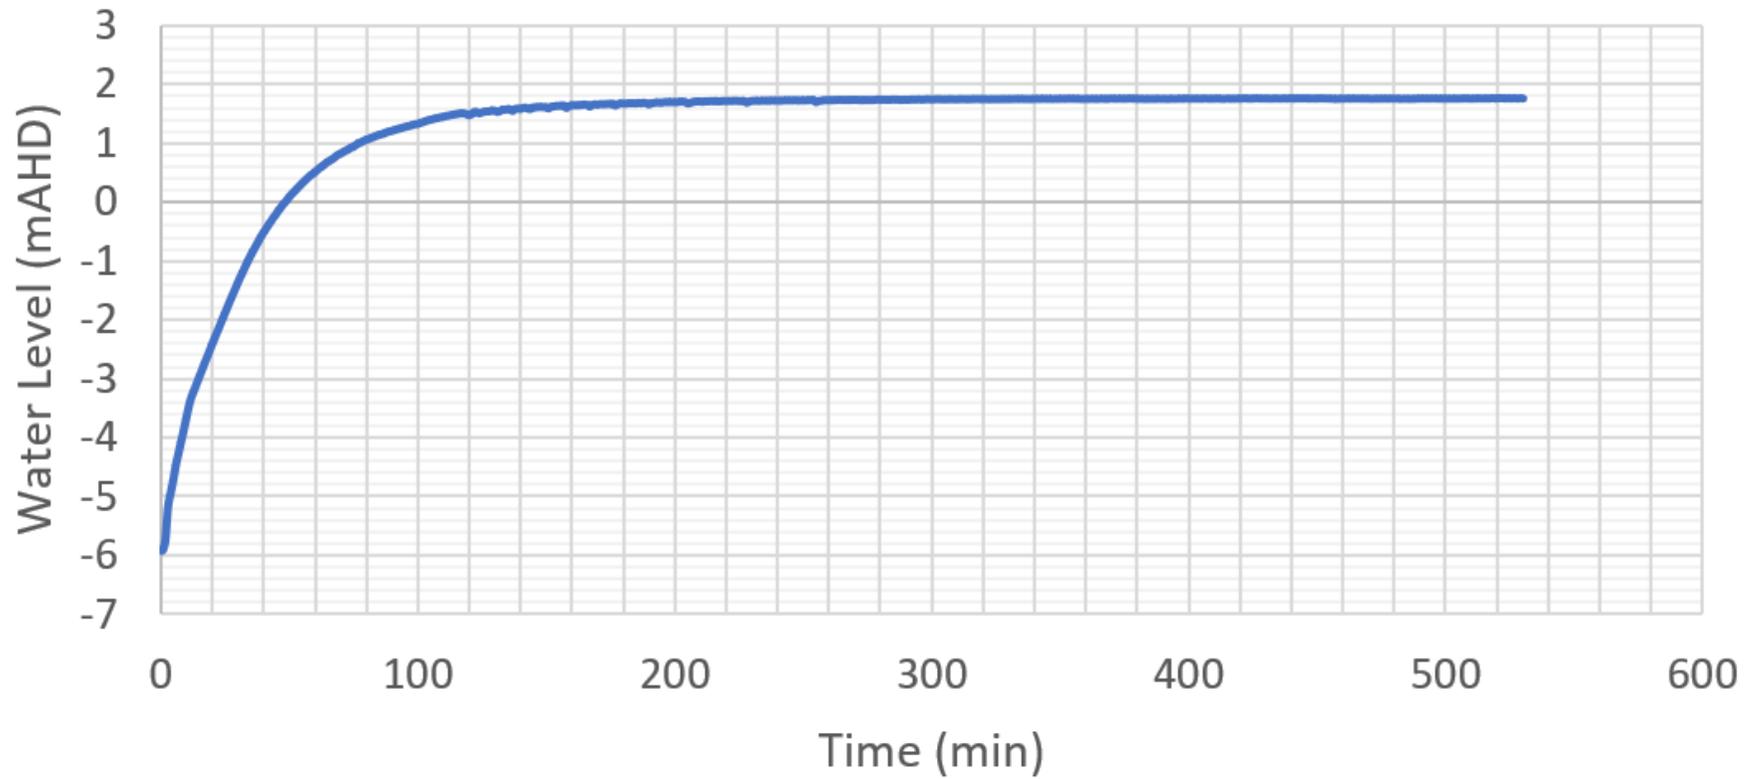
### PUMP-OUT RECOVERY TESTING V TIME PLOT – BH102

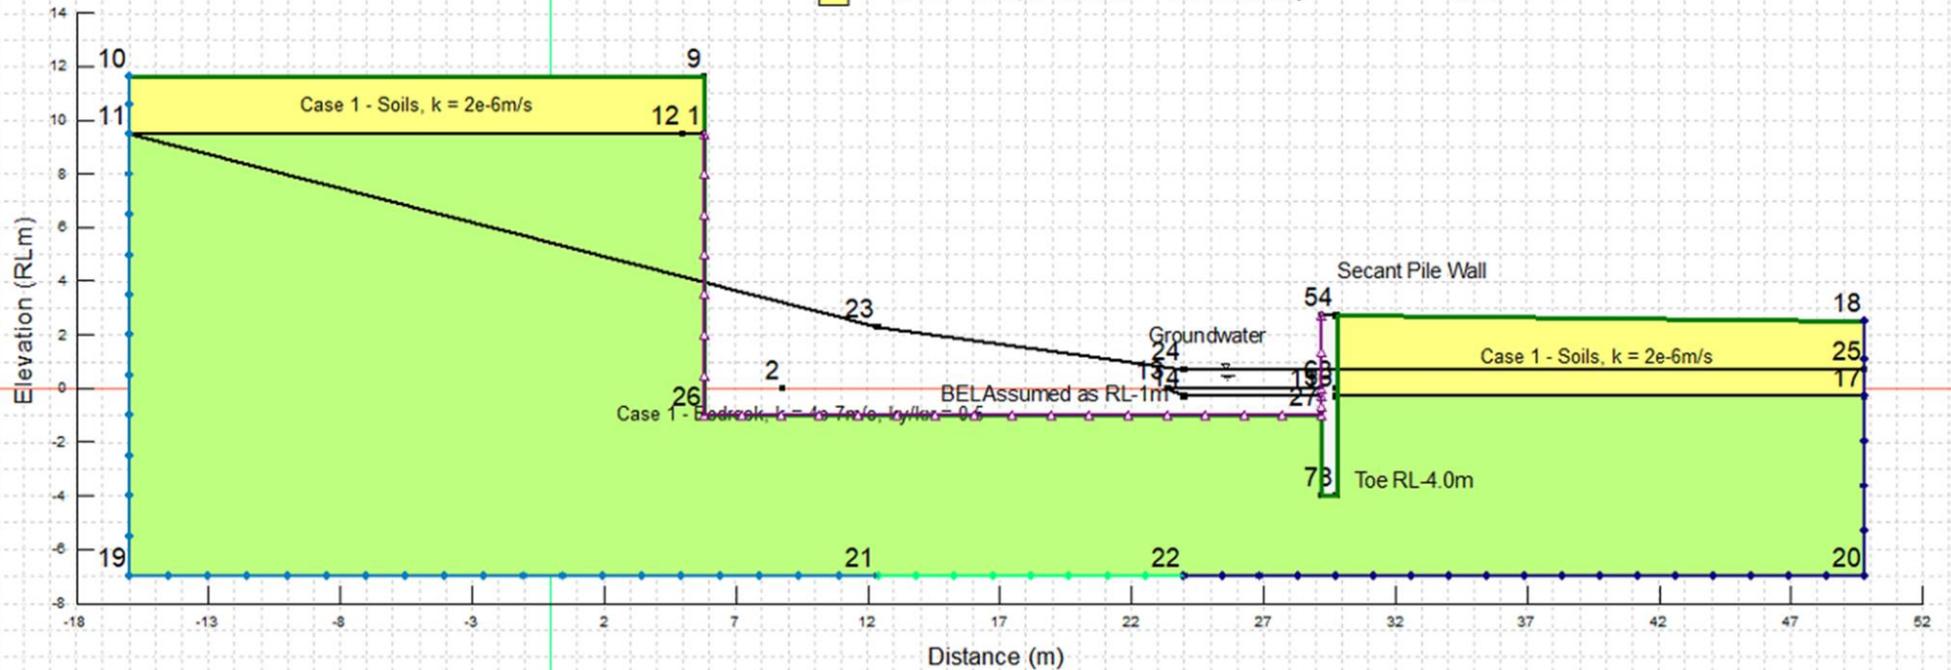
Color	Name	Hydraulic Material Model	Sat Kx (m/sec)	Ky'/Kx' Ratio
Light Green	Case 1 - Bedrock, k = 4e-7m/s, ky/kx = 0.5	Saturated Only	4e-07	0.5
Yellow	Case 1 - Soils, k = 2e-6m/s	Saturated Only	2e-06	1

## SEEP/W – GEOTECHNICAL MODEL

portion of the site, a 'cut-off' wall will be required to prevent soil and water flowing into the excavation both during construction and in the long term and provide both temporary and permanent support. In this regard the cut-off wall has been assumed to be impermeable. As a consequence, seepage inflows must flow around the toe of the cut-off wall and come up into the excavation through the floor of the basement excavation. Over the eastern portion of the site where bedrock is at shallow level, groundwater inflow will be through the rock mass exposed in both the cut faces and base of the excavation. The geotechnical model is shown in Figure 9.

In this case we have modelled the basement excavation with a vertical cut on the eastern side and a 'cut-off wall' on the western side. Total head boundary conditions have been adopted at the sides and base of the model. Infinite elements have been utilised at the sides and base of the model to represent the total head conditions beyond the model boundaries. The model geometry adopted is presented in Figure 9.

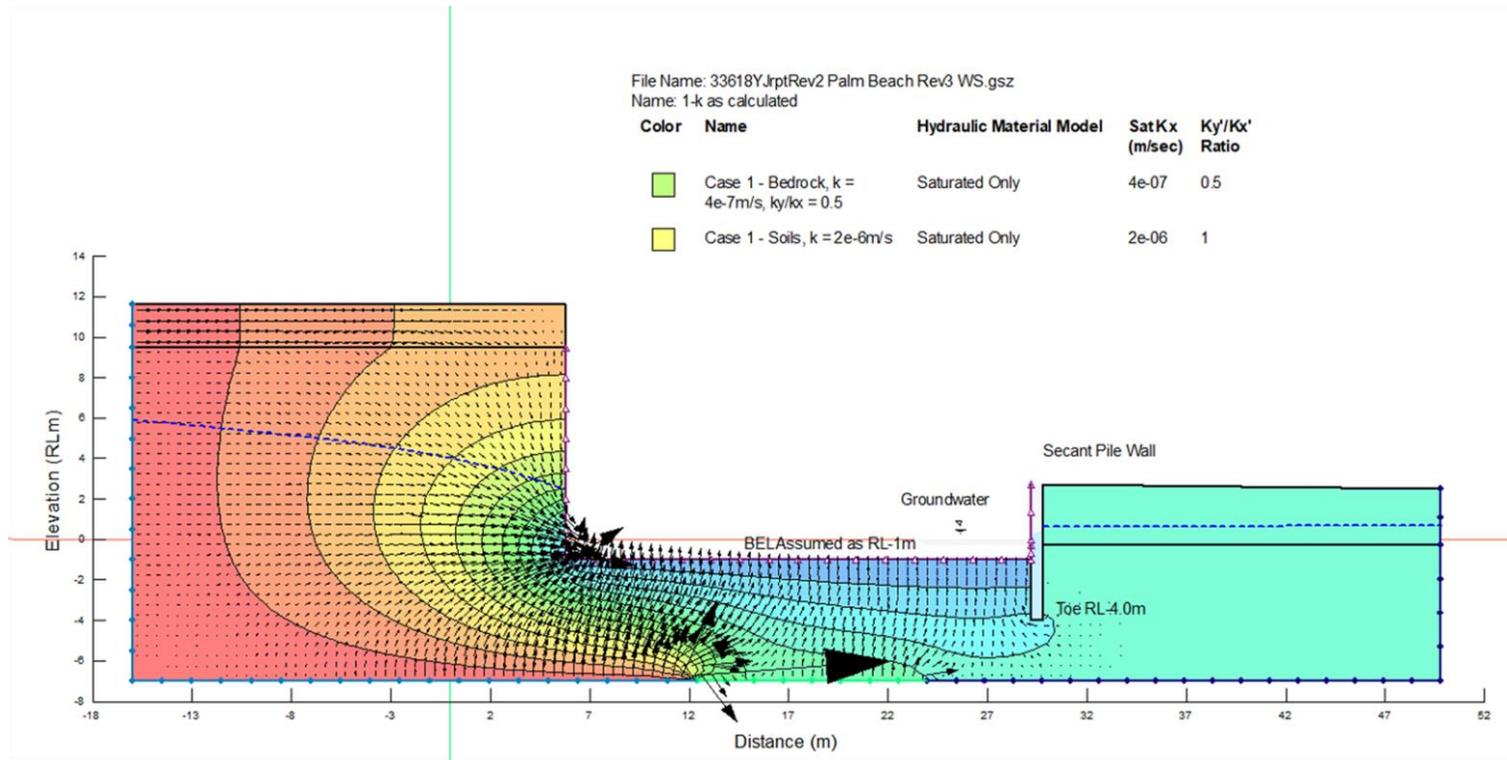
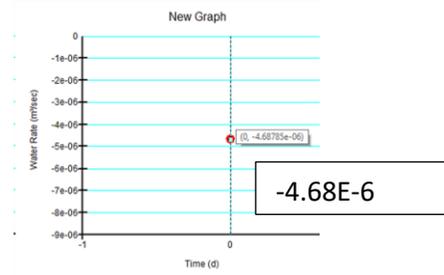
SEEP/W – OUTPUT EXTRACTION VOLUMES

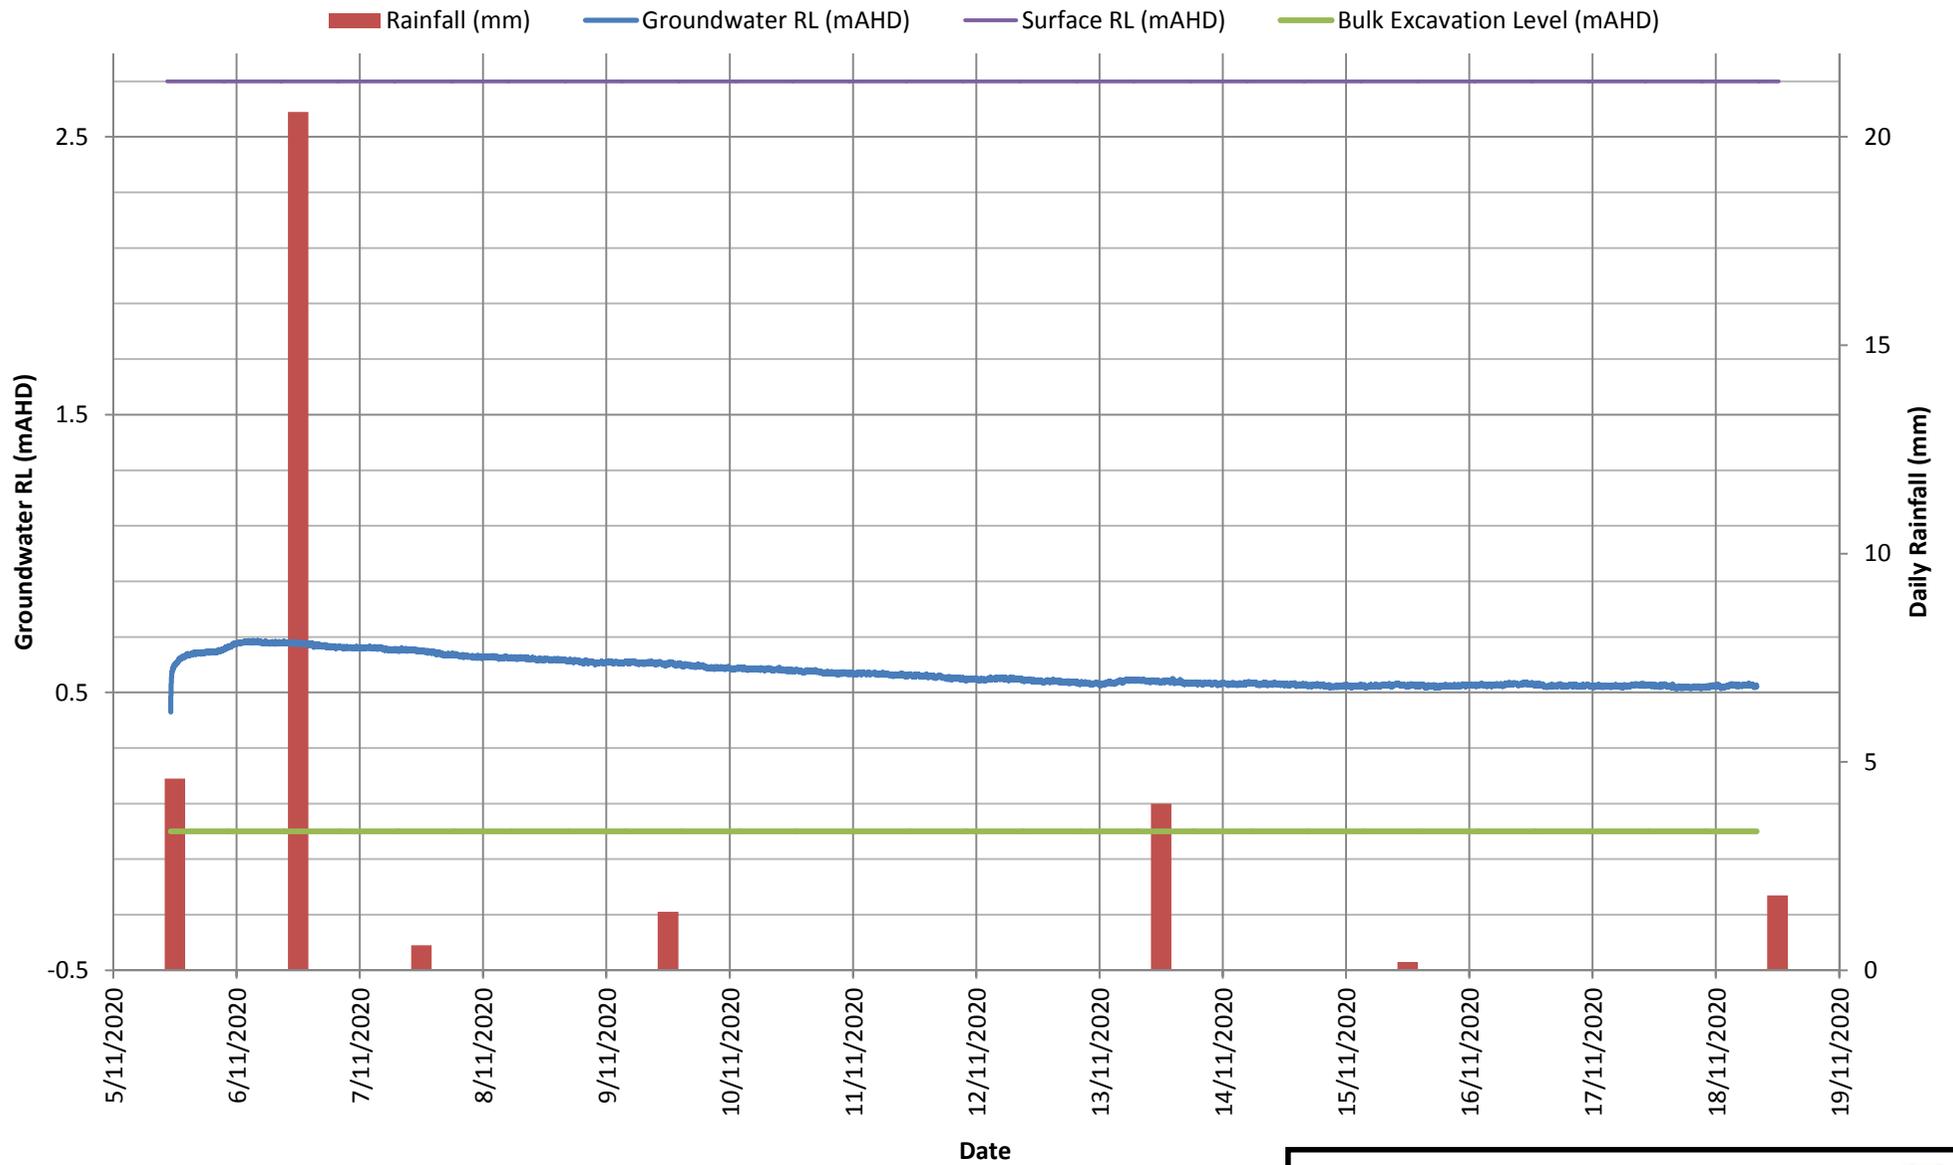
## Groundwater Level and Daily Rainfall -vs- Time Plot BH101

Rainfall data from Mona Vale Golf Club, Station number : 066141

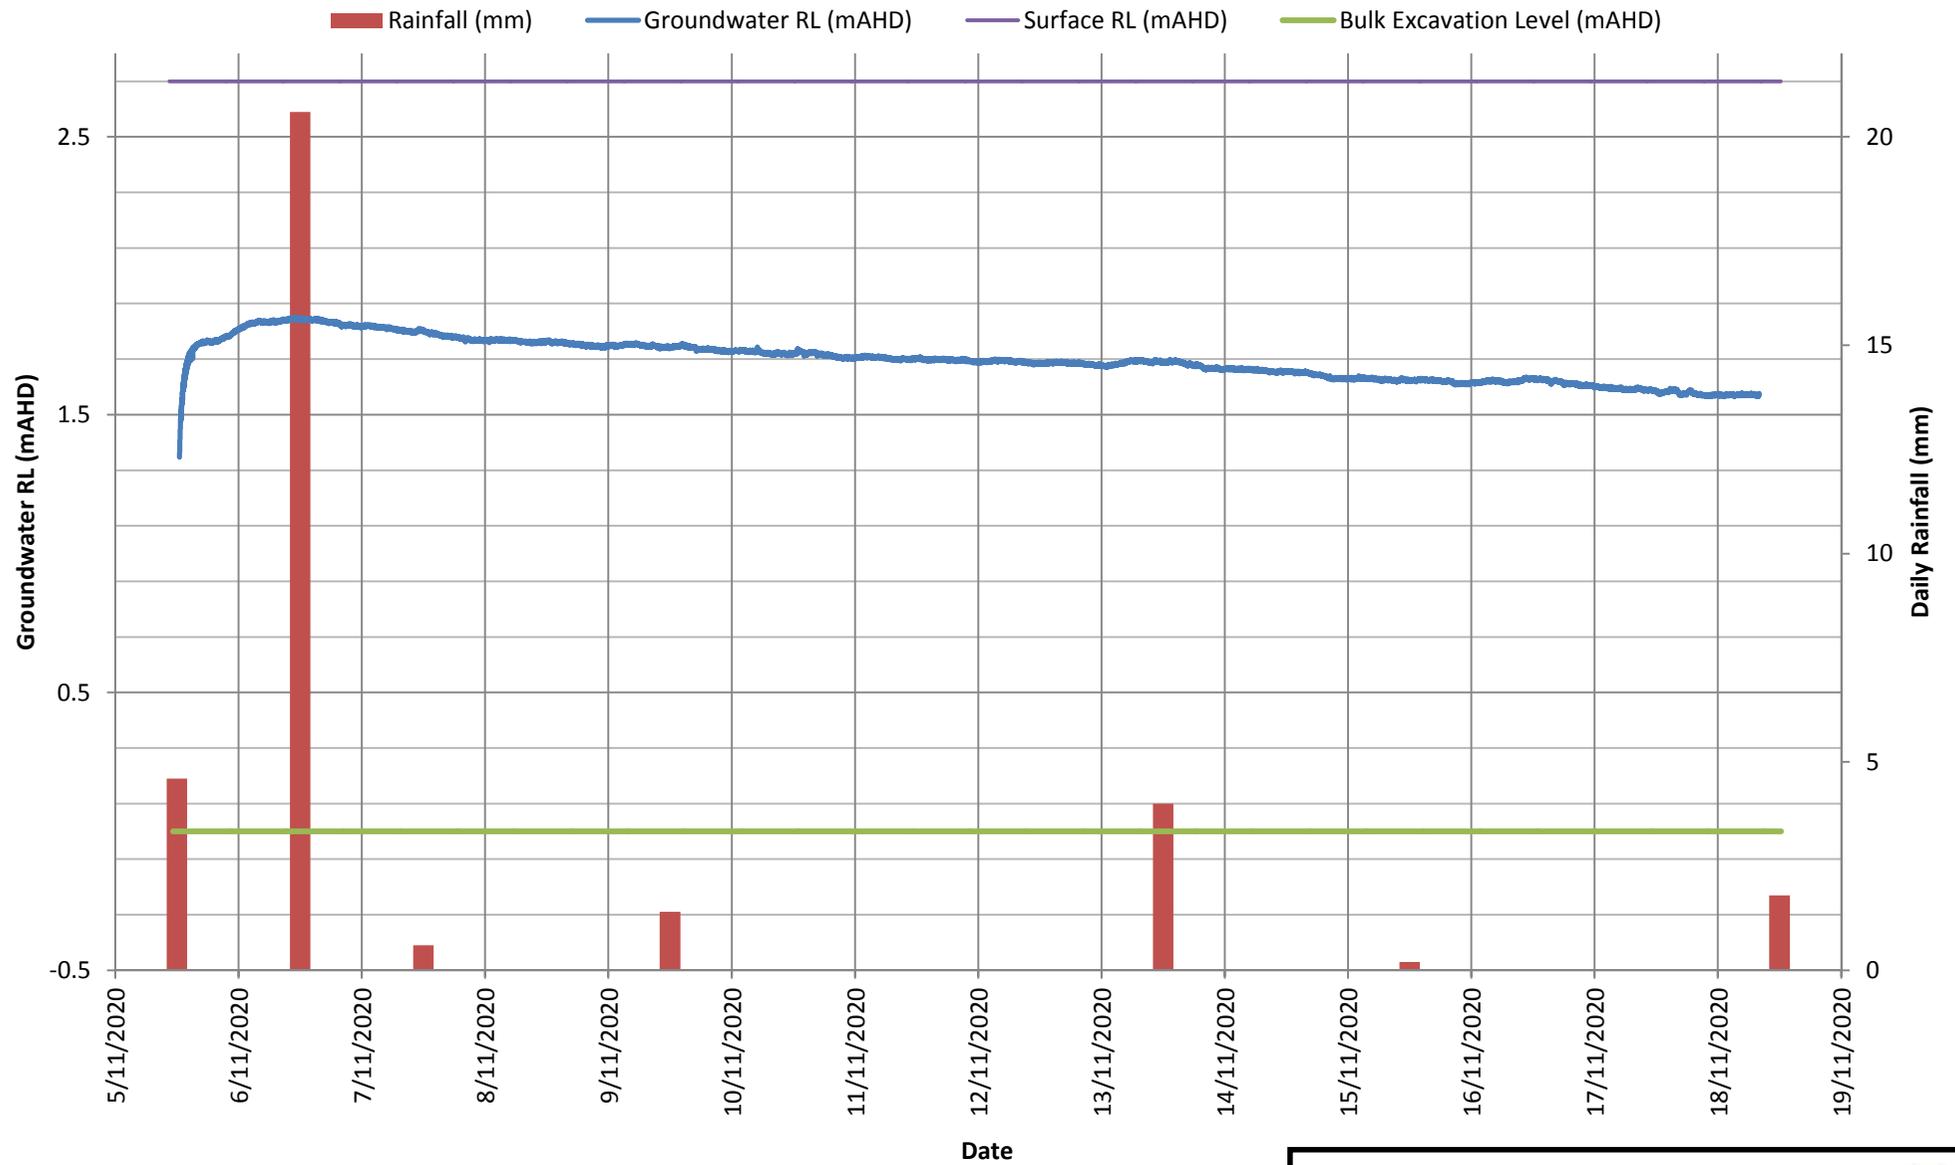
## Groundwater Level and Daily Rainfall -vs- Time Plot BH102

Rainfall data from Mona Vale Golf Club, Station number : 066141

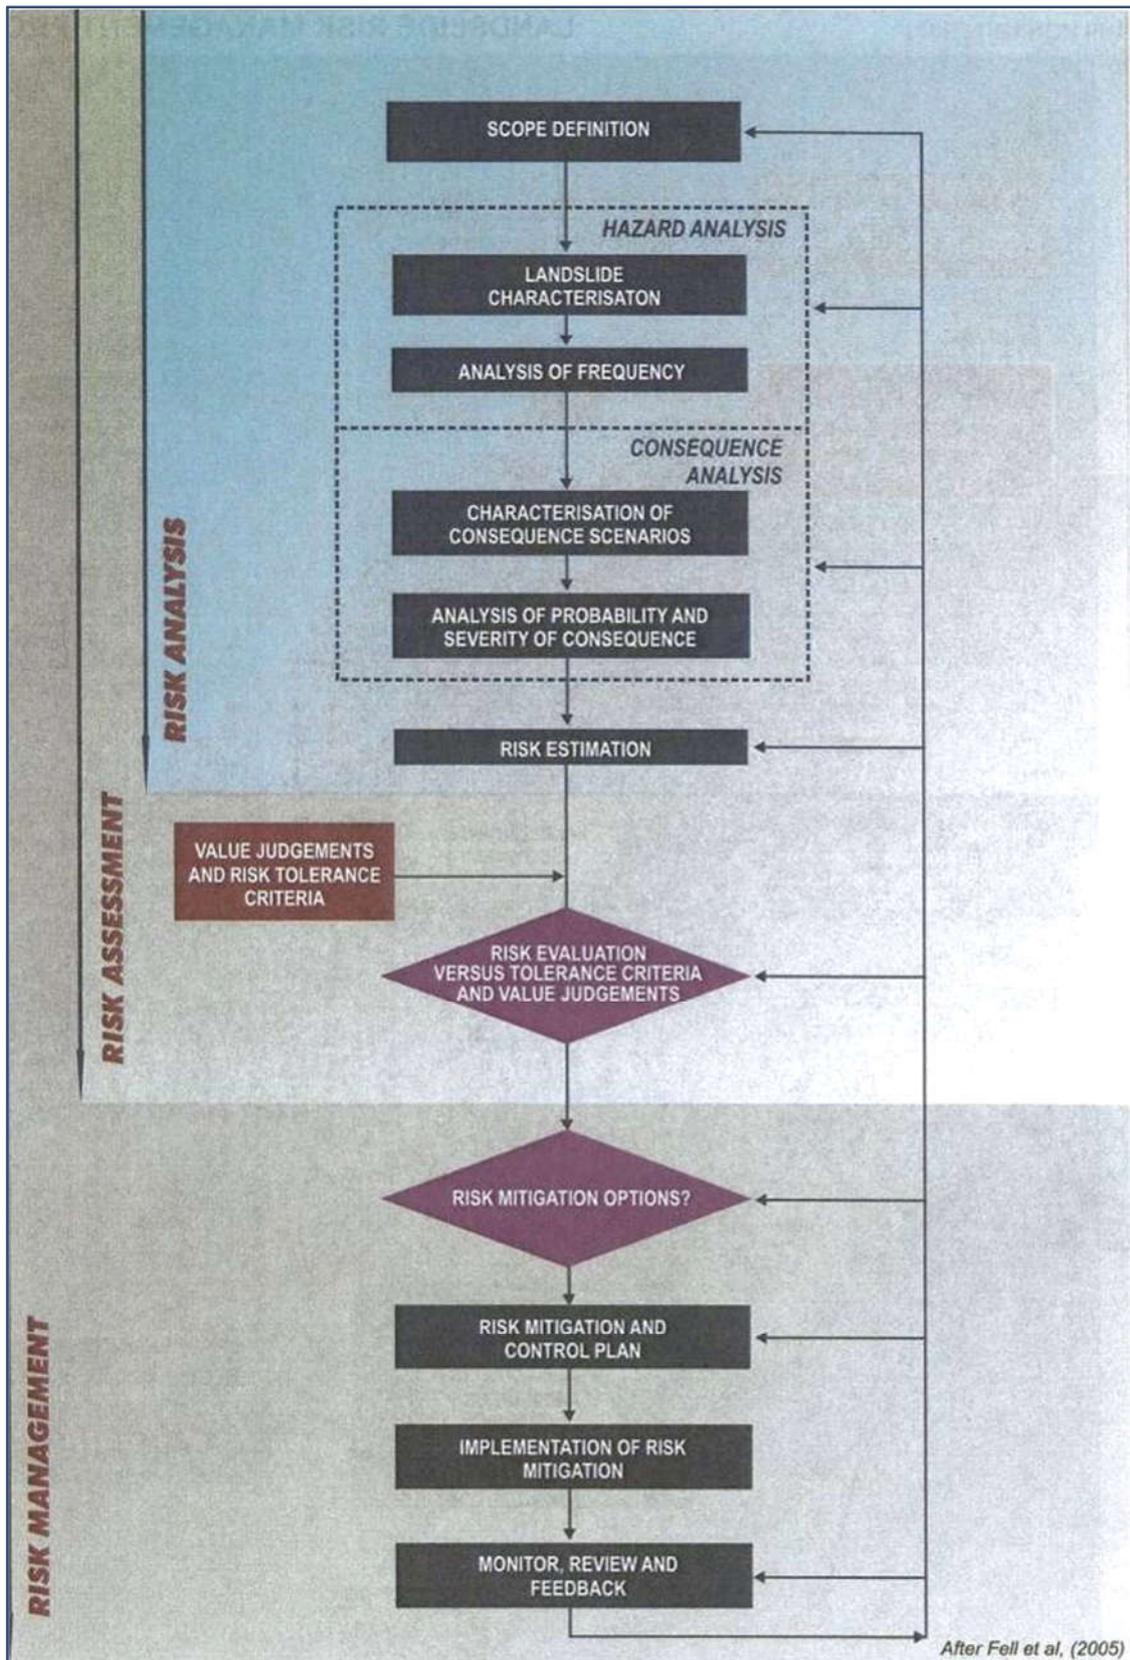
FIGURE A1: Flowchart for Landslide Risk Management.

This figure is an extract from GUIDELINE FOR LANDSLIDE SUSCEPTIBILITY, HAZARD AND RISK ZONING FOR LAND USE PLANNING, as presented in Australian Geomechanics Vol 42, No 1, March 2007, which discusses the matter more fully.

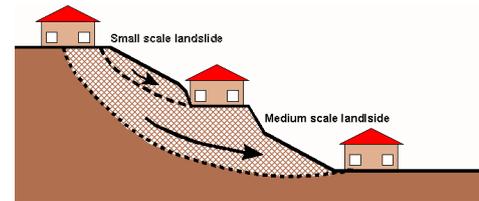
Figure 1

**Rotational or circular slip failures (Figure 1)** - can occur on moderate to very steep soil and weathered rock slopes (Table 1). The sliding surface of the moving mass tends to be deep seated. Tension cracks may open at the top of the slope and bulging may occur at the toe. The ground may move in discrete "steps" separated by long periods without movement. More rapid movement may occur after heavy rain.

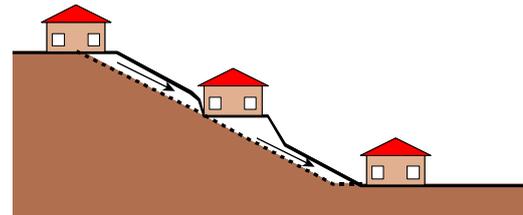
Figure 2

**Translational slip failures (Figure 2)** - tend to occur on moderate to very steep slopes (Table 1) where soil, or weak rock, overlies stronger strata. The sliding mass is often relatively shallow. It can move, or deform slowly (creep) over long periods of time. Extensive linear cracks and hummocks sometimes form along the contours. The sliding mass may accelerate after heavy rain.

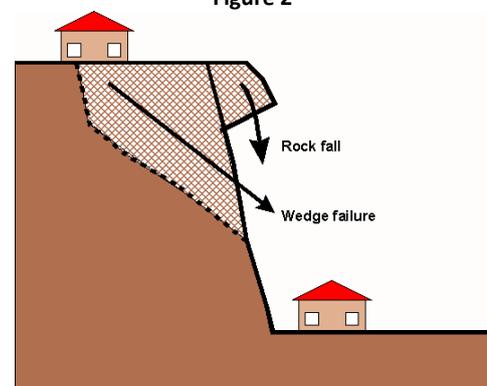
Figure 3

**Wedge failures (Figure 3)** - normally only occur on extreme slopes, or cliffs (Table 1), where discontinuities in the rock are inclined steeply downwards out of the face.

**Rock falls (Figure 3)** - tend to occur from cliffs and overhangs (Table 1).

Cliffs may remain, apparently unchanged, for hundreds of years. Collections of boulders at the foot of a cliff may indicate that rock falls are ongoing. Wedge failures and rock falls do not "creep". Familiarity with a particular local situation can instil a false sense of security since failure, when it occurs, is usually sudden and catastrophic.

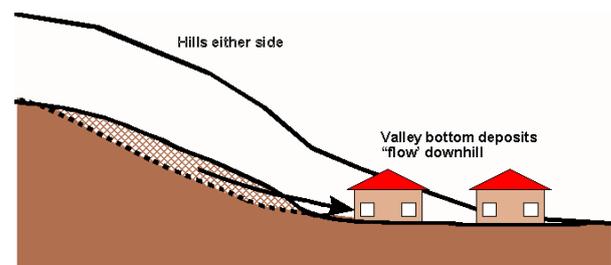
Figure 4

**Debris flows and mud slides (Figure 4)** - may occur in the foothills of ranges, where erosion has formed valleys which slope down to the plains below. The valley bottoms are often lined with loose eroded material (debris) which can "flow" if it becomes saturated during and after heavy rain. Debris flows are likely to occur with little warning; they travel a long way and often involve large volumes of soil. The consequences can be devastating.

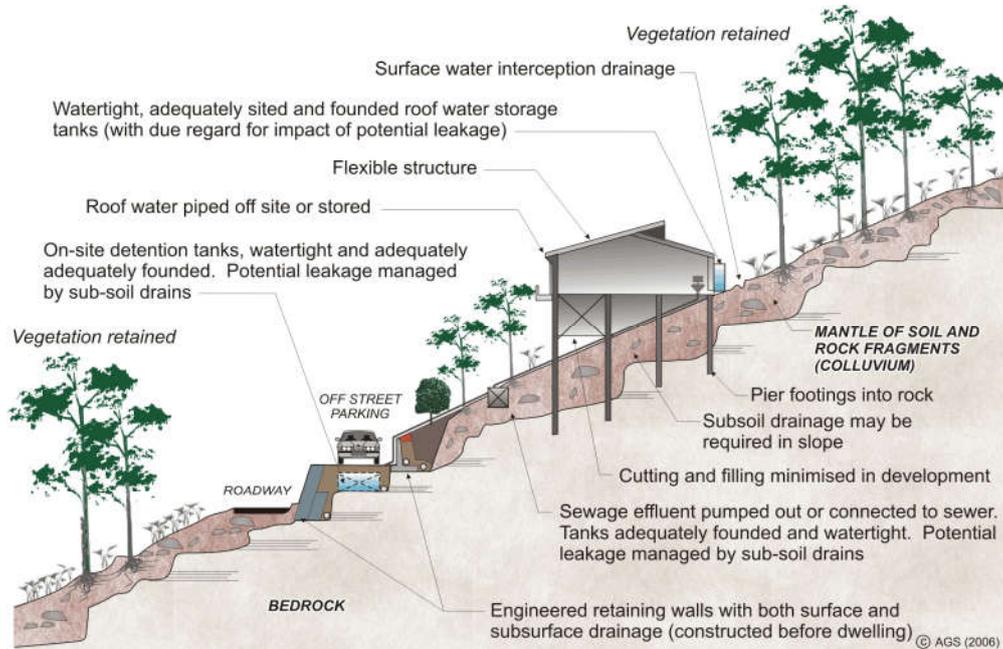
### EXAMPLES FOR **GOOD** HILLSIDE CONSTRUCTION PRACTICE

#### WHY ARE THESE PRACTICES GOOD?

**Roadways and parking areas** - are paved and incorporate kerbs which prevent water discharging straight into the hillside (GeoGuide LR5).

Sensible development practices are required when building on hillsides, particularly if the hillside has more than a low risk of instability (GeoGuide LR7). Only building techniques intended to maintain, or reduce, the overall level of landslide risk should be considered. Examples of good hillside construction practice are illustrated below.

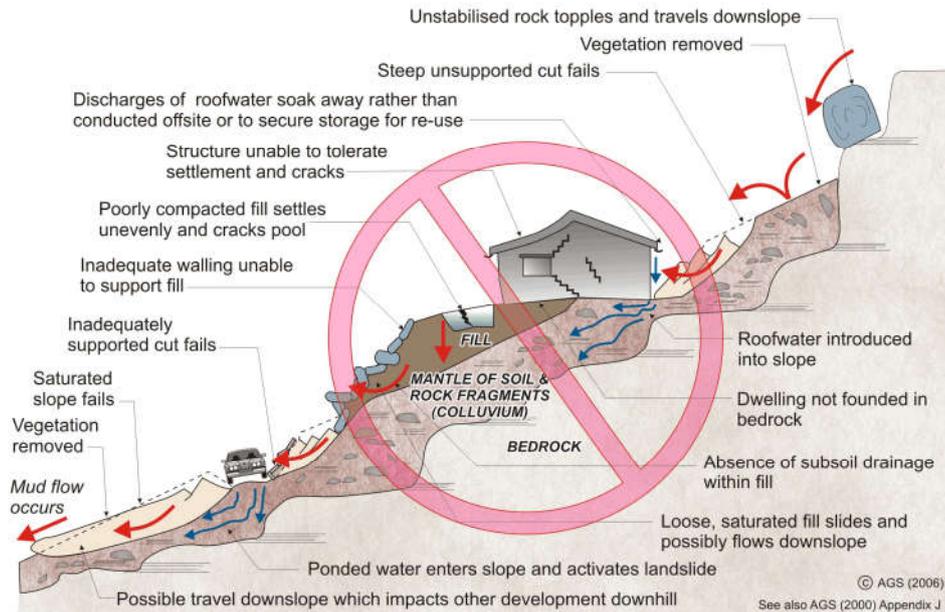
## EXAMPLES FOR **POOR** HILLSIDE CONSTRUCTION PRACTICE

### WHY ARE THESE PRACTICES POOR?

**Roadways and parking areas** - are unsurfaced and lack proper table drains (gutters) causing surface water to pond and soaks into the ground.
