Development Application for \_\_\_\_\_ Civia \_\_\_\_\_  
Name of Applicant  
Address of site \_\_ 1102 Barrenjoey Road, Palm Beach \_\_\_\_\_

REPORT TO  
**CIVIA**

ON  
**THREE-DIMENSIONAL (3D) NUMERICAL ANALYSIS**

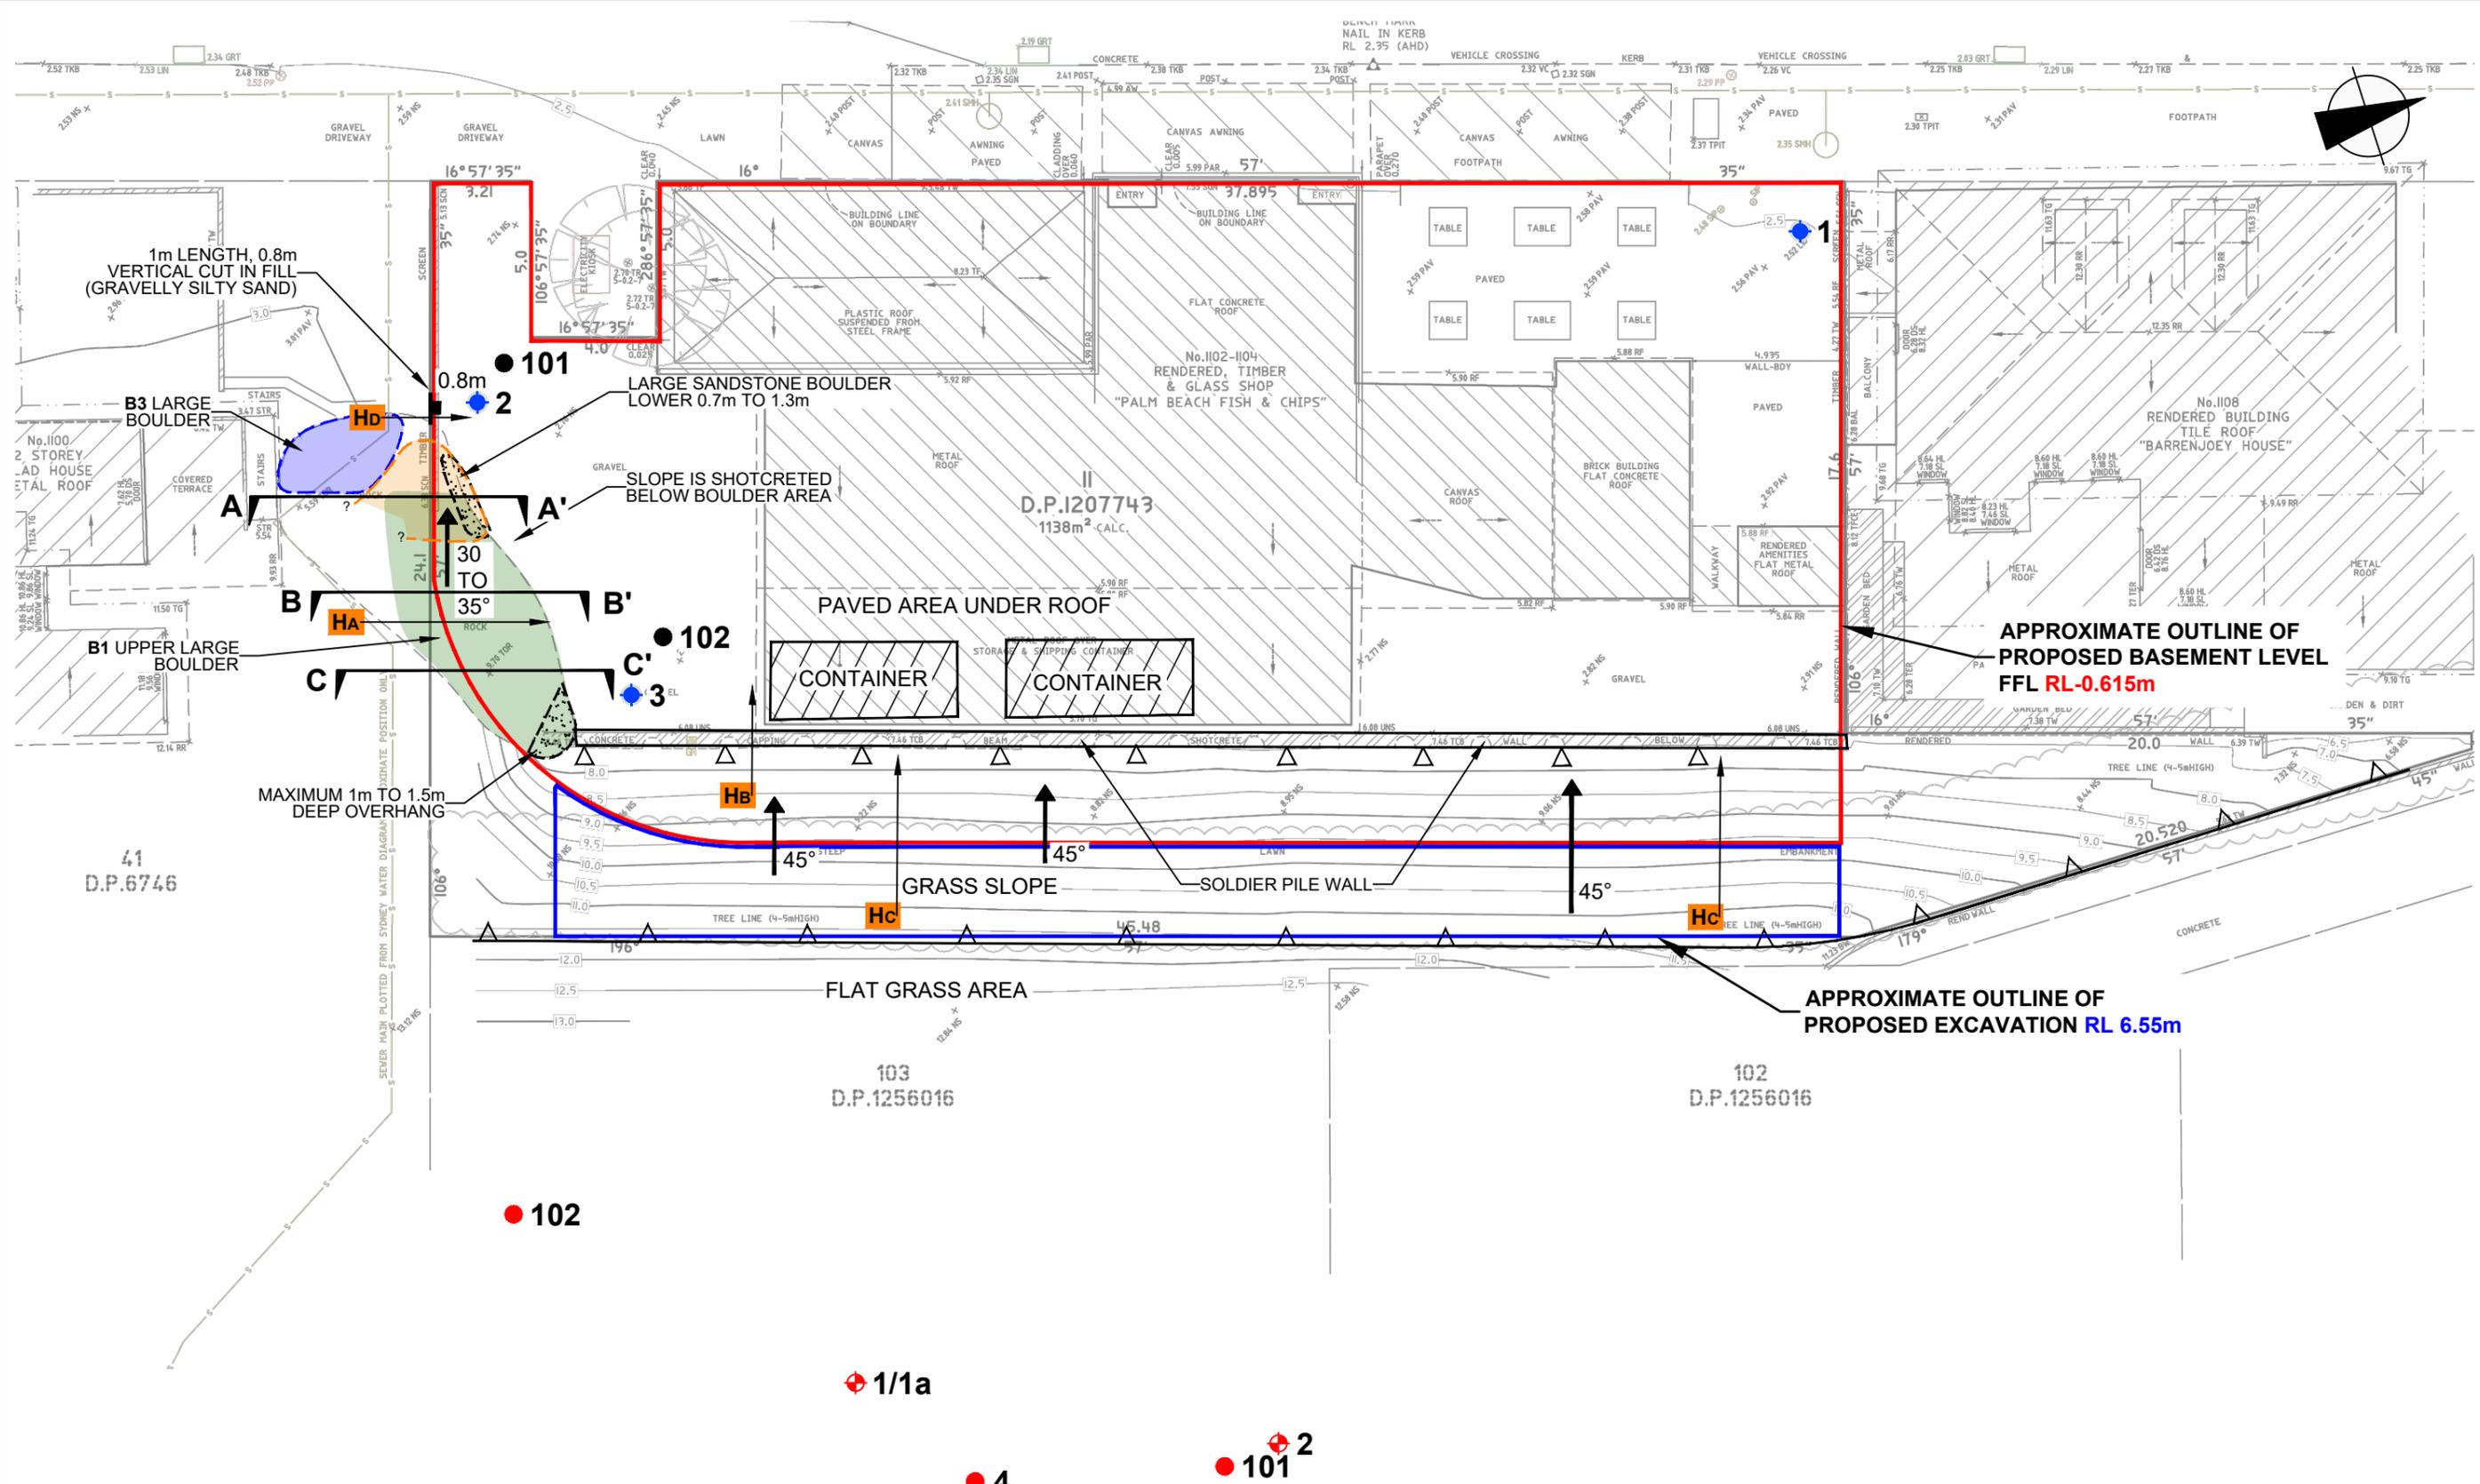
<p>SCALE 1:200 @A3 METRES</p>	<p>Title: <b>PLAN SHOWING LOCATIONS OF SECTIONS</b></p>	
	<p>Location: 1102 - 1106 BARRENJOEY ROAD, PALM BEACH, NSW</p>	
	<p>Report No: 33618YJlet2rev4</p>	<p>Figure No: 1</p>
<p><b>JKGeotechnics</b></p>

NOTE: REFER TO FIGURE 2 FOR CROSS SECTIONS A-A', B-B' AND C-C'.

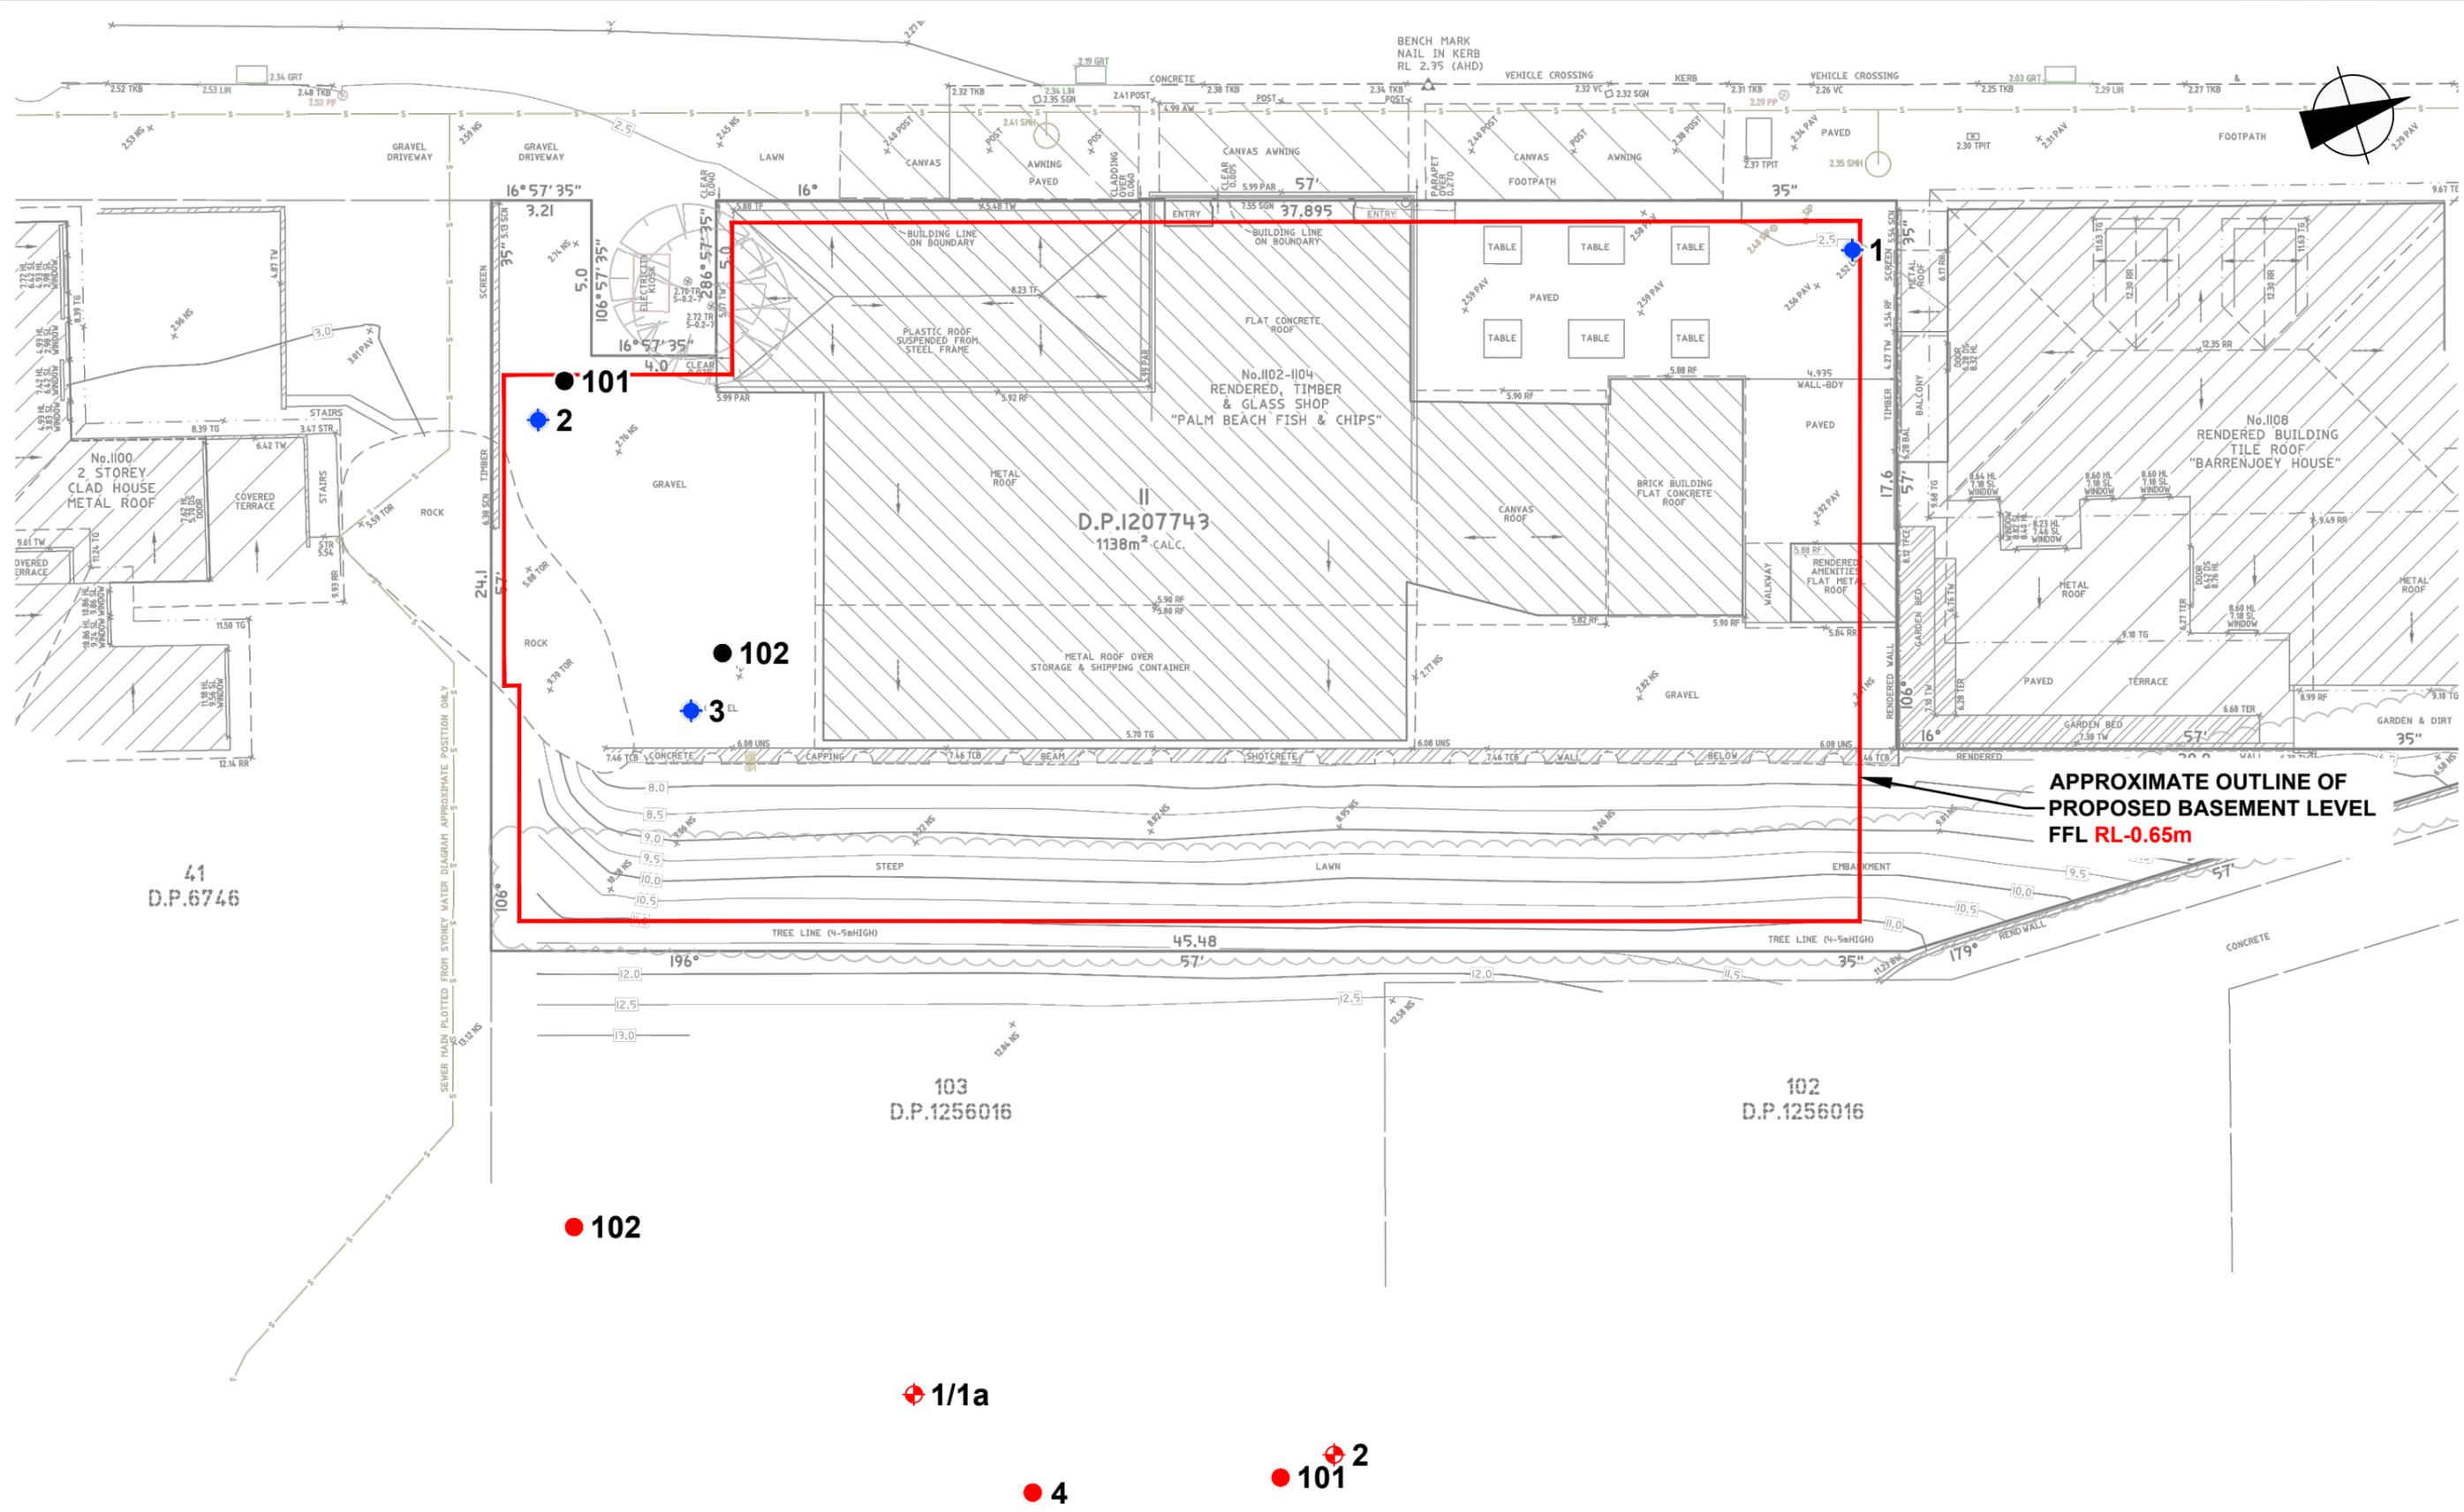
<p>Title: <b>BOREHOLE LOCATION PLAN</b></p>	
<p>Location: 1102 - 1106 BARRENJOEY ROAD, PALM BEACH, NSW</p>		<p>Report No: 33618YJrptrev4 Figure No: 1A</p>	
<p>Scale 1:200 @A3 METRES</p>		<p><b>JKGeotechnics</b></p>

APPROXIMATE OUTLINE OF PROPOSED BASEMENT LEVEL  
FFL RL -0.65m

This plan should be read in conjunction with the JK Geotechnics report.

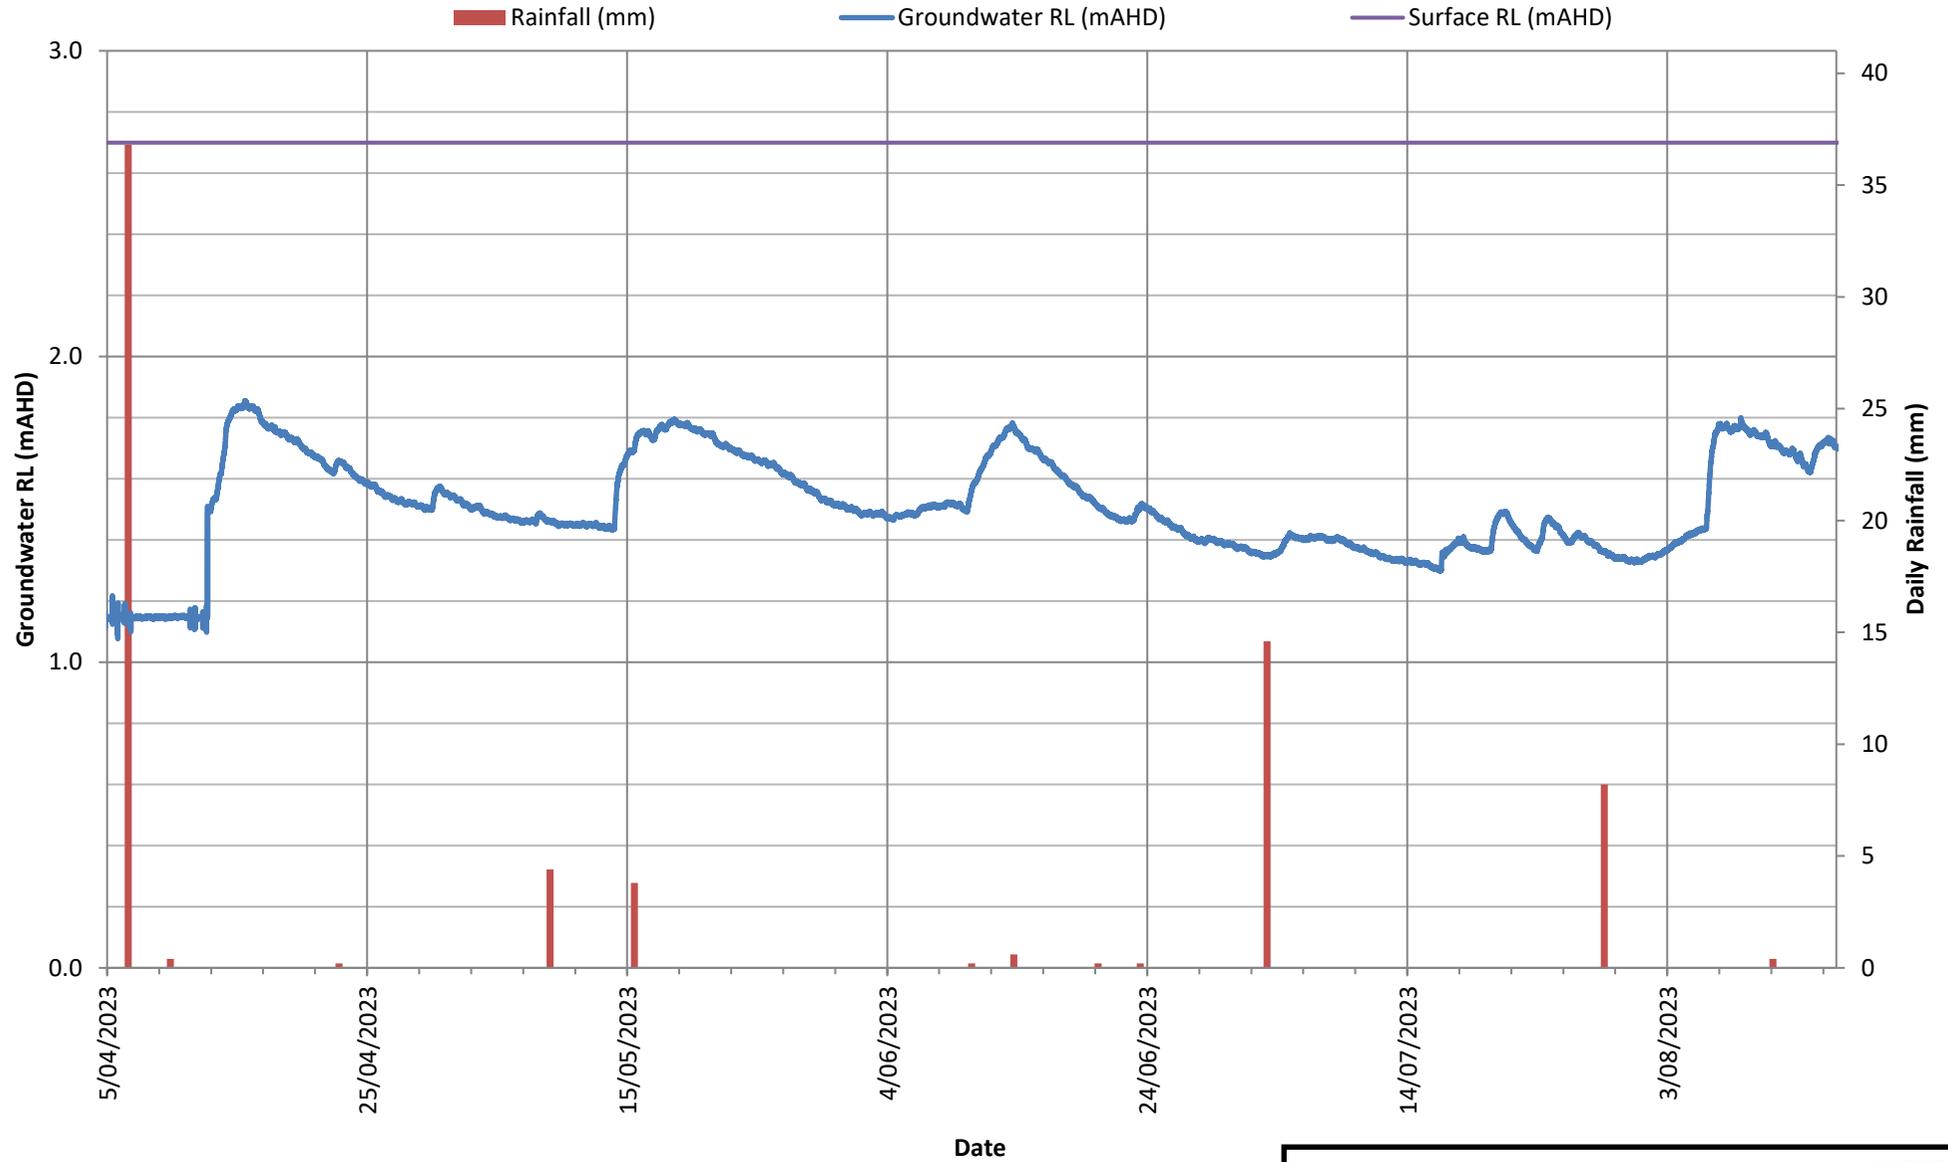
# Groundwater Level and Daily Rainfall -v- Time Plot BH102

Rainfall data from Holsworthy Control Range, Station number : 6711

**JKGeotechnics**  
Report No. 33618YJ      Figure No. 2

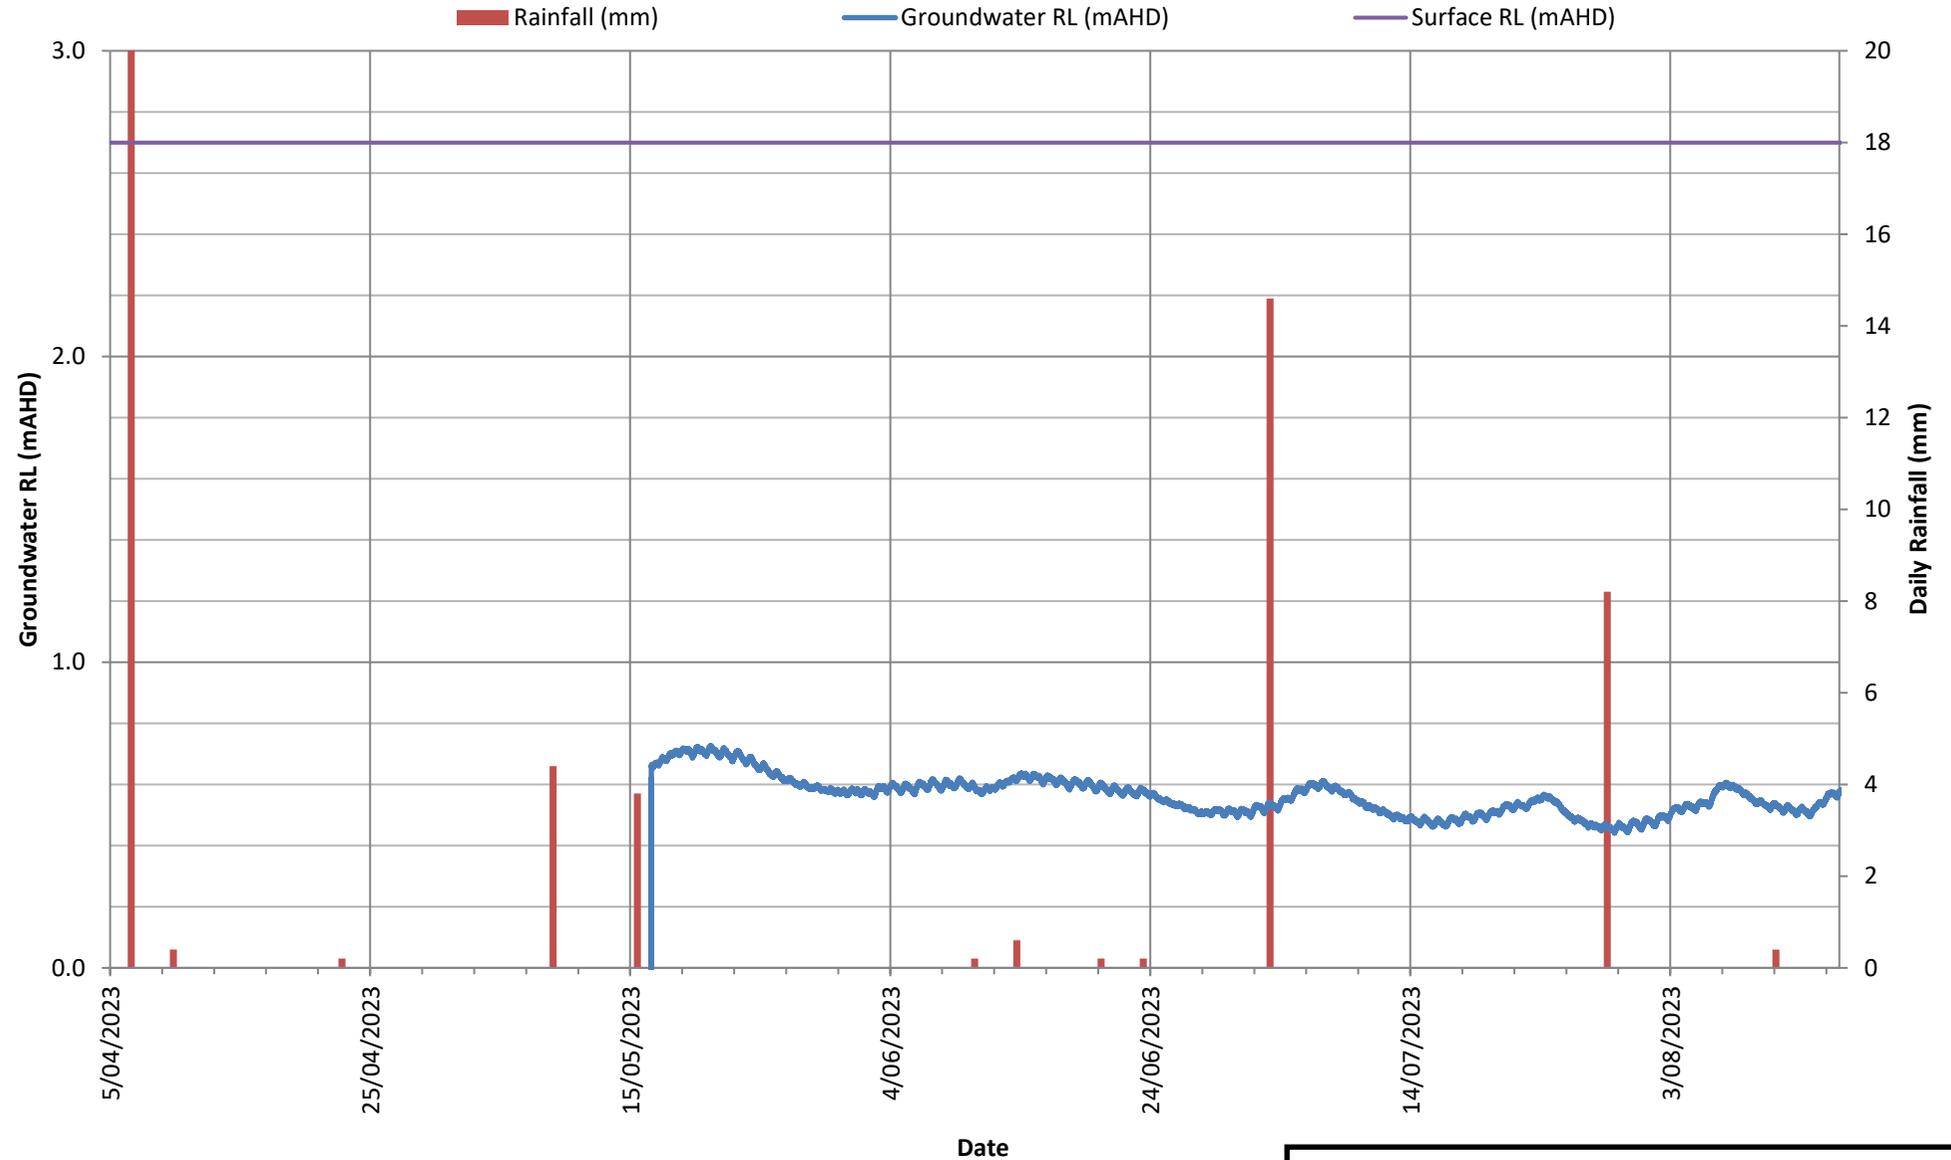
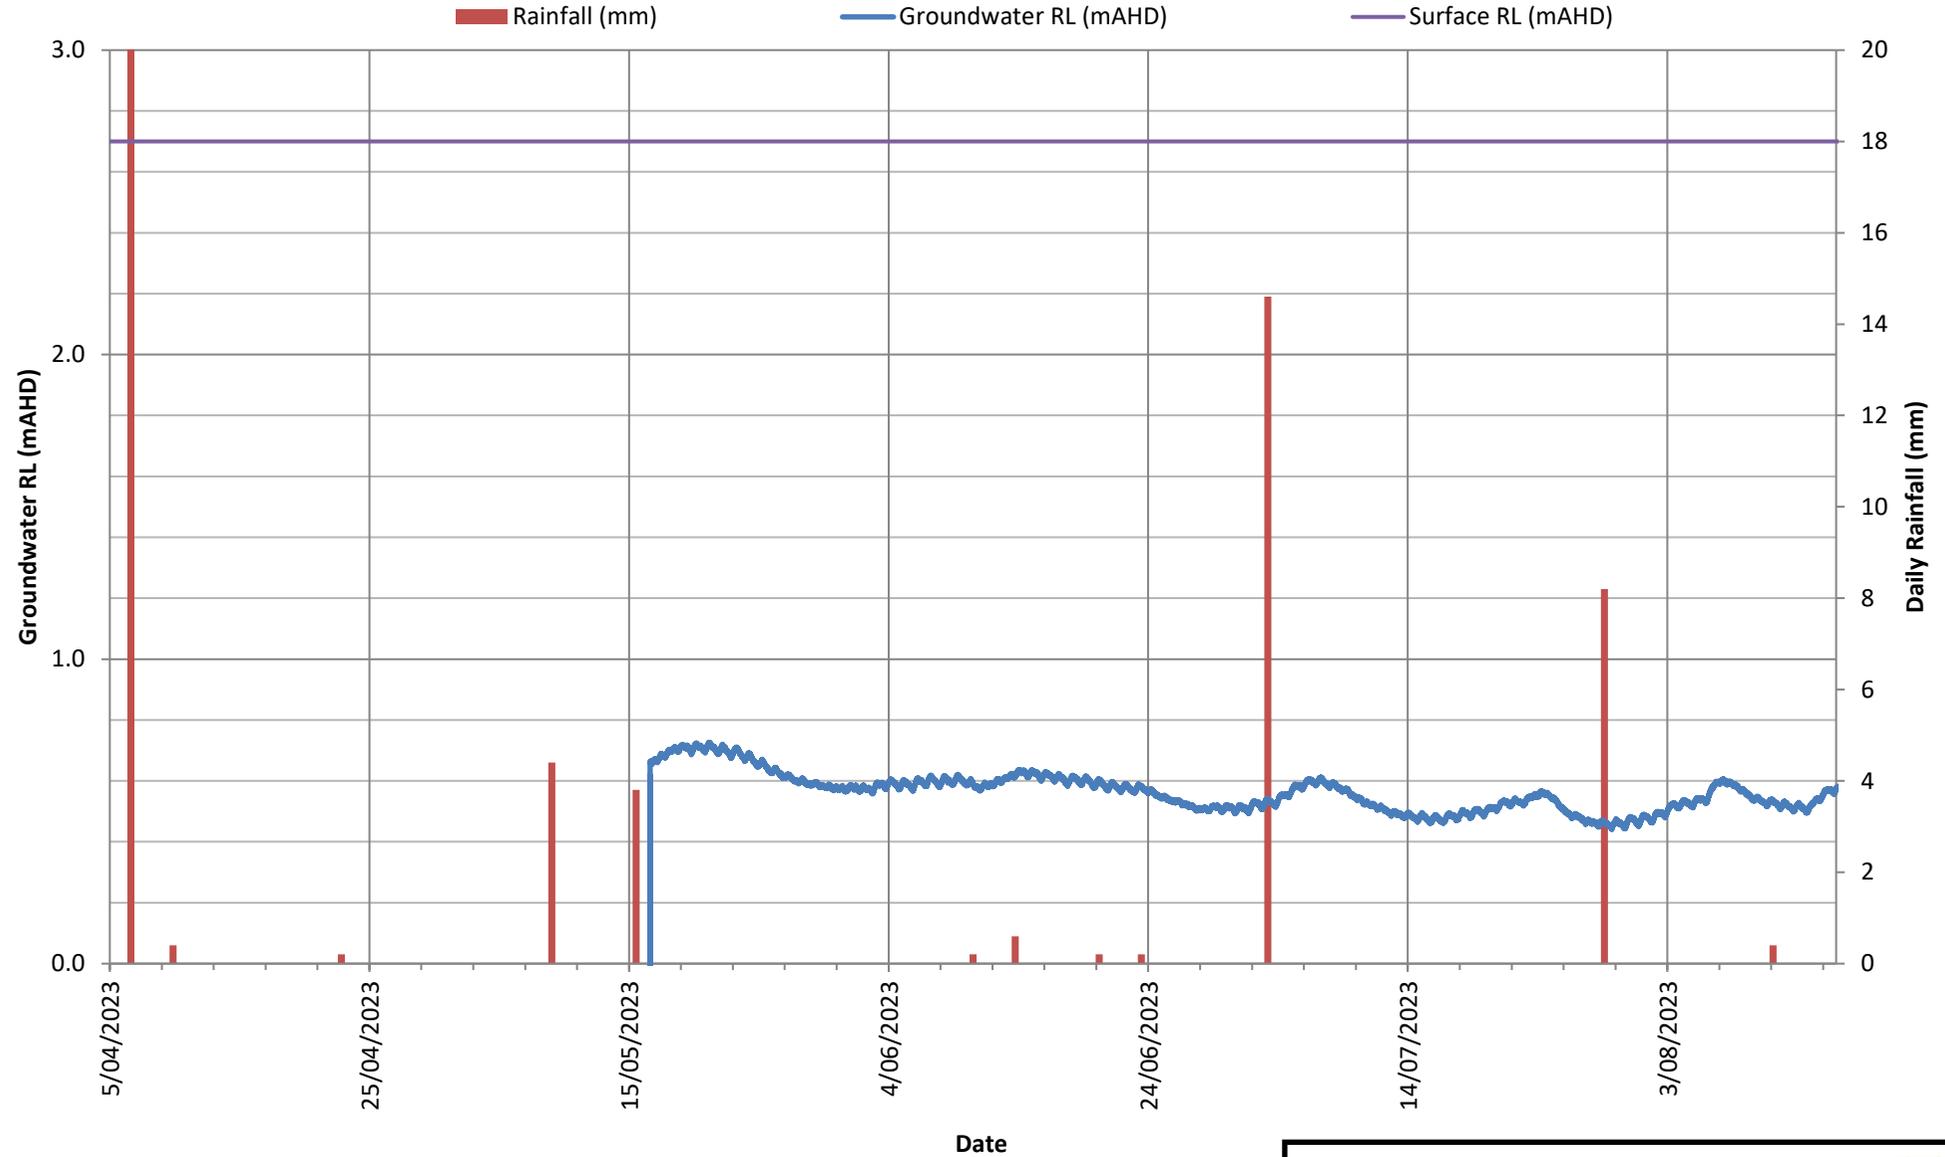
## BH201

# Groundwater Level and Daily Rainfall -v- Time Plot

Rainfall data from Holsworthy Control Range, Station number : 6711

**JKGeotechnics**  
Report No. 33618YJ      Figure No. 3

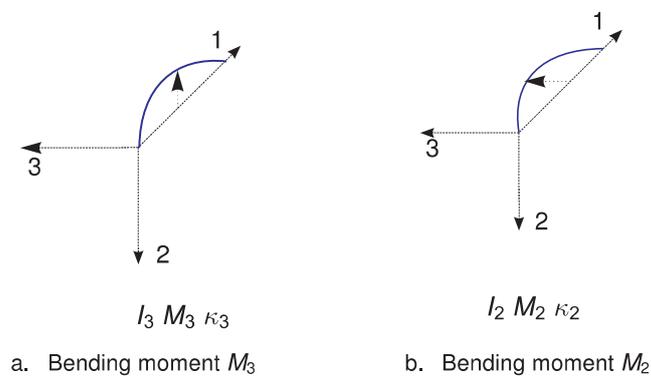
Figure 9.7 Positive bending moments in beams

The *Bending moment*  $M_3$  is the bending moment due to bending around the third axis (Figure 9.7a), whereas the *Bending moment*  $M_2$  is the bending moment due to bending around the second axis (Figure 9.7b). The *Bending moment*  $M_1$  is the *Torsion* (bending around the first axis).

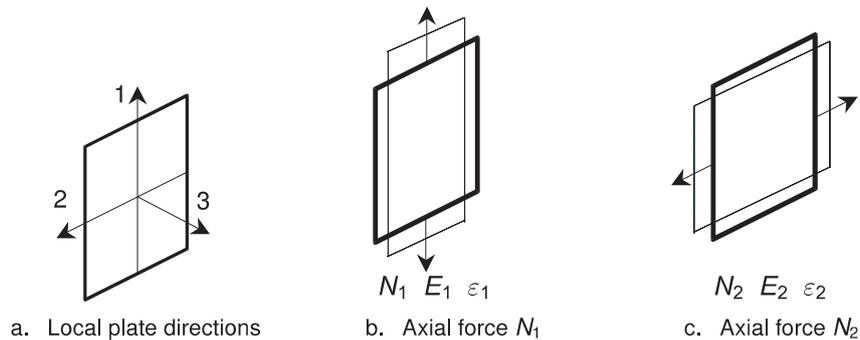
Figure 9.8 Positive axial forces in plates and geogrids

The *Axial force*  $N_1$  is the axial force in the first direction (Figure 9.8b). The *Axial force*  $N_2$  is the axial force in the second direction (Figure 9.8c).

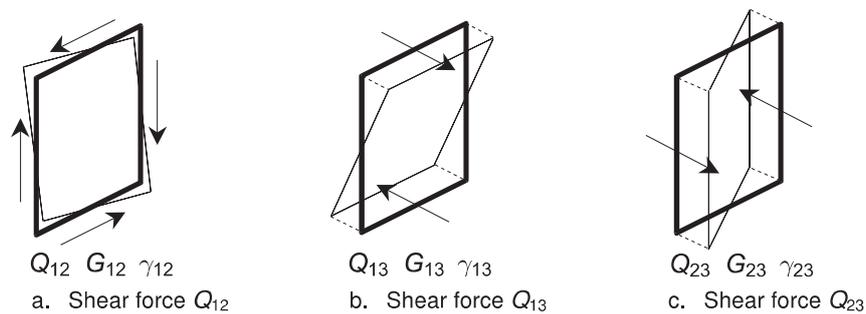
Figure 9.9 Positive shear forces in plates

The *Shear force*  $Q_{12}$  is the in-plane shear force (Figure 9.9a). The *Shear force*  $Q_{13}$  is the shear force perpendicular to the plate over the first direction (Figure 9.9b), whereas the *Shear force*  $Q_{23}$  is the shear force perpendicular to the plate over the second direction

(Figure 9.9c).

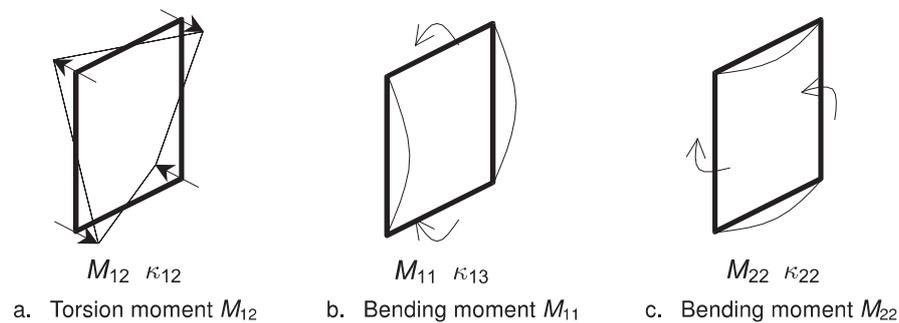
Figure 9.10 Positive bending moments in plates

The *Bending moment*  $M_{11}$  is the bending moment due to bending over the second axis (around the second axis) (Figure 9.10b). The *Bending moment*  $M_{22}$  is the bending moment due to bending over the first axis (around the first axis) (Figure 9.10c).

The *Torsion moment*  $M_{12}$  is the moment according to transverse shear forces (Figure 9.10a).
