Flooding and Estuarine Risk Management

Boat House, Palm Beach

59916081/R004

Prepared for London Lakes Partnership

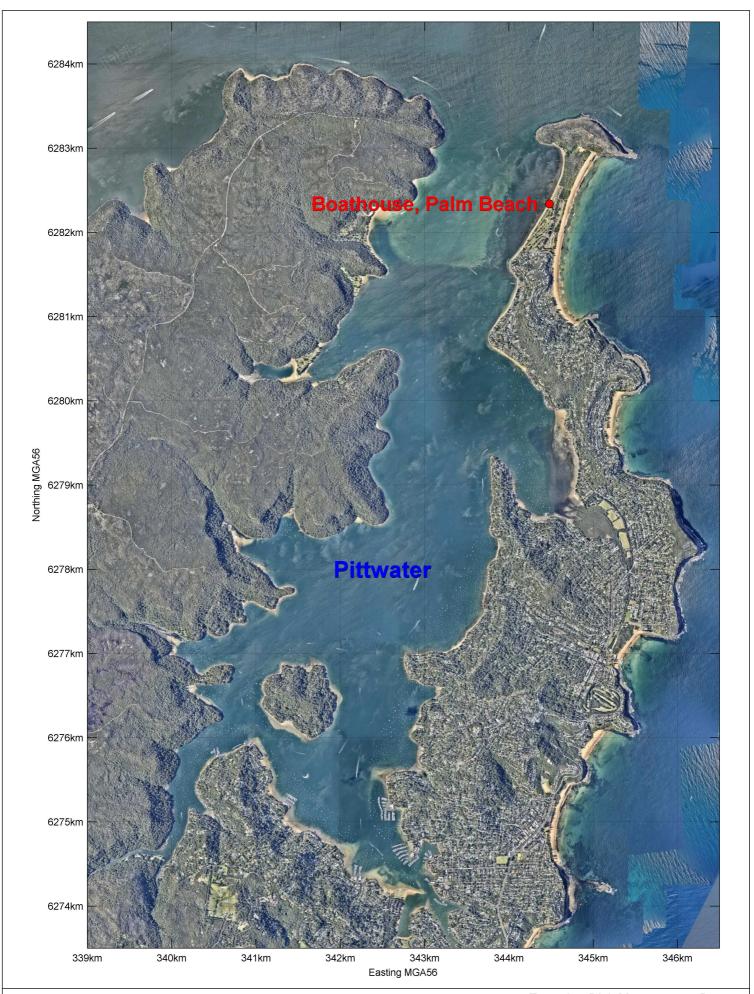
Estuarine Risk Management Report Locality Plan

Figure 1.1 provides a locality plan of the site. Note that the survey includes beach levels, which will be needed for design and construction of replacement works, including below and along parts of the building. Note that Council has recently constructed a cut sand-stone block seawall near the back beach area to the south – extending south about 20m from the edge of the southern deck area.
