GEOTECHNICAL INVESTIGATION REPORT

Project Title – 22 Forest Way, Frenchs Forest NSW

Project Type – Addition of Basement and Alteration of the Shopping complex

Project No. – GR23239

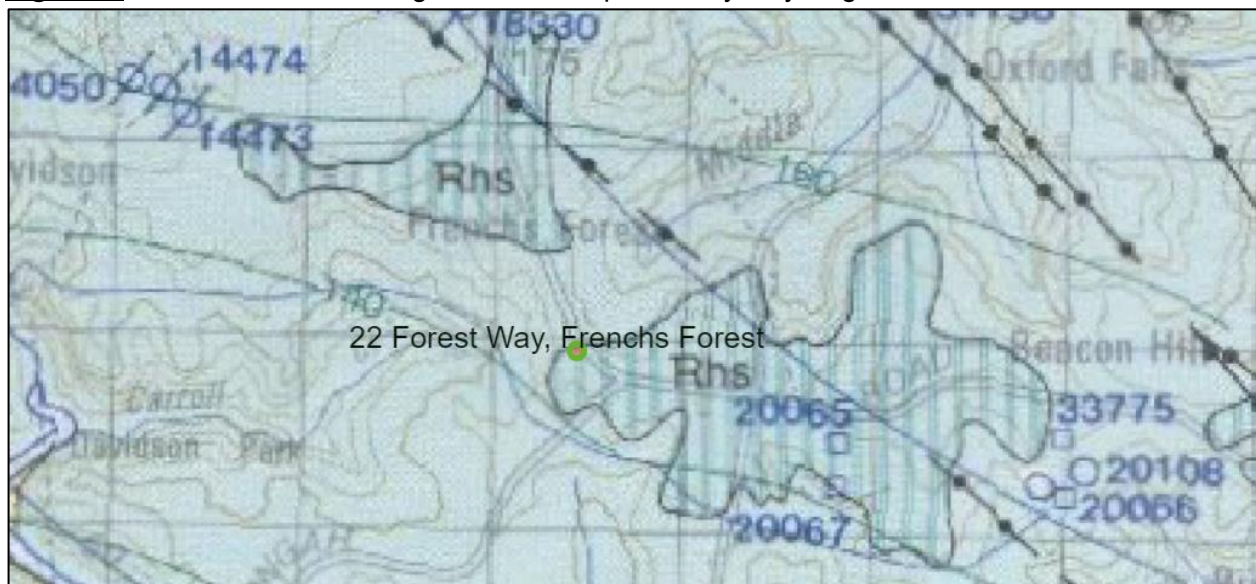
Figure 2: 1:100,000 scale Geological Series Map of the Sydney Region

The 1:100,000 scale Geological Series Sheet 9130 (Edition 1) 1991 of the Sydney region (Figure 2) indicates that the subject site is underlain by Hawkesbury group SANDSTONE (Rh) consisting of medium to coarse grained quartz sandstone containing minor shale and laminite lenses.

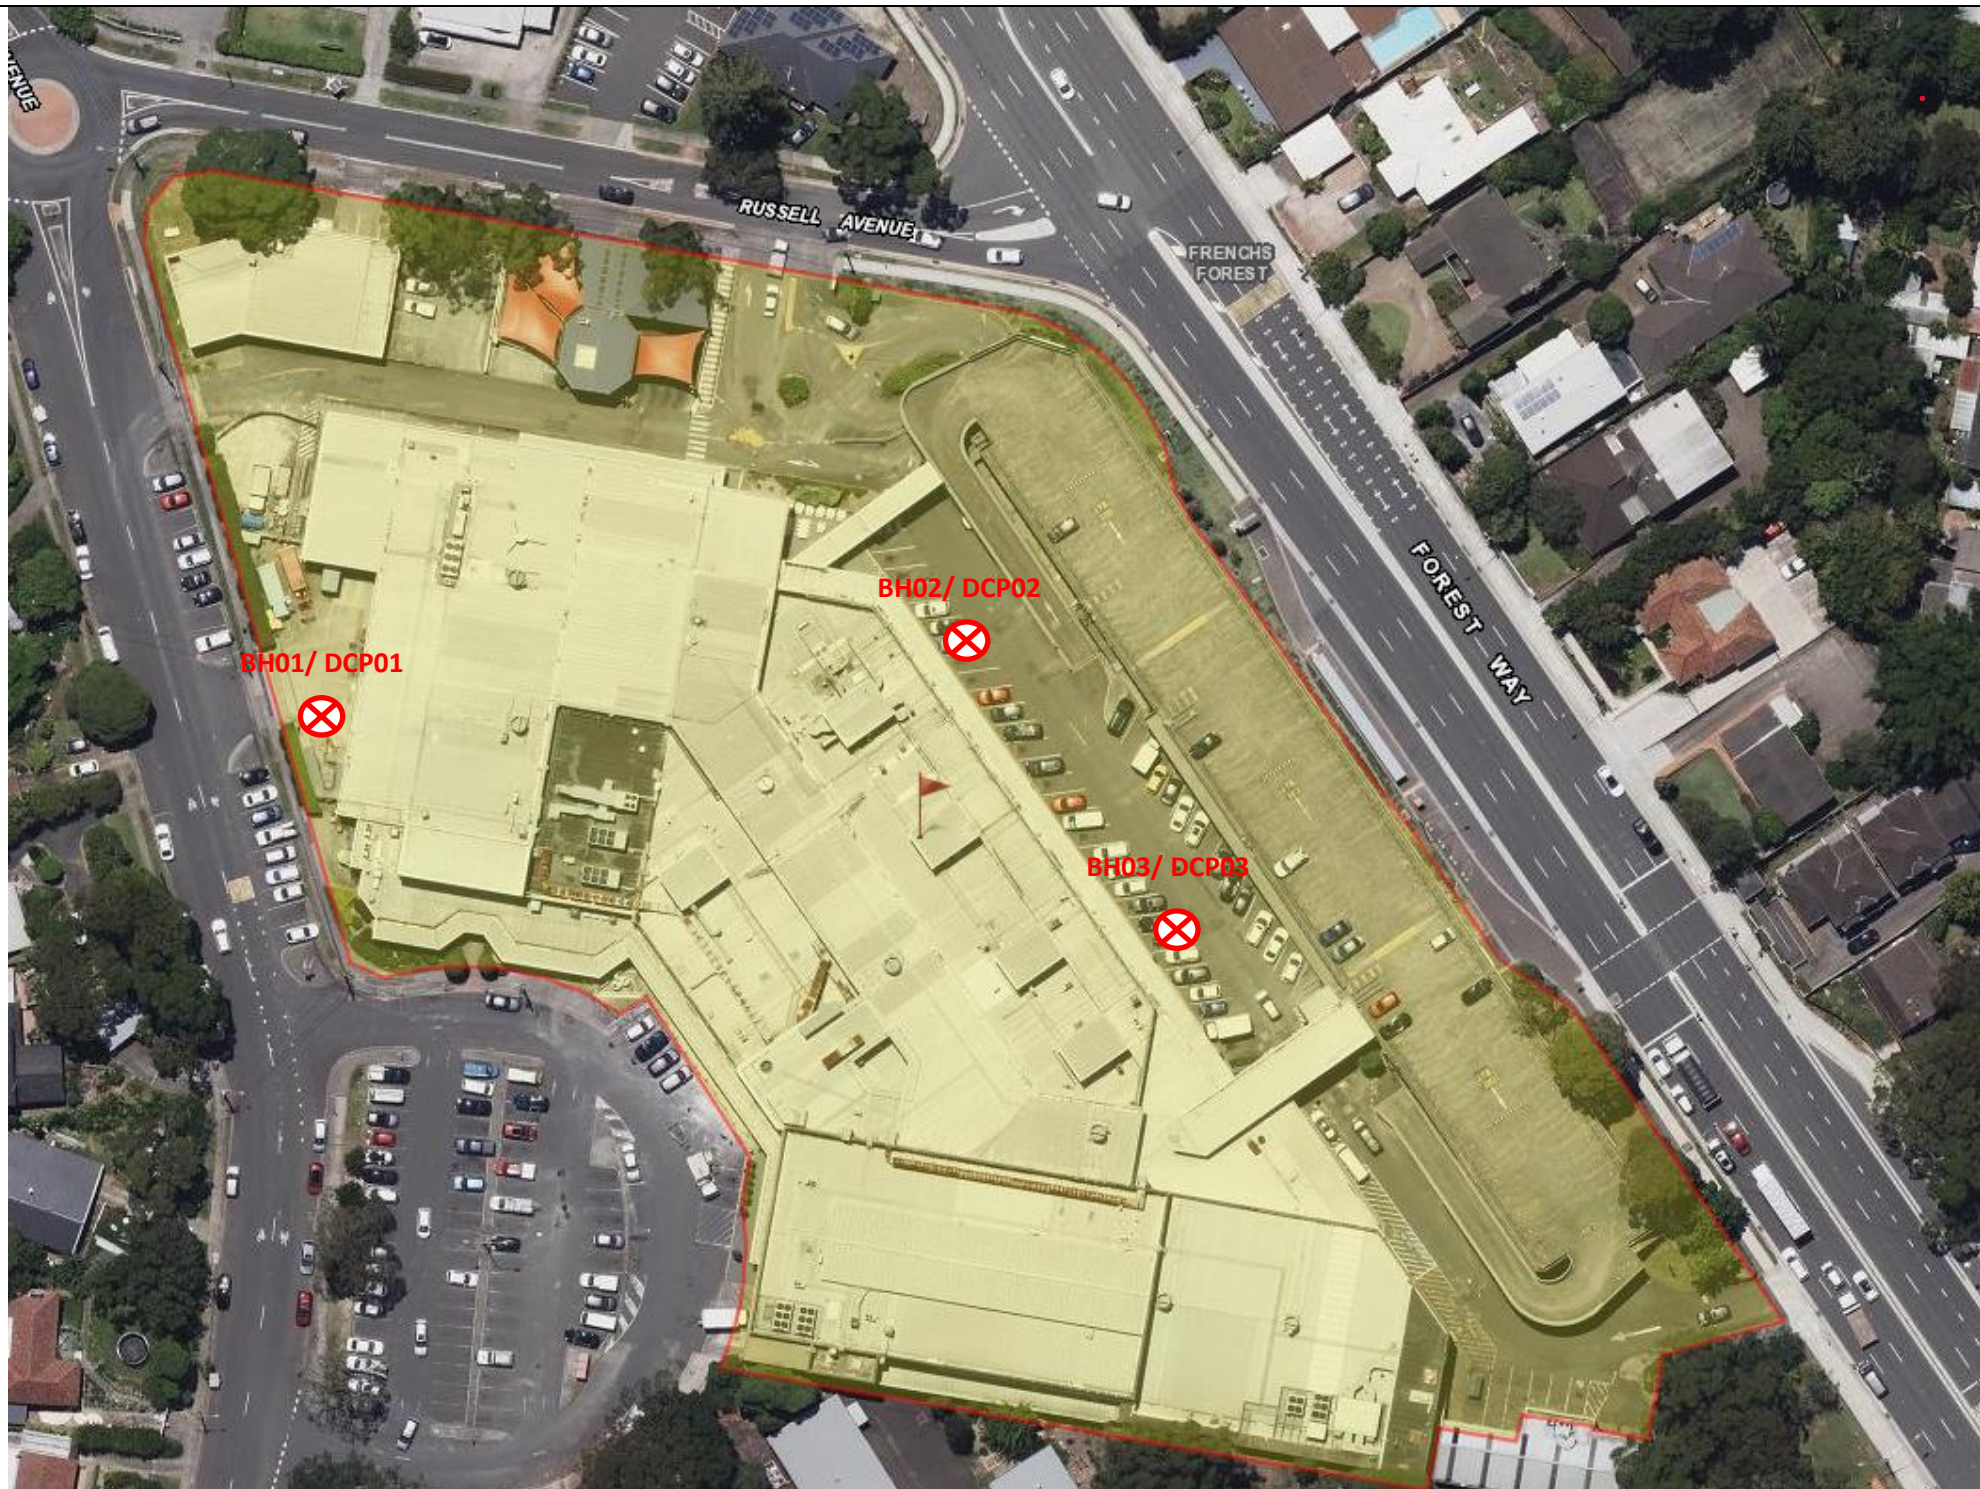
Site Plan with Borehole Locations

Drawn	KT	CLIENT: REVELOP BUILDING & DEVELOPMENTS SITE ADDRESS: 22 Forest Way, Frenchs Forest	Figure	1
Checked	SG		Title	Site Plan
Date	1/12/2023		Job No	GR23239
Scale @ A3	NTS

The results of the investigation indicate that the subsurface profile comprises of poorly graded clayey sand underlain by sandstone bedrock. Based on the borehole information, a summary of subsurface conditions is presented below. The location of each borehole can be found in Appendix A and more detailed logs can be found in Appendix B.

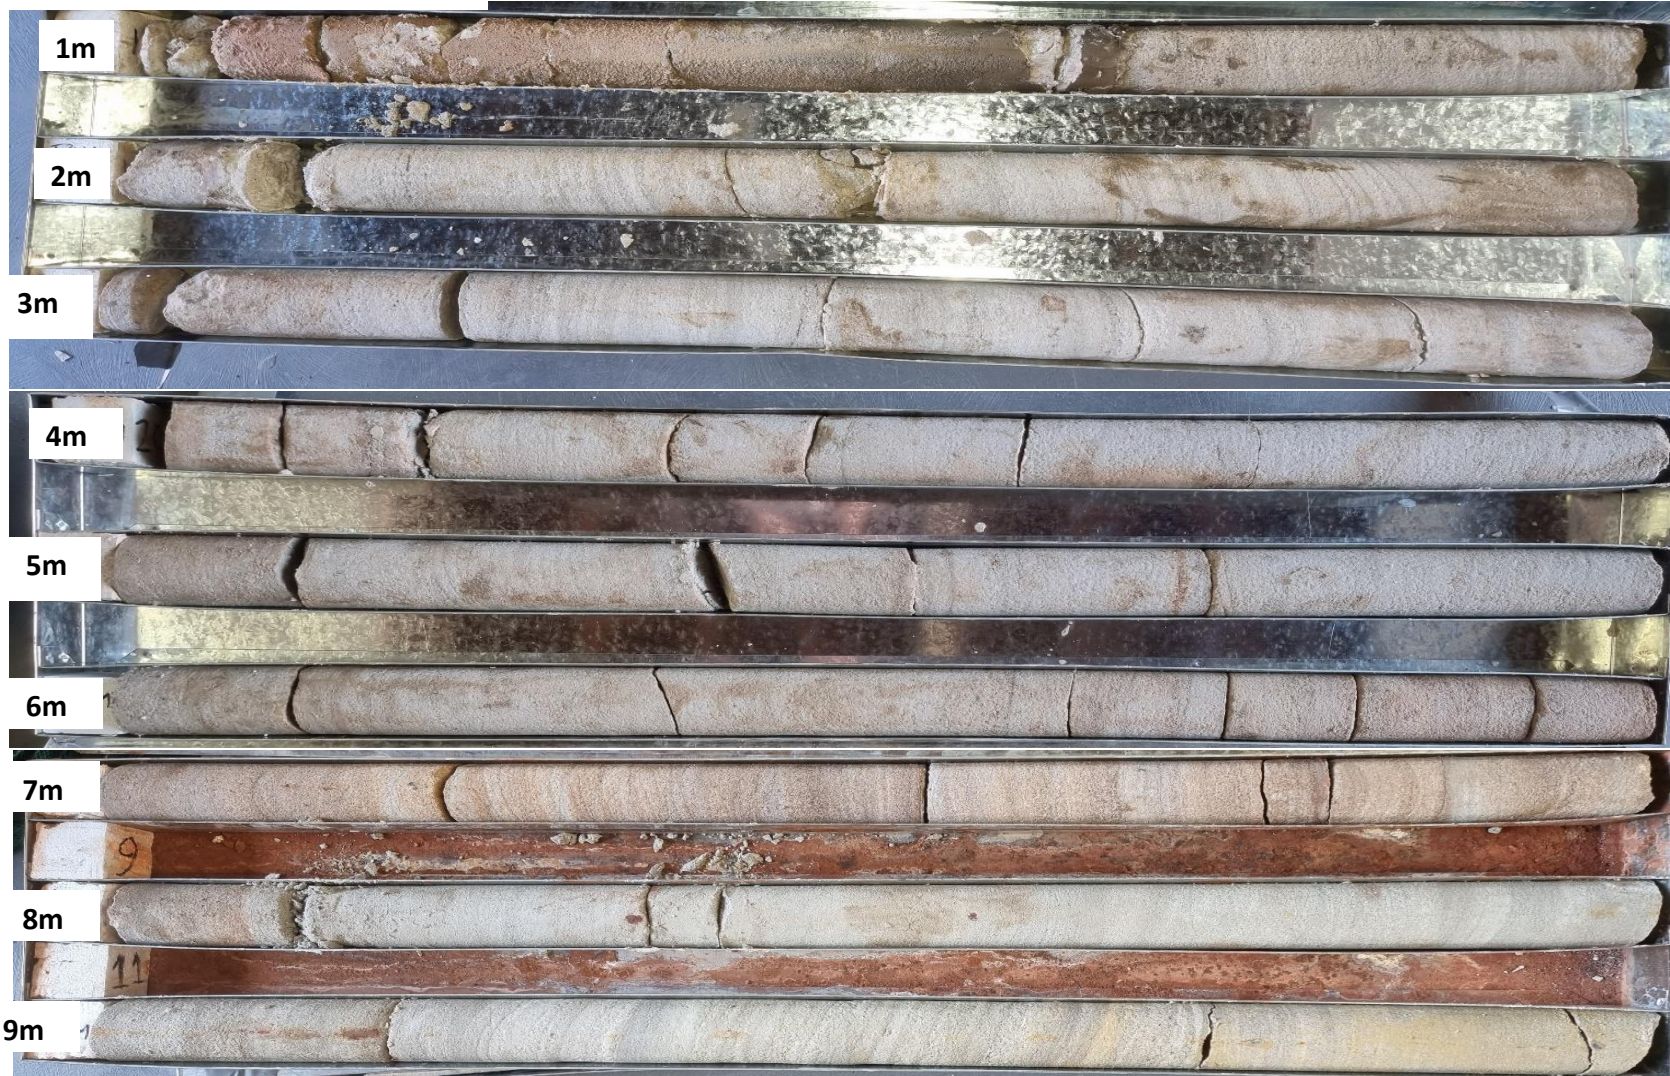
GR23206 BH01 Coring Commenced 1.0m

End of Borhole 10.0m

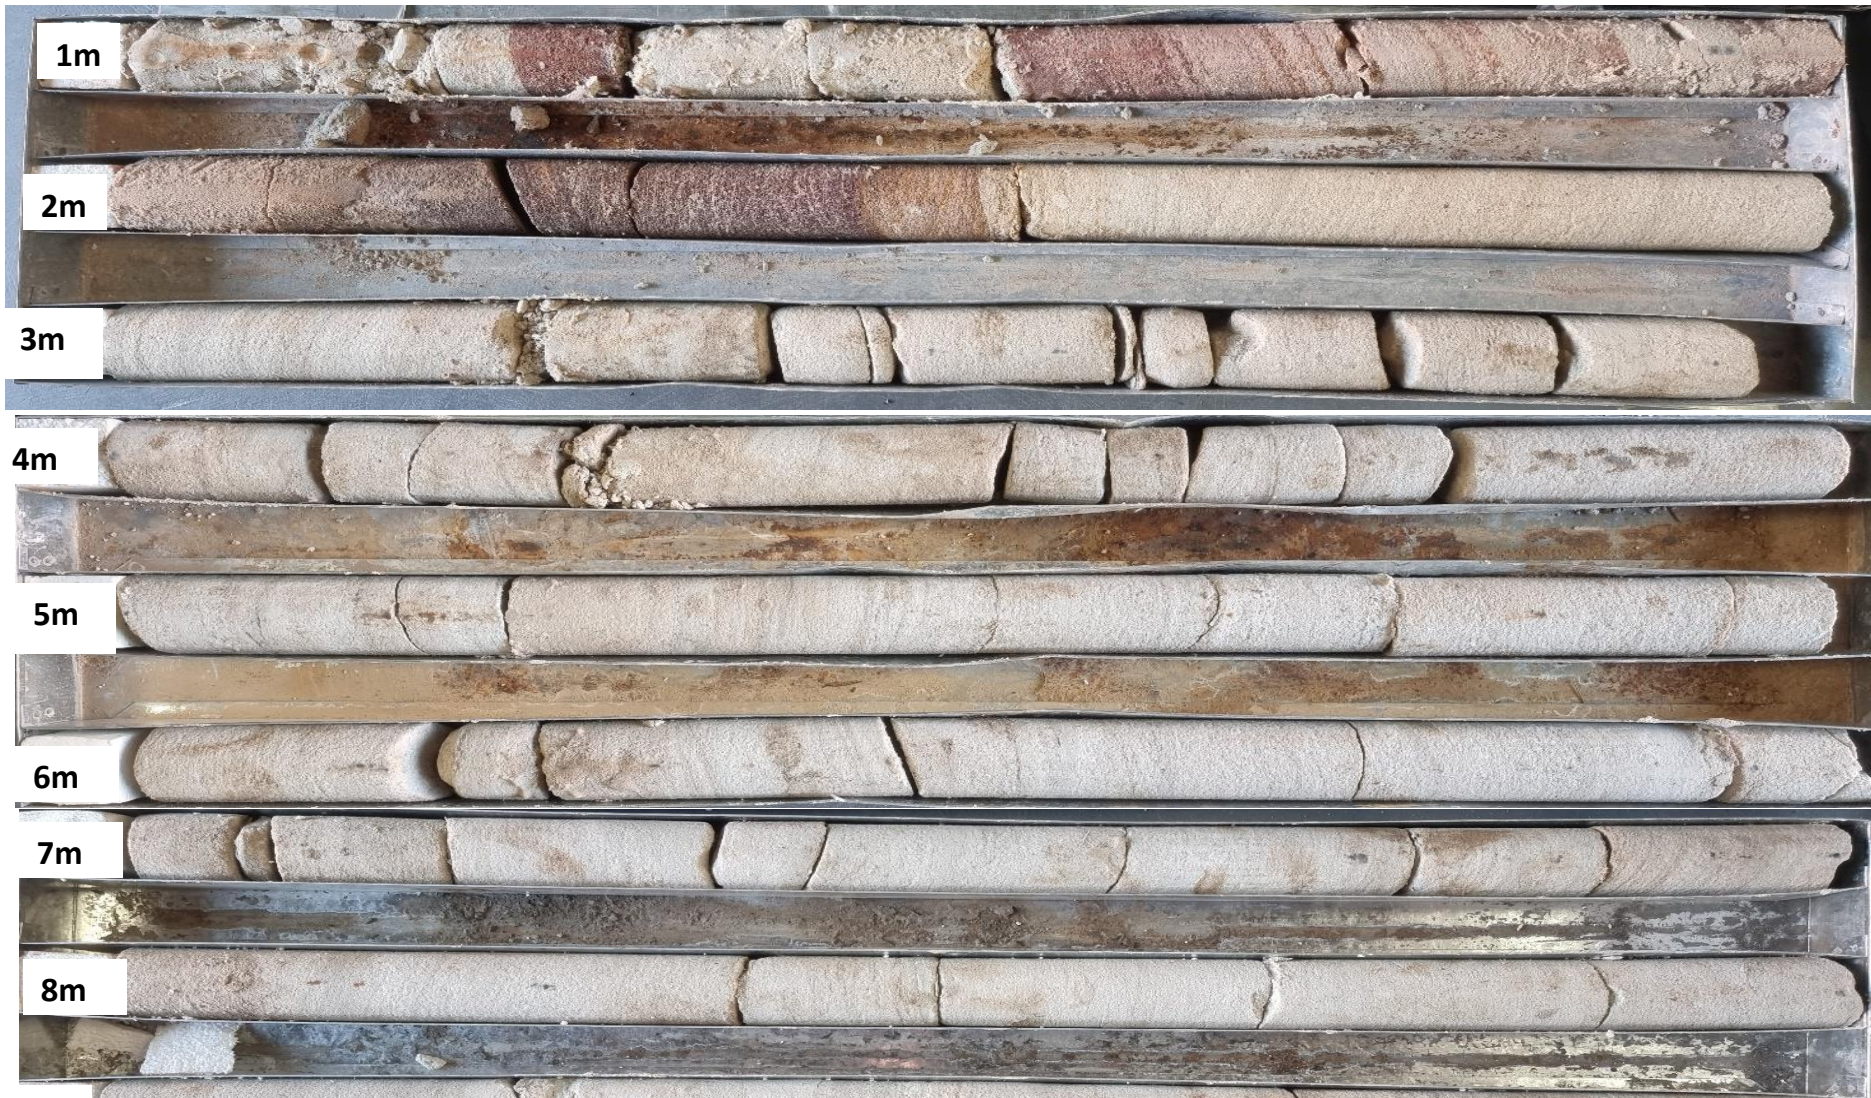
GR23206 BH02 Coring Commenced 1.0m

Client:	Revelop Building & Developments
Project Number:	GR23239
Bore No.:	BH02
Project Location:	22 Forest Way, Frenchs Forest

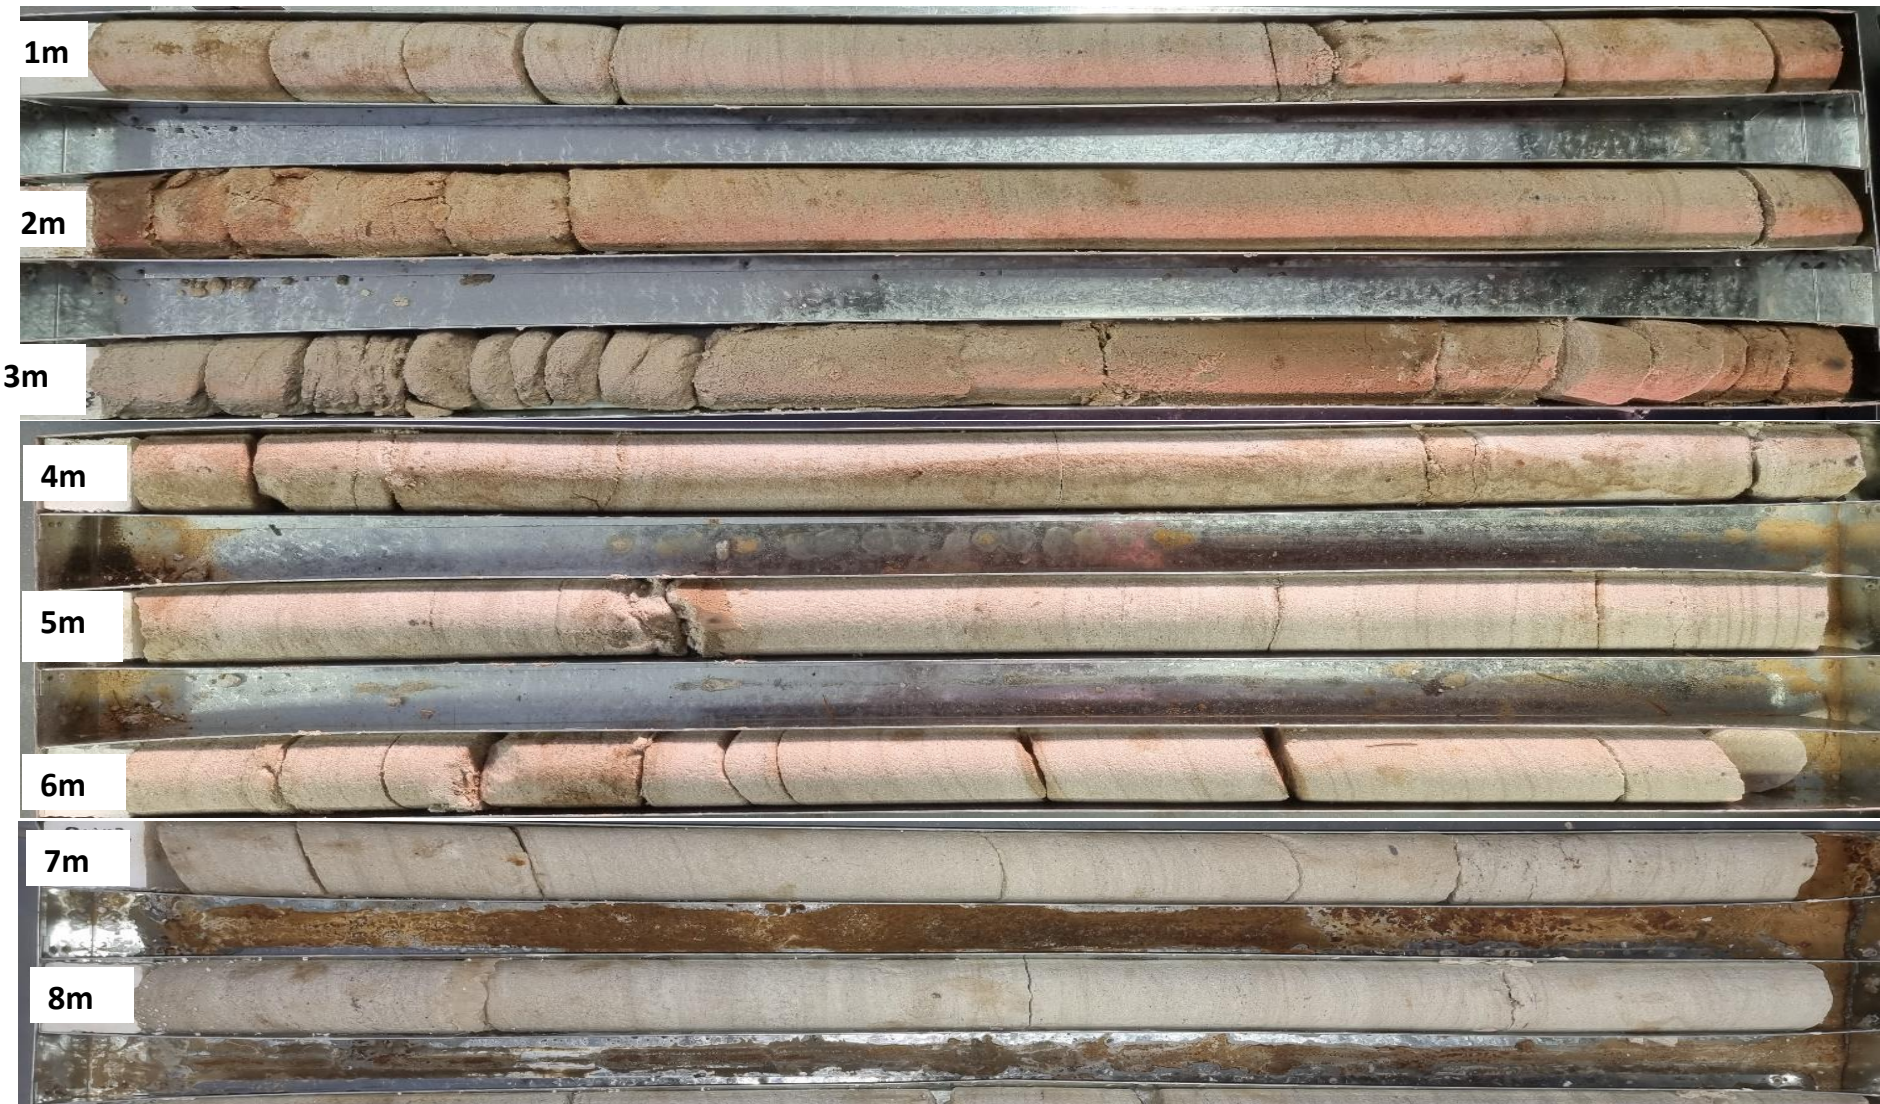
GR23206 BH03 Coring Commenced 1.0m

Client:	Revelop Building & Developments
Project Number:	GR23239
Bore No.:	BH03
Project Location:	22 Forest Way, Frenchs Forest
