GEOTECHNICAL INVESTIGATION REPORT

Project Title – 43-45 & 49 Warriewood Rd, Warriewood

Project Type – Proposed Residential Flat Development & 11 Single Dwellings

Project No. – GR24249

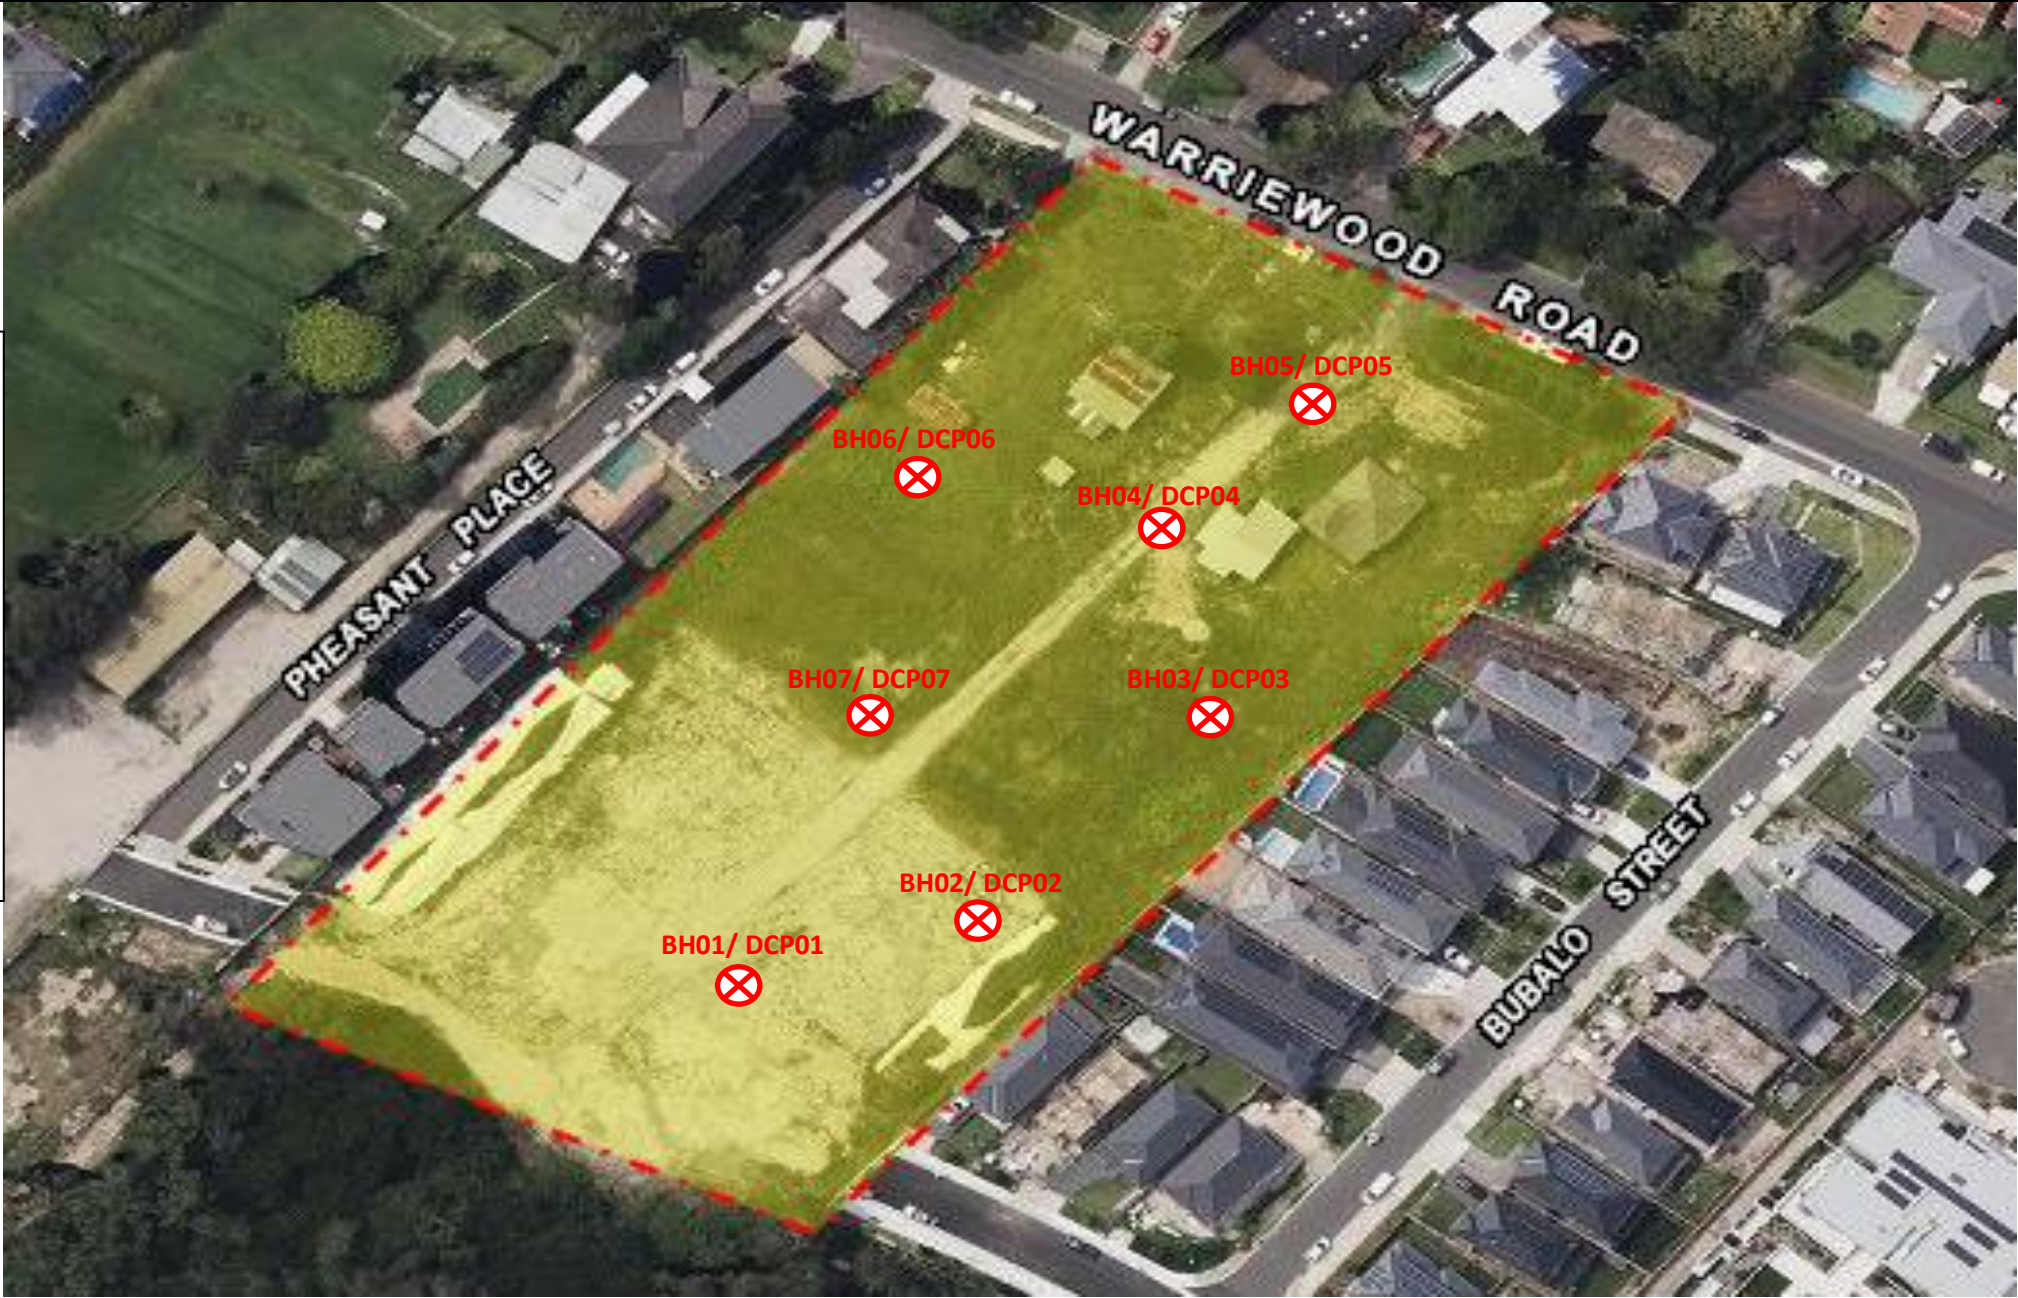
Drawn	DM	CLIENT: WARRIEWOOD DEVELOPERS PTY LTD SITE ADDRESS: 43-45 & 49 WARRIEWOOD RD, WARRIEWOOD	Figure	1
Checked	AE		Title	Site Plan
Date	28/11/2024		Job No	GR24249
Scale @ A3	NTS

**Approximate Rock Depth
(BGL):**

BH01: 20.5m
BH02: 17.2m
BH03: 8m
BH04: 8.3m
BH05: 10m
BH06: 11.6m
BH07: 16.2m

The results of the investigation indicate that the subsurface profile comprises Sandy CLAY underlain by SANDSTONE bedrock. Based on the borehole information, a summary of subsurface conditions is presented below. The location of each borehole can be found in Appendix A and more detailed logs can be found in Appendix B.
