Geotechnical Assessment

Project: Alterations & Additions

55 Carefree Road, North Narrabeen NSW

Preliminary Geotechnical Assessment

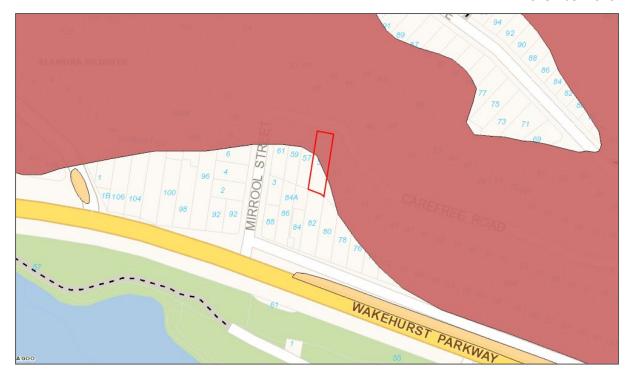
Image 1. 55 Carefree Road, North Narrabeen NSW. Pittwater Geotechnical Hazard Map (© NBC Mapping)

• The site is classified Geotechnical Hazard 'H1' with reference to the Pittwater Geotechnical Hazard Map PLEP (Image 1).
