## ENVIRONMENTAL INVESTIGATION SERVICES

**PROPOSED RESIDENTIAL/COMMERCIAL DEVELOPMENT (DA2014/0875) – HARBORD DIGGERS**  
**80 EVANS STREET, FRESHWATER, NSW, 2096**

EIS have prepared the following reports for the proposed development of the Harbord Diggers:

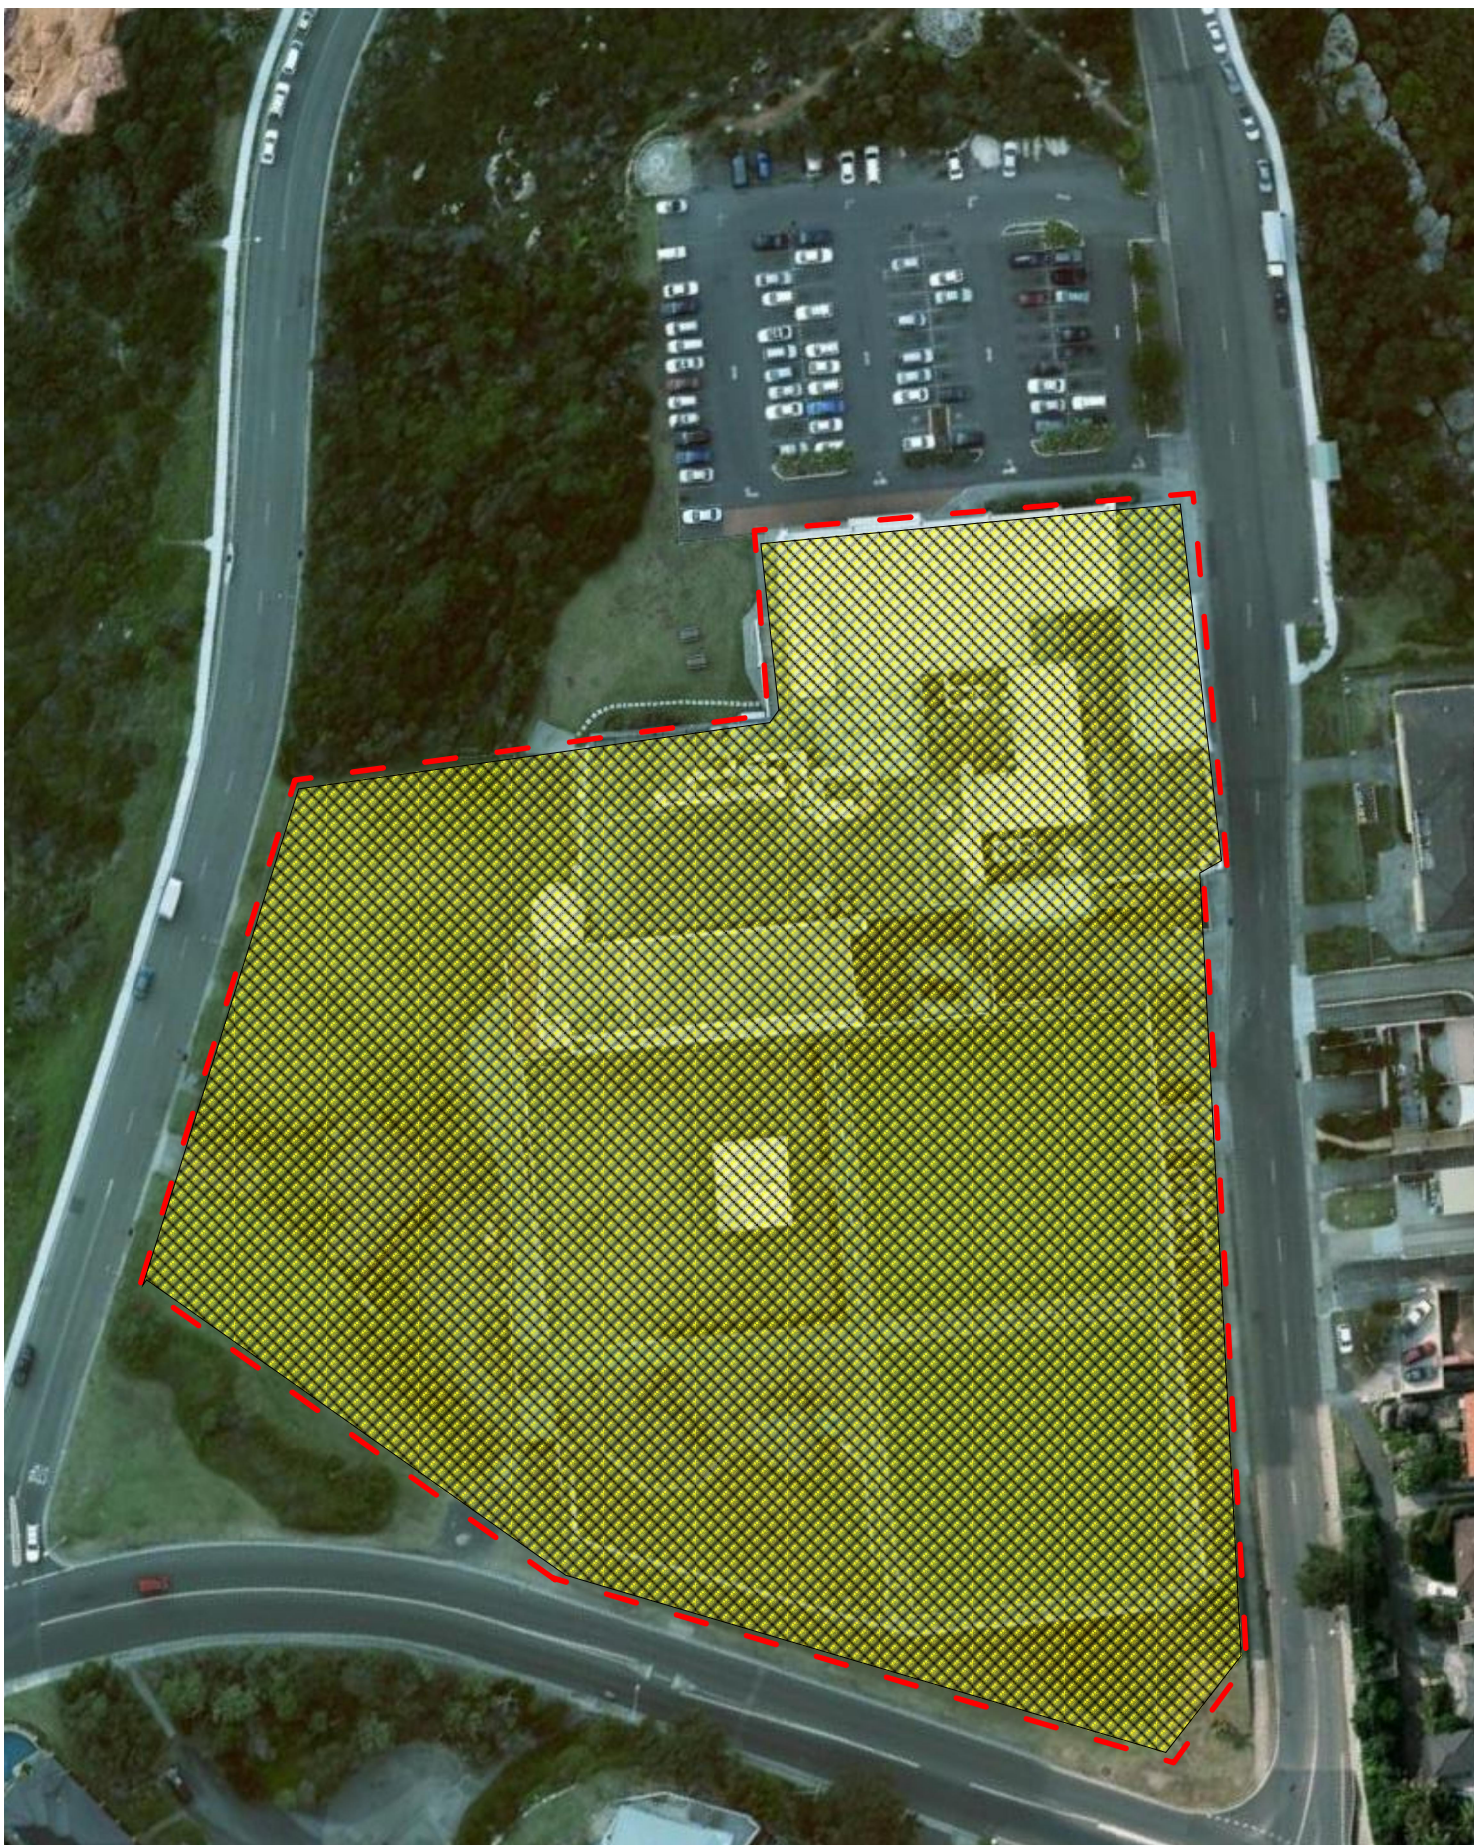
Approximate site boundary

The 'Asbestos Impacted Area' as shown on Figure 2 is defined as the area in which asbestos impacted fill material is considered to be present on the site. In this case, the Asbestos Impacted Area will be taken to be the development area/area of proposed disturbance. For this project, the Asbestos Impacted area will be the entire site where disturbance will be undertaken. This area must be isolated and clearly demarcated by the following methodology:
