Geotechnical Assessment

Project: New Residence
32 Garden Street, North Narrabeen NSW

REF: AG 21258
25 August 2021

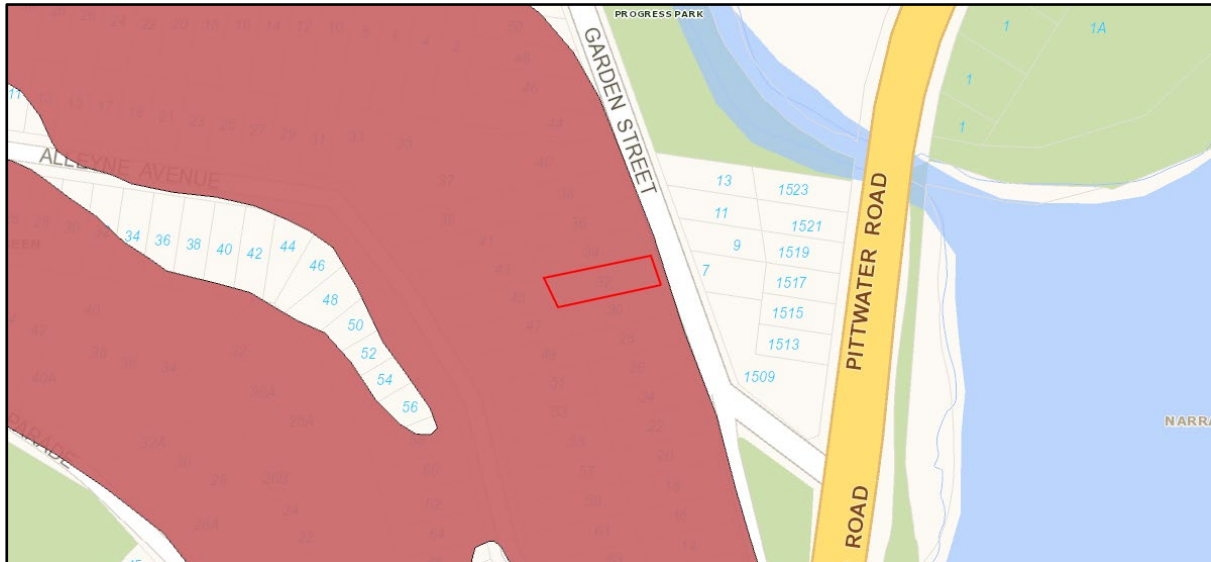
Image 2. PLEP Geotechnical Hazard Map
– 32 Garden Street, North Narrabeen NSW

LEGEND
Pittwater Geotechnical Hazard Map
■ Geotechnical Hazard H1
■ Geotechnical Hazard H2

- No evidence of significant soil creep, tension cracks or landslip instability were identified across the site or on adjacent properties as viewed from the subject site at the time of our inspection.
- Based on reference to the plan entitled “Geotechnical Hazard Mapping” (Ref. P21DCP-BC-MDCP2002, dated 2007) prepared by GHD LONGMAC on behalf of Pittwater Council, the site is not identified as a mapped geotechnical hazard area.

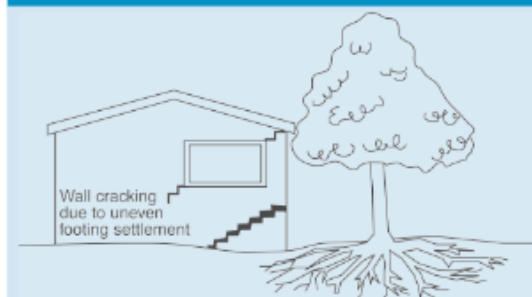
Trees can cause shrinkage and damage

As the weather pattern changes and the soil begins to dry out, the external footings will be first affected, beginning with the locations where the sun's effect is strongest. This has the effect of lowering the external footings. The doming is accentuated and cracking reduces or disappears where it occurred because of dishing, but other cracks open up. The roof lines may become convex.

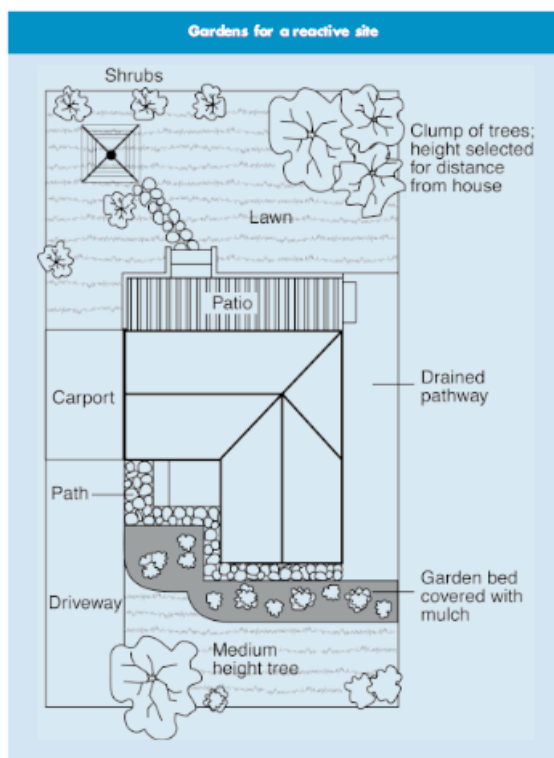
should extend outwards a minimum of 900 mm (more in highly reactive soil) and should have a minimum fall away from the building of 1:60. The finished paving should be no less than 100 mm below brick vent bases.

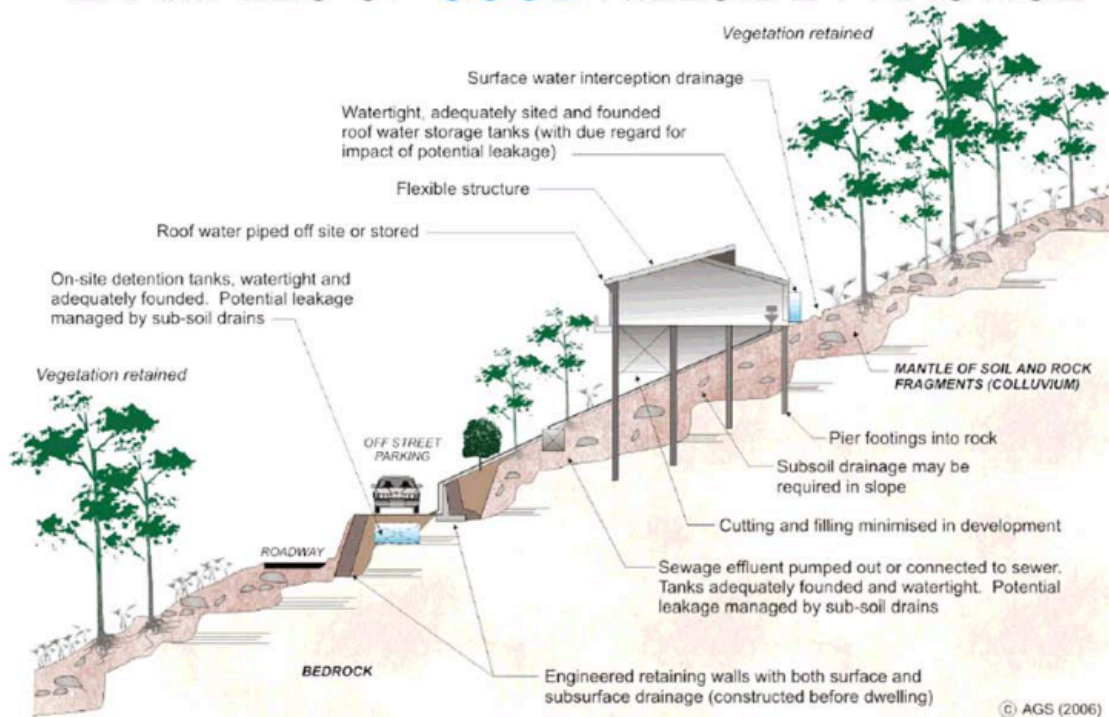
EXAMPLES OF **GOOD** HILLSIDE PRACTICE

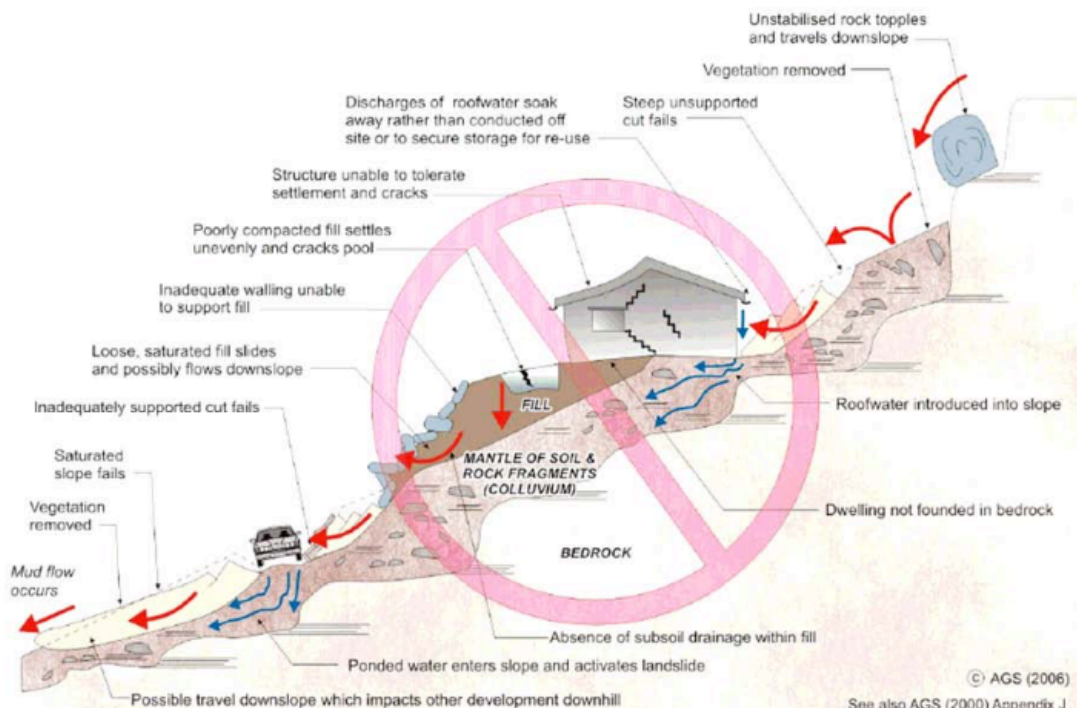
EXAMPLES OF **POOR** HILLSIDE PRACTICE

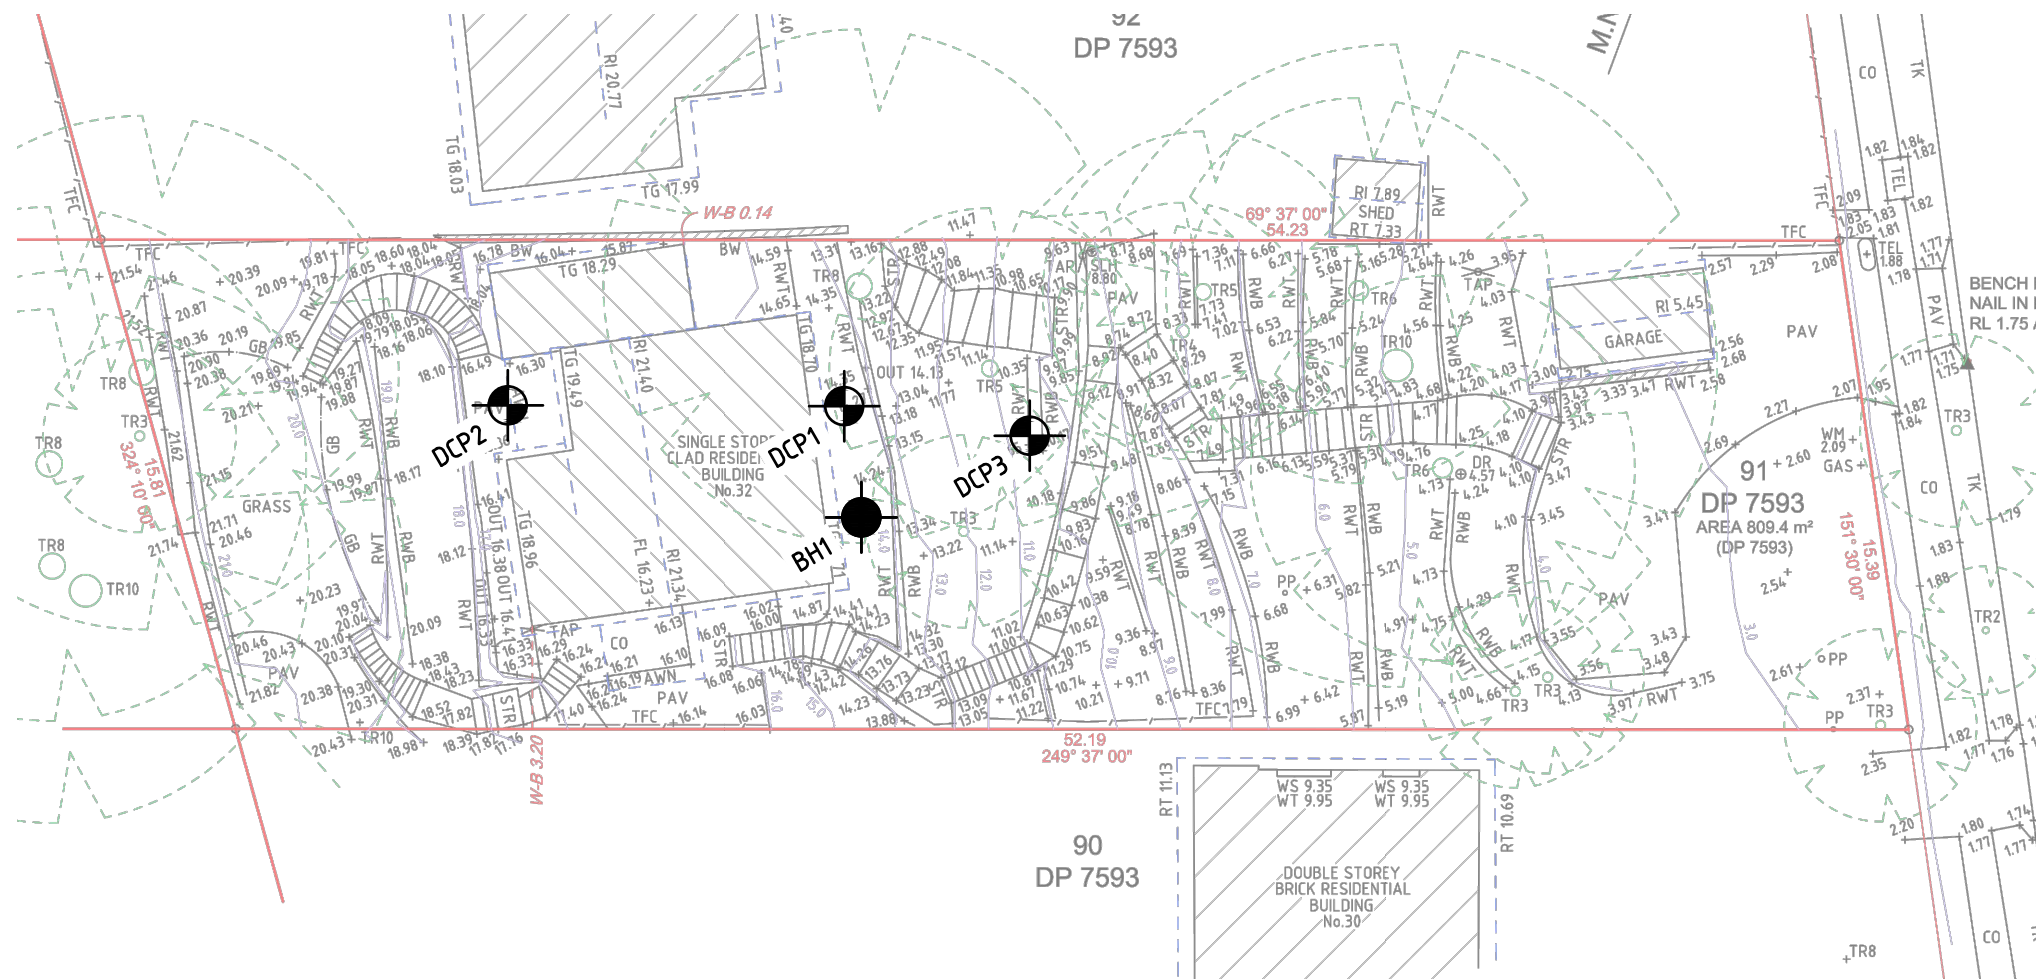
DATE:	24/08/2021
SCALE:	AS SHOWN @ A3
DRAWING TITLE:	SITE PLAN
DRAWING NO:	AG21258- S1

DCP LOCATIONS

BOREHOLE LOCATION

SITE PLAN/GROUND TEST LOCATIONS
SCALE NTS

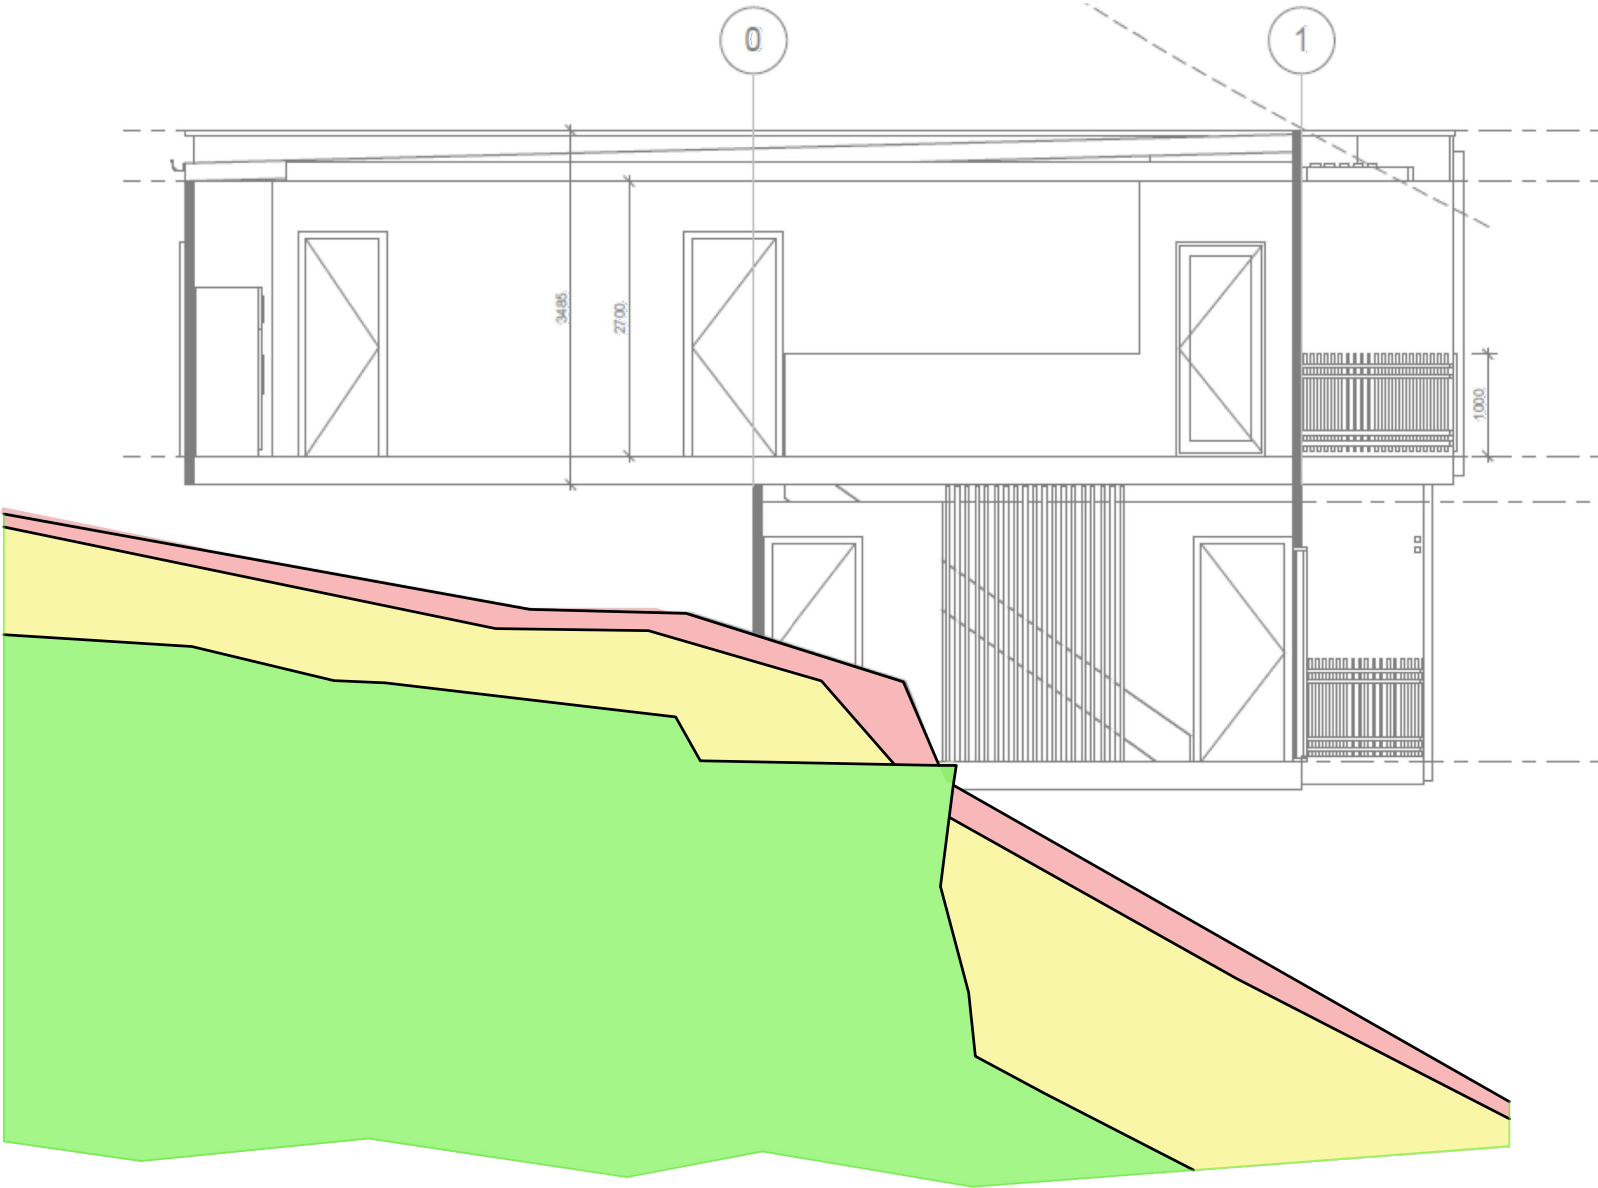
INTERPRETED SUBSURFACE SECTION ONLY.
ACTUAL GROUND CONDITIONS MAY VARY.

INFERRED GEOLOGICAL SECTION
SCALE NTS

- UNCONTROLLED FILL/SANDY TOP SOIL
- SANDY CLAY
- SANDY CLAY

The soil profile consists of shallow uncontrolled fill and sandy topsoil (O & A Horizons), silty sand and sandy clay (B Horizon) and weathered bedrock (C Horizon). Based on our observations and the results of testing on site, we would expect weathered bedrock to be found within 1.05 to 2.55 metres below current surface levels across the area of the proposed works.
