AS2870-2011 SITE CLASSIFICATION & SALINITY

Lot 25 No 34 Alleyne Avenue
North Narrabeen NSW

AS2870 Site Classification

Class P

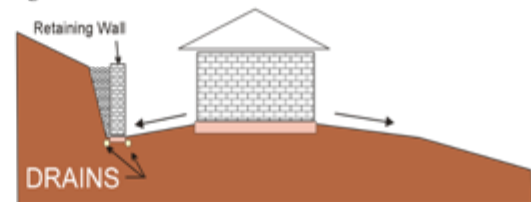
Fig. 5 Well Drained Sites

- Constructing sheds or outdoor roofed areas without connecting the roof drainage to storm water lines.
- Constructing paving around the building without sufficient slope away from the building. (In sandy soils and low and moderate "reactivity" clays, a slope of 1:40 up to 1 metre away from the building is adequate. In highly reactive clays a slope of 1:20 works better. In large paved areas a drain and collection pit may be necessary). (Fig. 5 & 18)
