MARINE POLLUTION RESEARCH PTY LTD

AQUATIC ECOLOGY SURVEY & ASSESSMENT

52 STURDY LANE LOVETT BAY, PITTWATER

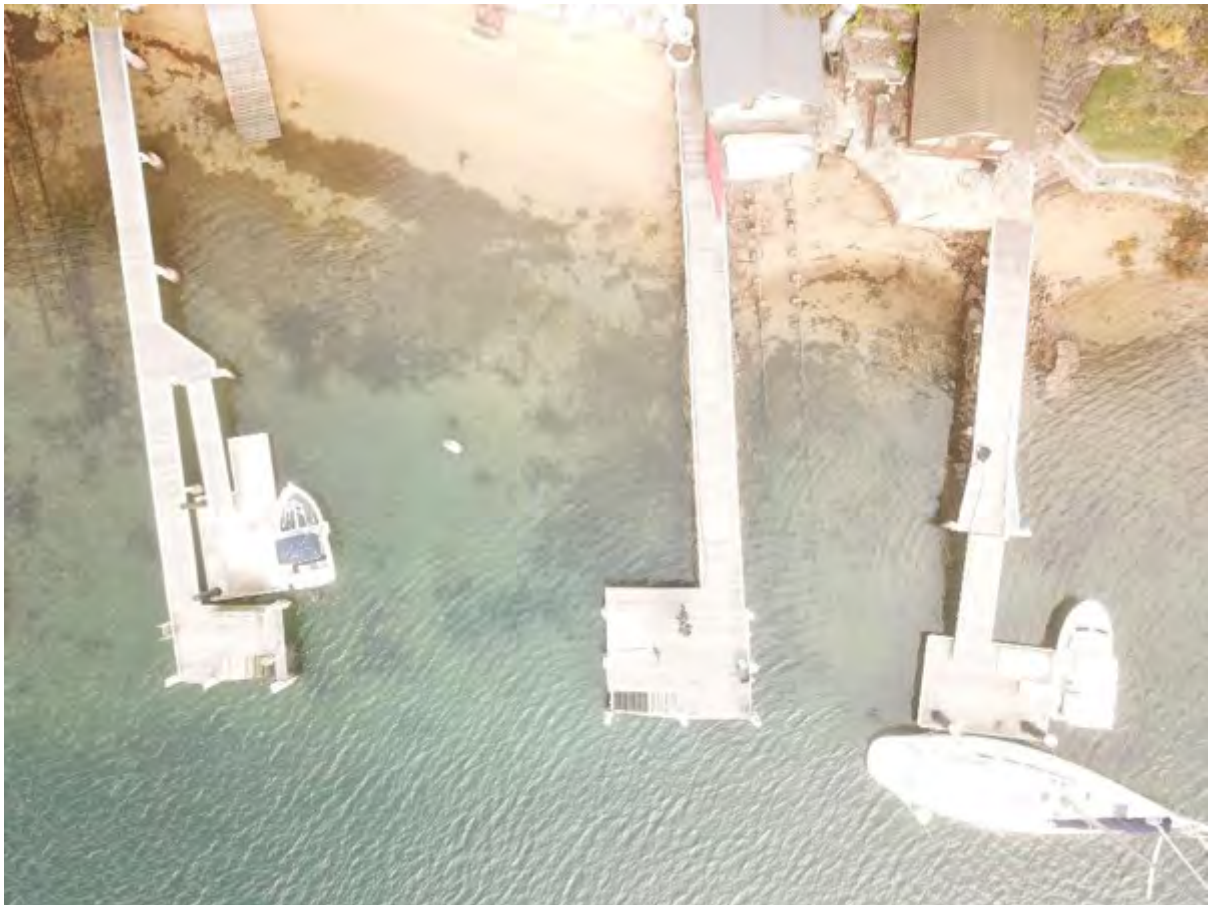
Figure 1 Drone view of existing facility (centre) in June 2020 at neap low tide. Note that North is down to the right for this view.

The existing marine facility is shown in a drone photograph from June 2020 (**Figure 1**). **Figure 2** provides a view from the water looking south. **Figures 3 and 4** provide views north-east from the south end of the existing jetty looking along the western and eastern sides of the property jetty with **Figure 5** showing the inshore beach. SCA have prepared a plan showing the existing and proposed facility outlines (see plan DA01 attached to this report). The intent of the refurbishment is to remove the unsafe sea-stair facility and provide a ramp and pontoon facility plus a new berthing pen.

- The upper intertidal and shallow sub-tidal seabed in this locality comprises an irregular extended area of sand with some gravel shale with a banked-up layer of beach sand inshore (**Figures 1 & 3 to 5**). There is less exposed gravel offshore and the sand becomes progressively more silty.

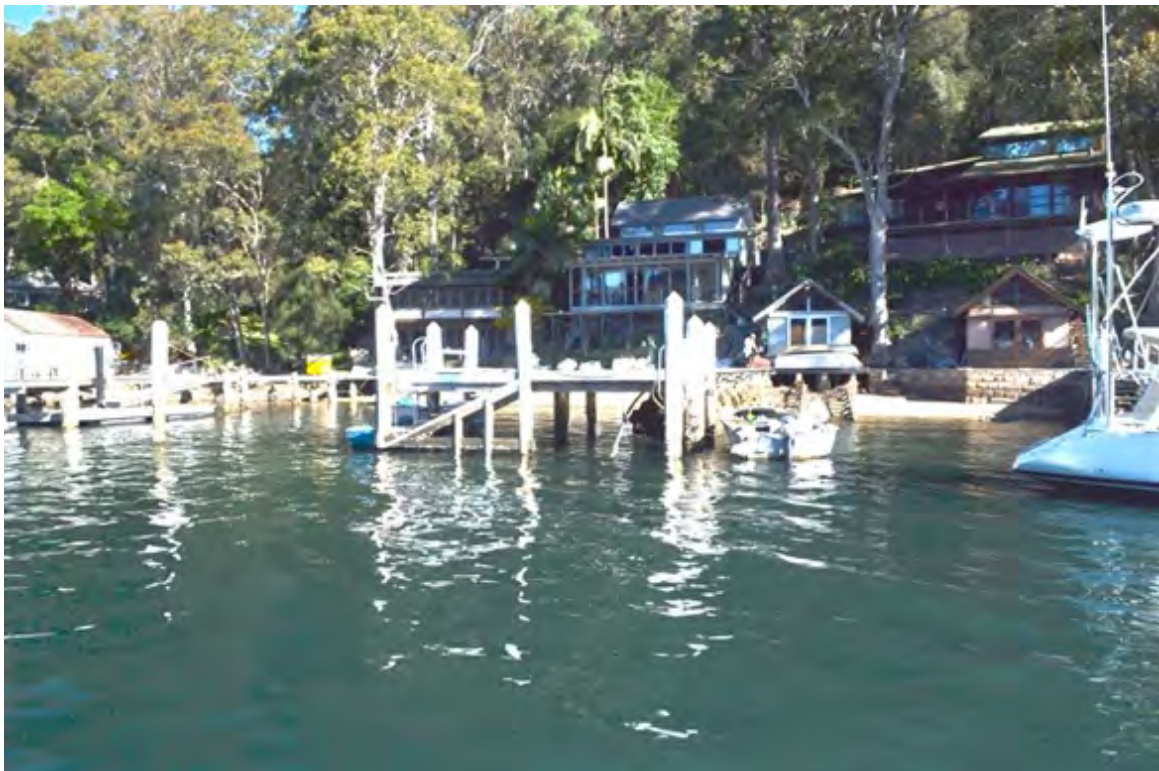
Figure 2 Existing Facility Jetty. Boatshed and sliprails looking inshore from Lovett Bay.

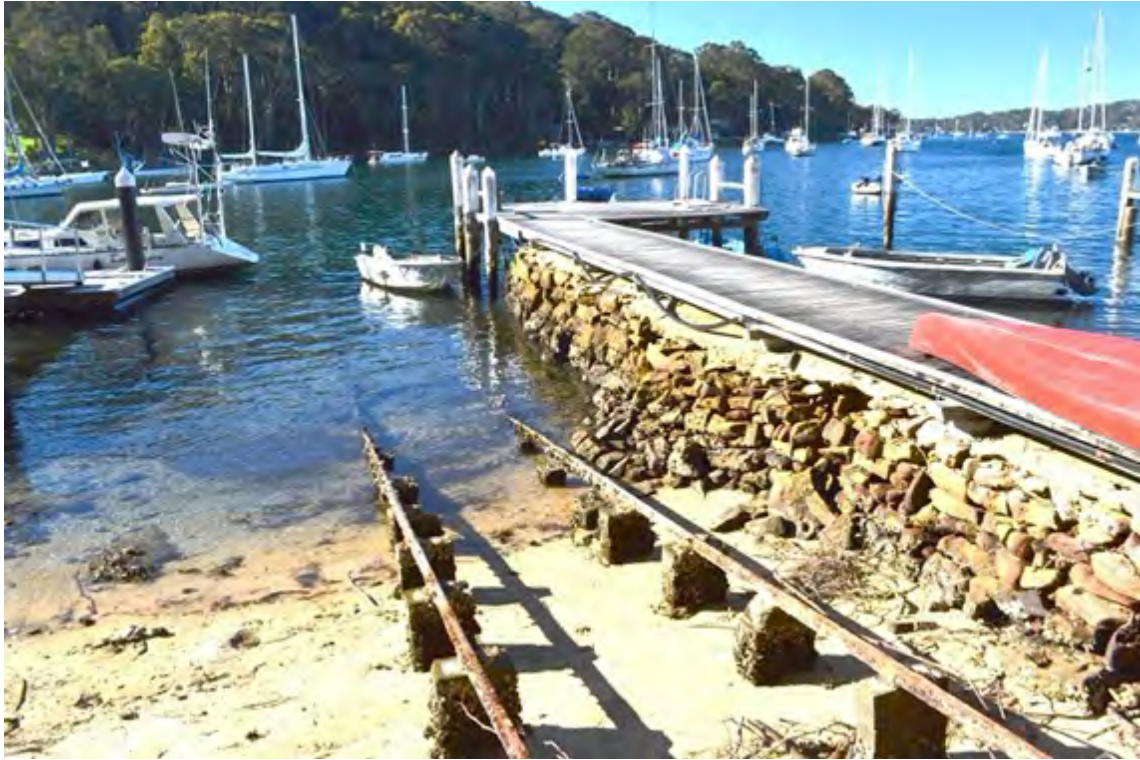
Figure 3 View of western side of facility showing sliprails, stone jetty with wood deck and offshore jetty.

- There is a rock rubble jetty located under the wood jetty (**Figures 3 and 6**) and the sub-tidal portion of this rubble supports a variety of brown macro-algae, mainly *Sargassum* and *Padina* (**Figures 7 to 9**). The intertidal rocks supported oysters plus littorinid snails and Zebra Periwinkles (*Austrocochlea constricta*). There were also sand whelks (*Velacumantus australi*) scattered throughout the rubble.

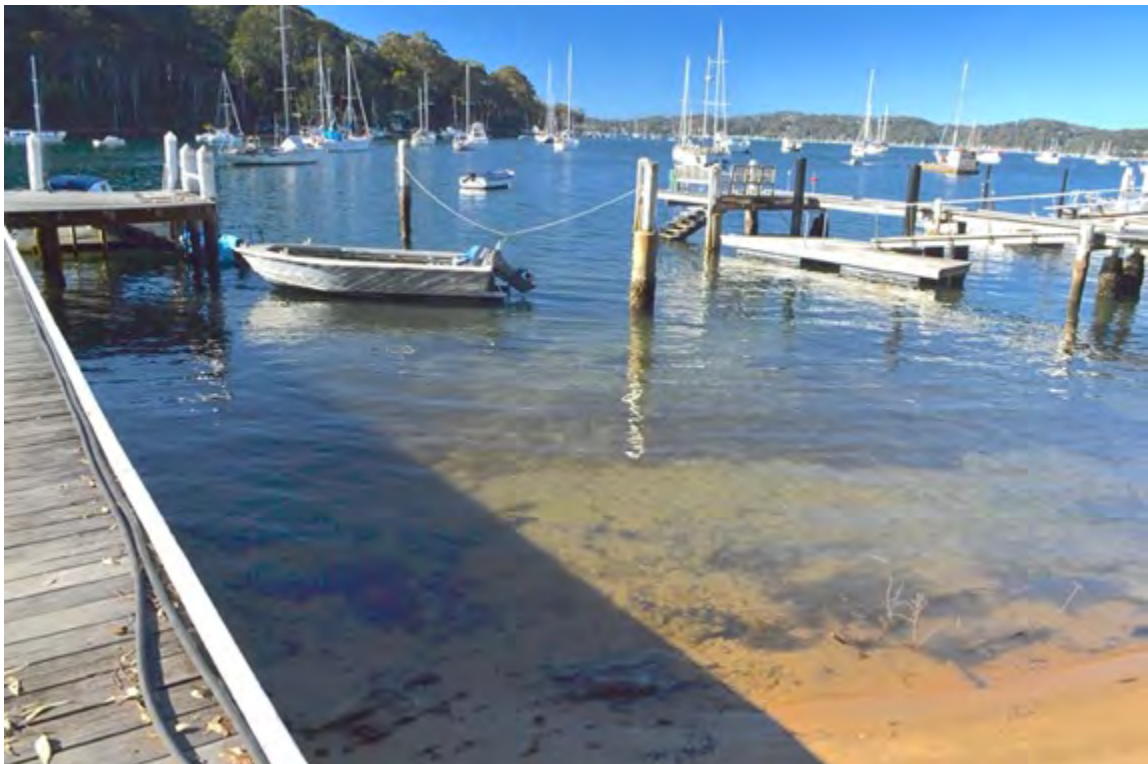
Figure 4 View of eastern side of facility showing sandy beach inshore and jetty plus sea-stairs offshore.

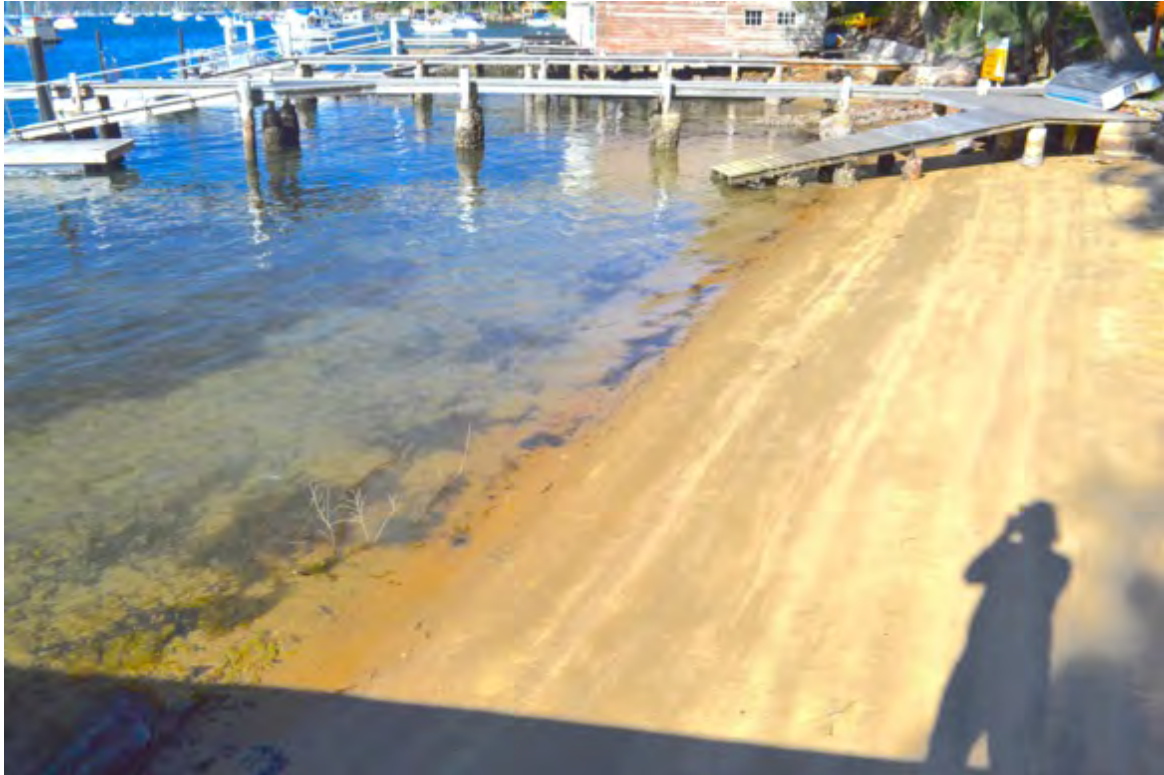
Figure 5 Sand beach inshore extends into the shallow subtidal and there is banked up algae debris inshore and immediately offshore.

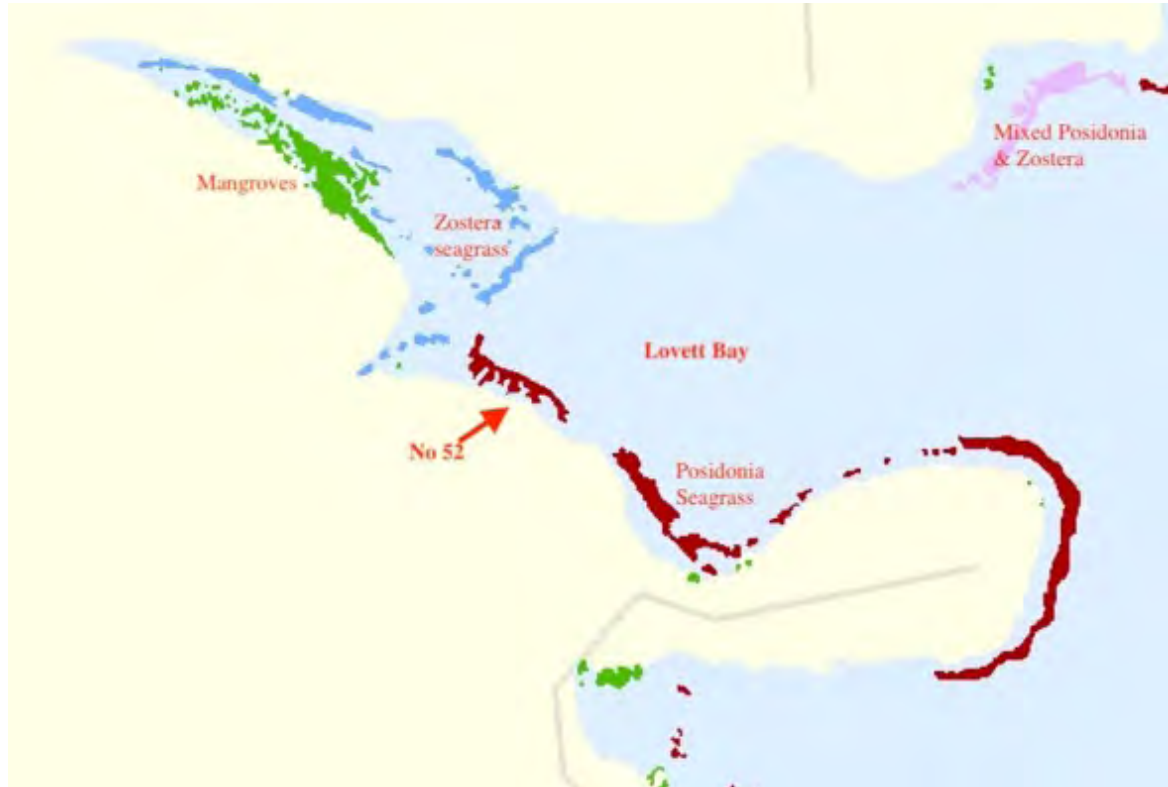
Figure 6 Distribution of marine vegetation along the Lovett Bay shoreline in the vicinity of the subject property (red arrow). Green = mangroves, Red = *Posidonia*., Blue = *Zostera*.

With respect to expected marine vegetation, estuarine vegetation mapping on NSW DPI Fisheries Map 37) indicate a *Posidonia australis* (Strapweed) bed off-shore at this location (see **Figure 6**).

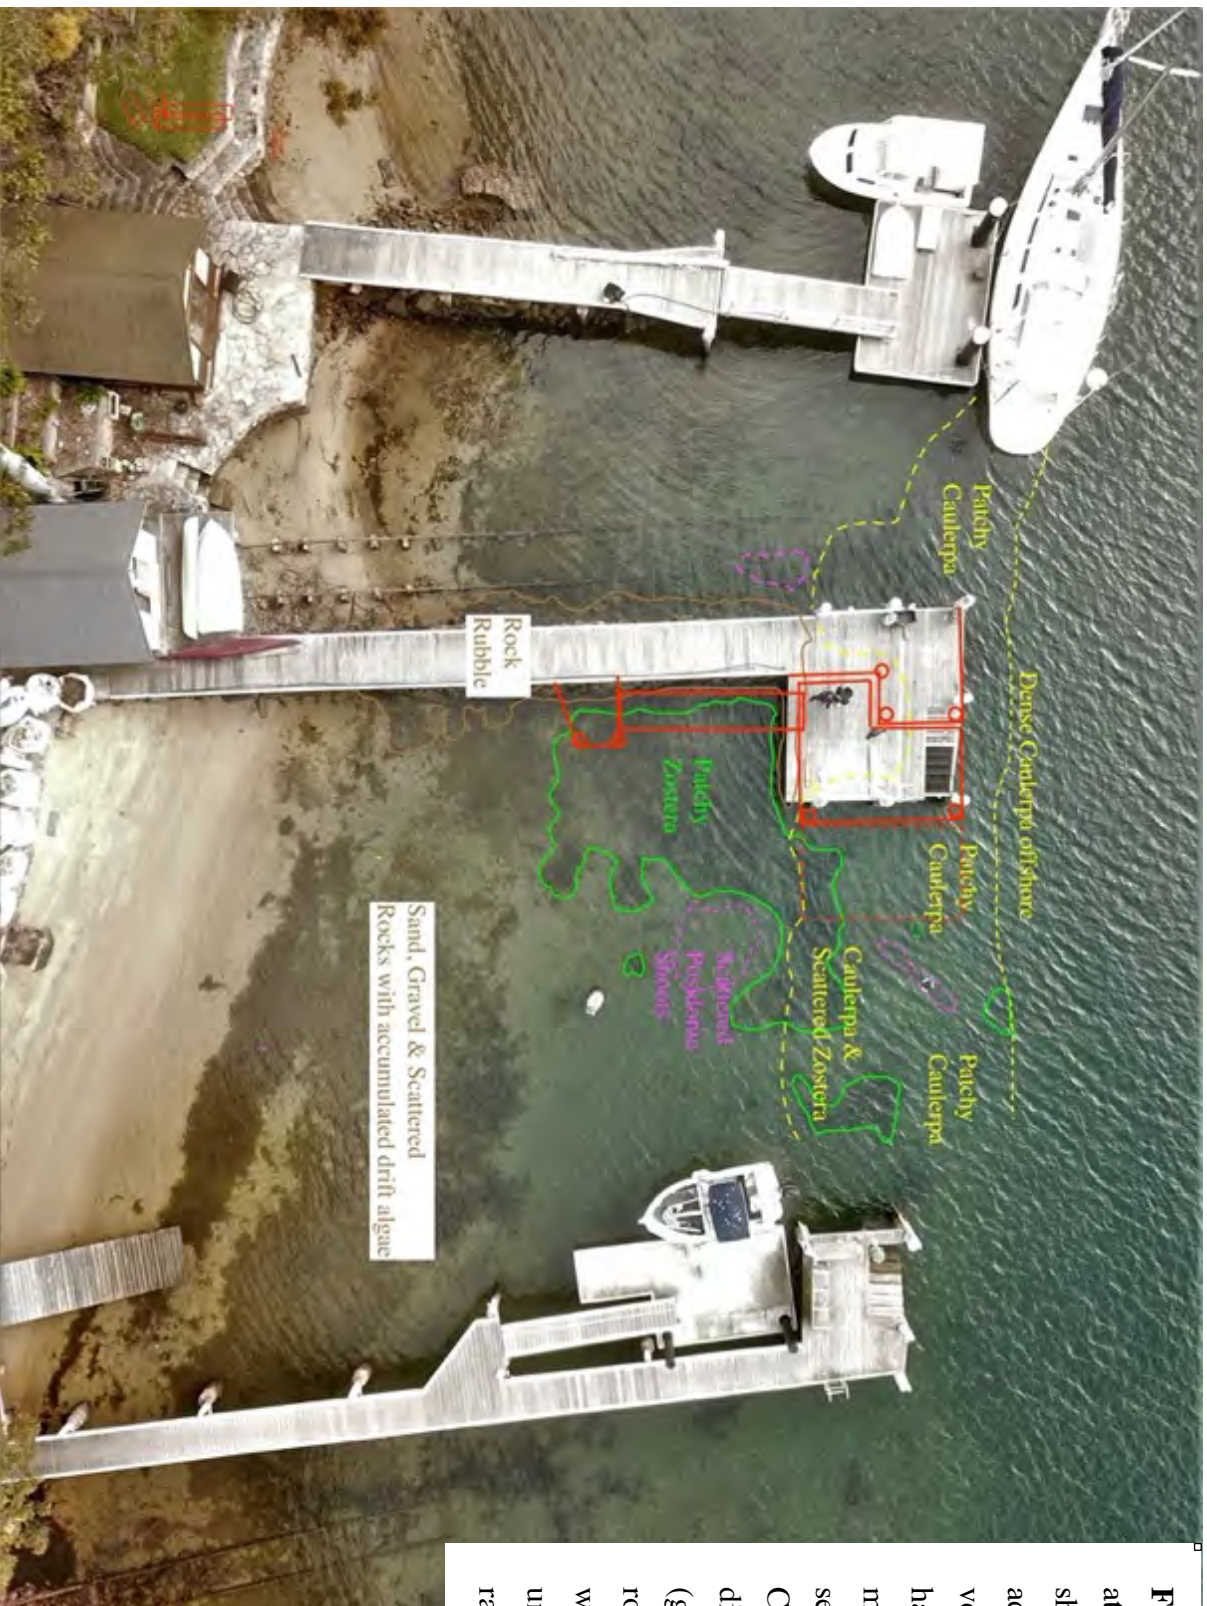
Figure 6 Site at low tide showing main aquatic vegetated habitats; mixed *Zostera* seagrass plus *Caulerpa* distribution (green) and rock rubble with algae under jetty and ramp (brown).

- There is a mixed and patchy *Caulerpa taxifolia* and *Zostera* seagrass distribution as indicated on **Figure 6** (see also **Figures 10 and 11**).
- Whilst there was no *Posidonia* bed found for the survey area, there were a few small patches of scattered shoots noted as indicated in **Figure 6** (see **Figures 12 to 14**). There were also a few individual *Posidonia* shoots noted within the patchy *Caulerpa* distribution off shore from the facility deck, but none were located in the area of the proposed mooring pen.

- There are no saltmarsh or mangrove plants or patches at the site but there are mangroves in the bay to the west of the property as indicated on **Figure 6**.
- There are no aquacultural activities, or commercial fishing (hauling or meshing) in the locality (EPA 1992).

- There will be no stockpiling of construction materials on the seabed.
- No vessel is to be moored with anchor or other bottom tackle located in the marine vegetation habitats indicated on **Figure 6**.

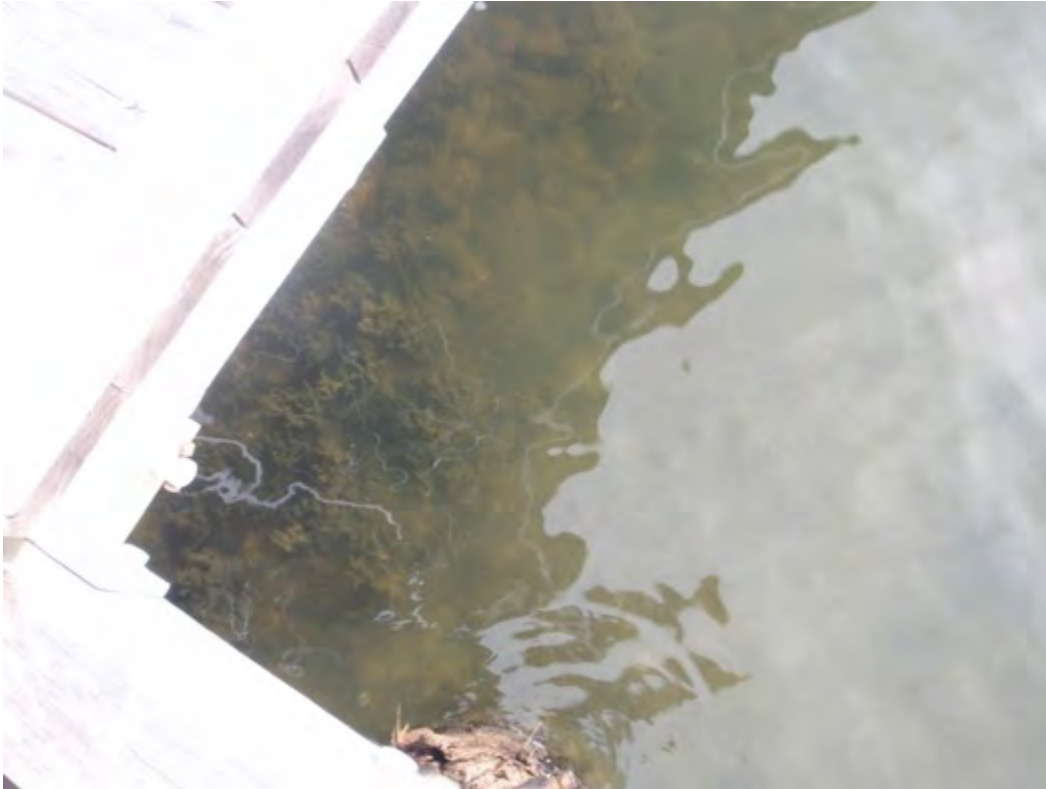
Figure 7 Brown *Sargassum* algae growing on shallow rock rubble under jetty.

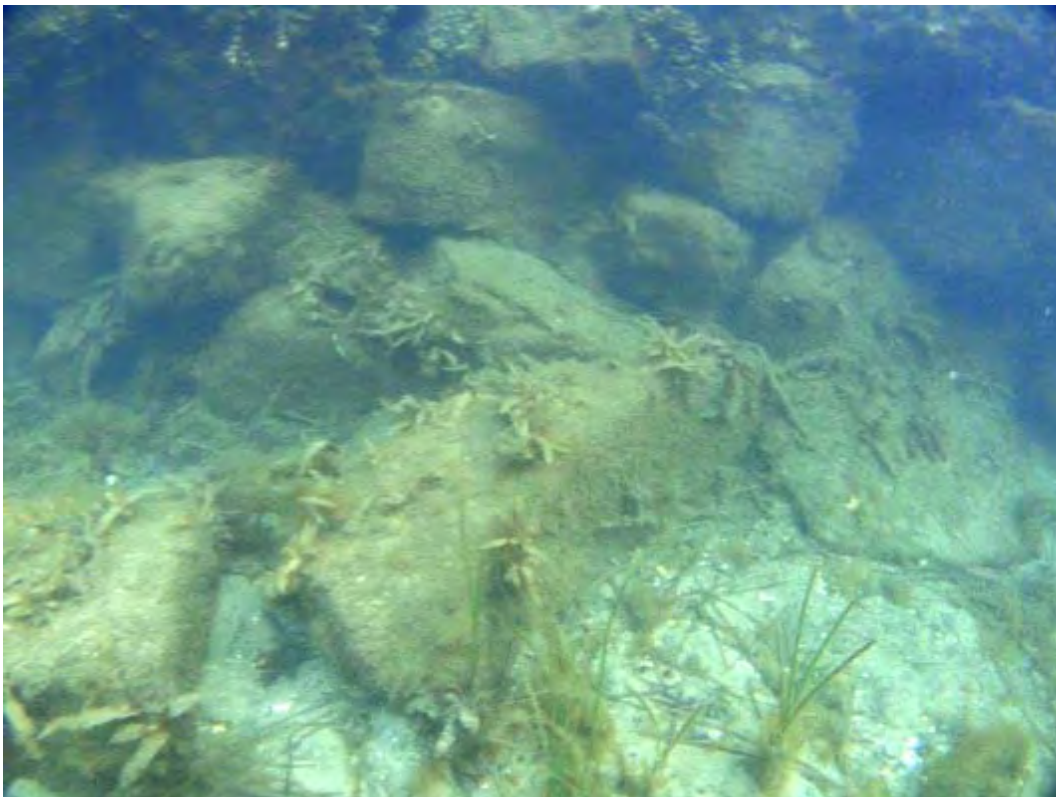
Figure 8 deeper sub-tidal rock rubble under proposed Access deck. Note sparse *Zostera* cover.

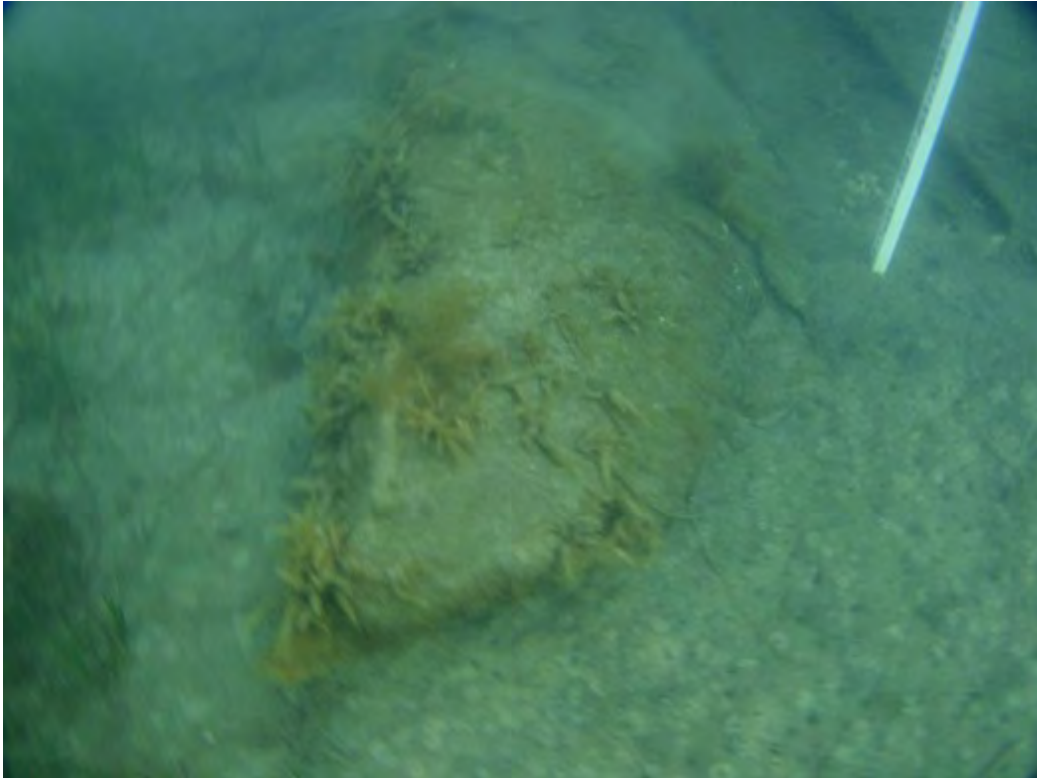
Figure 9 Deep rock off the south-east corner of the existing Jetty (indicated by the white survey staff) at top right) with *Zostera* inshore (to the left of the photograph).

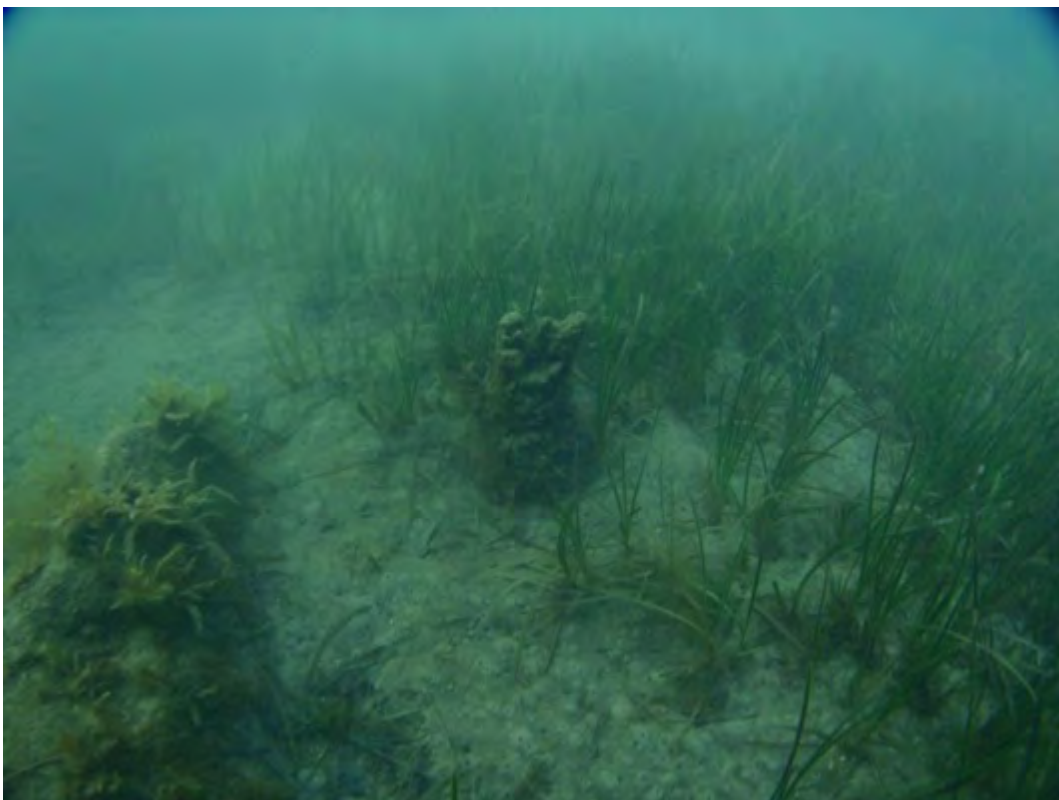
Figure 10 Patchy *Zostera* bed in the shallows looking north with the existing jetty to the left (out of view) and a pile stump mid picture.

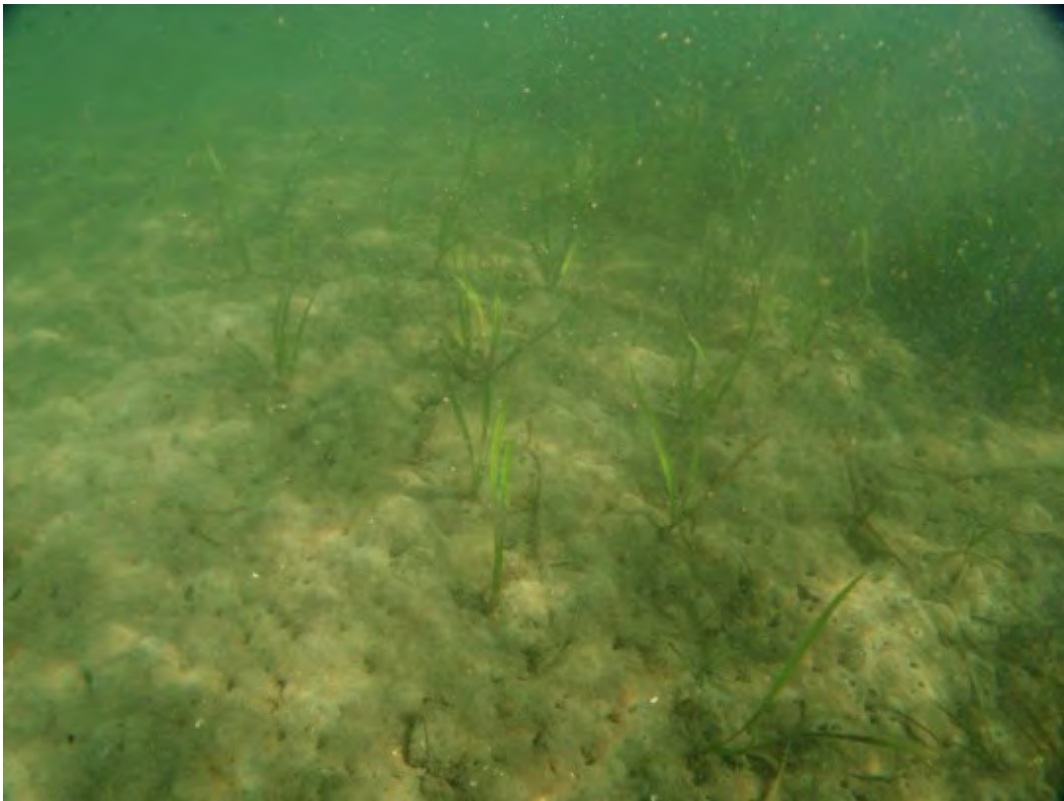
Figure 12 Scattered *Posidonia* patch located between the two mooring piles (see Figure 6).

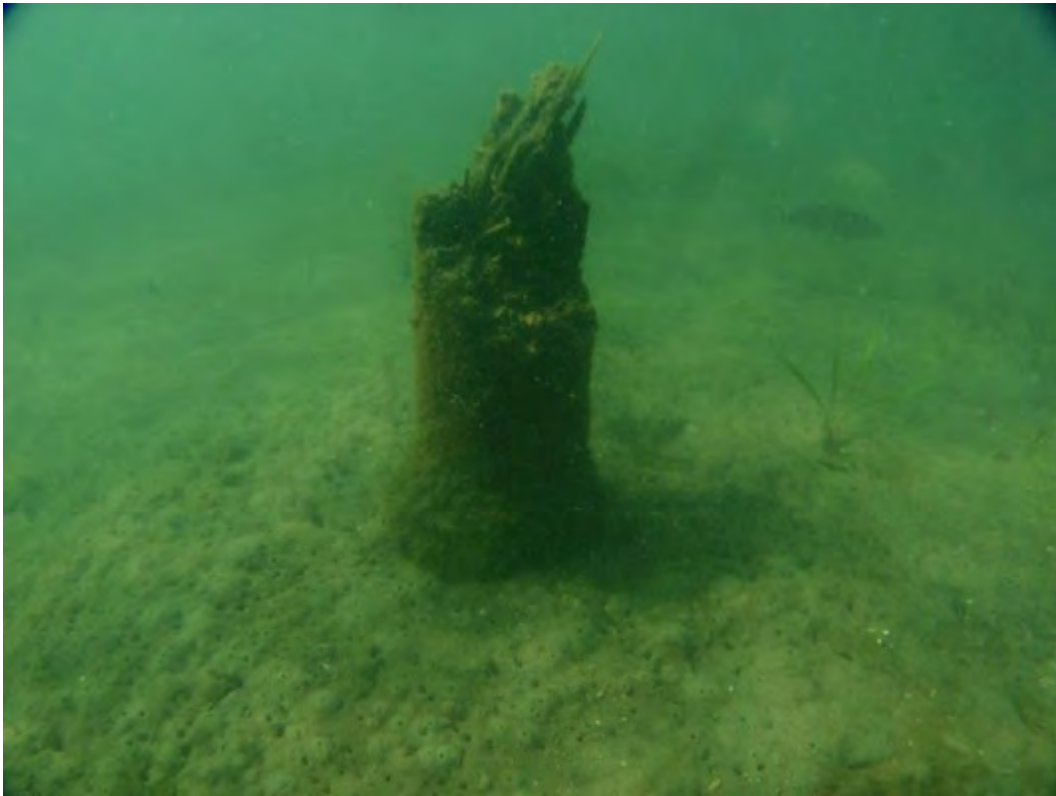
Figure 13 Outer snapped off mooring pile with very sparse *Posidonia* cover in vicinity.

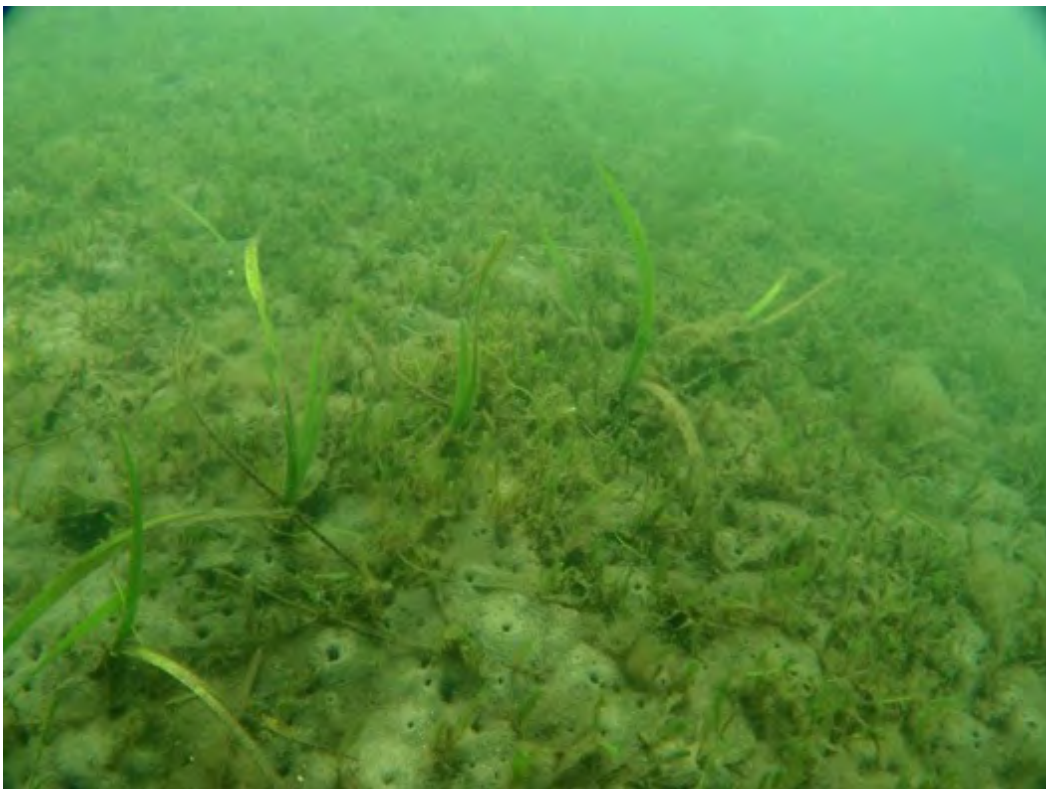
Figure 14 Close up view of *Posidonia* and *Caulerpa* patch in vicinity of snapped off pile (as indicated in Figure 6)

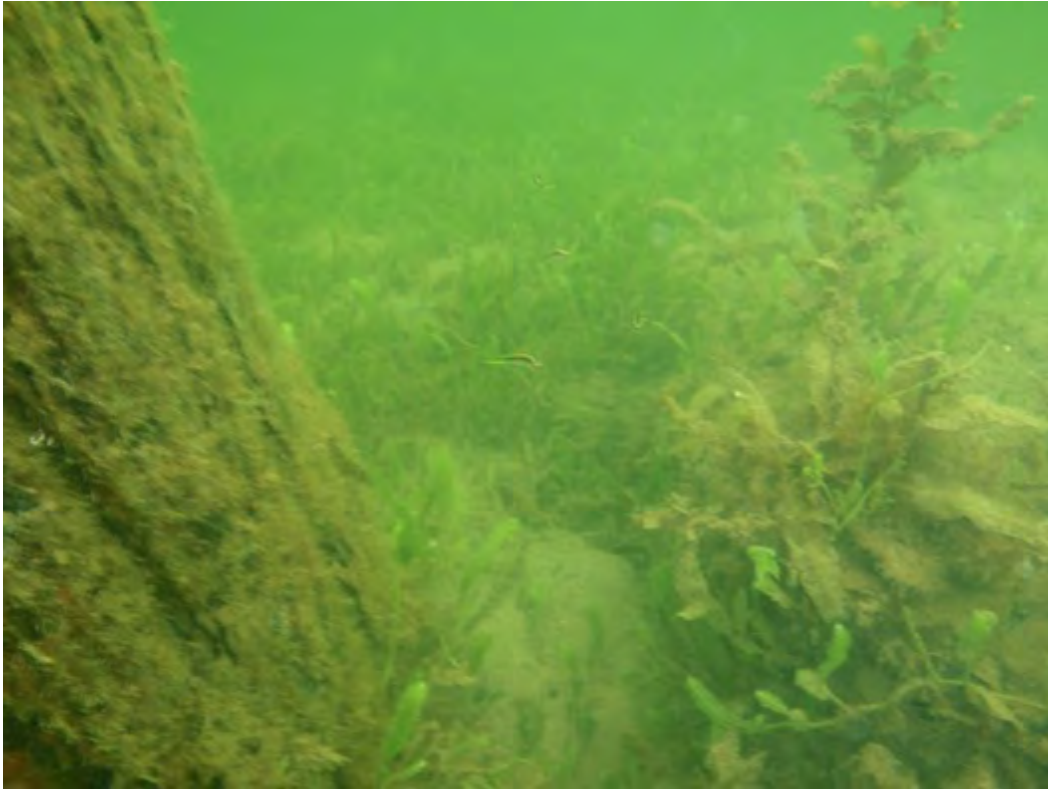
Figure 15 North-Western Deck support pile with *Caulerpa* and *Sargassum* around the pile. Note also reef colonising eastern hula fish.

- The *Caulerpa* cover became progressively denser offshore from the outer deck support piles (see **Figures 15 and 16**).
- The deck support piles had oysters bands in the intertidal to shallow sub-tidal depth range which, together with the attached biota on the rock rubble (and on pontoon wetted surfaces, as observed on adjacent facilities) provided some shelter and feeding habitat for a range of juvenile reef fish (**Figures 15, 17 and 18**).

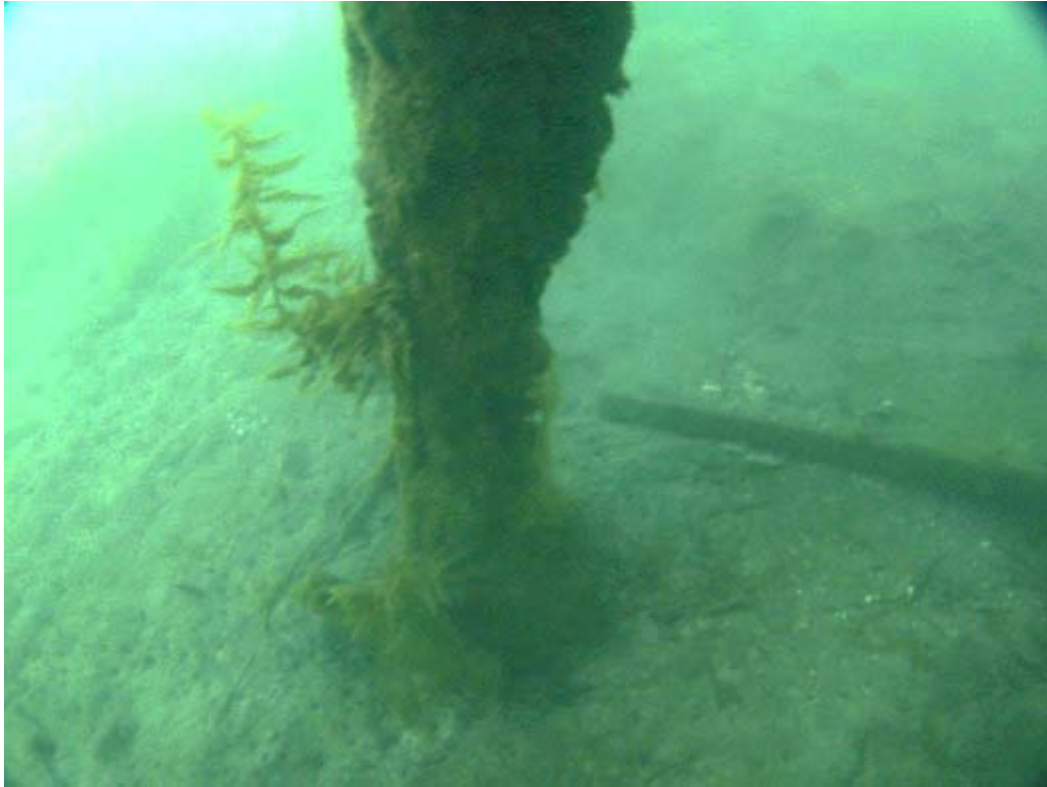
Figure 17 Bare sediment habitat around inner mooring pile between Nos 52 and 54 (to the east).

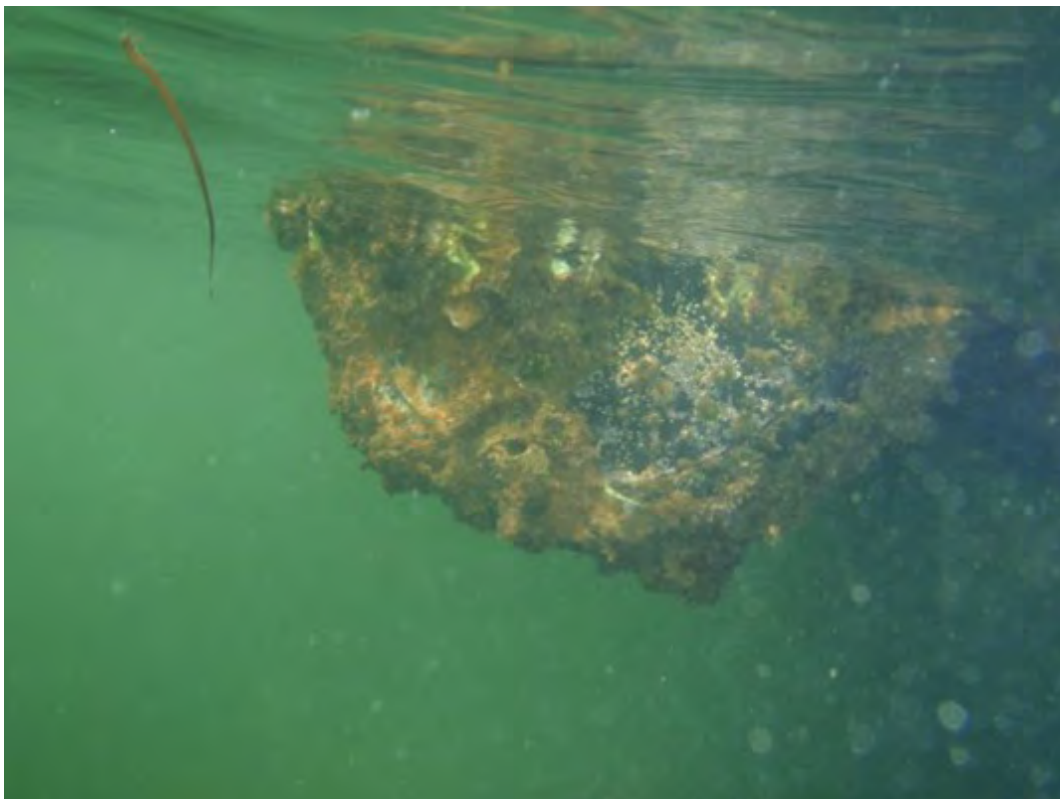
Figure 18 Simple assemblage of algae and attached fauna on pontoon support drum (on adjacent facility).

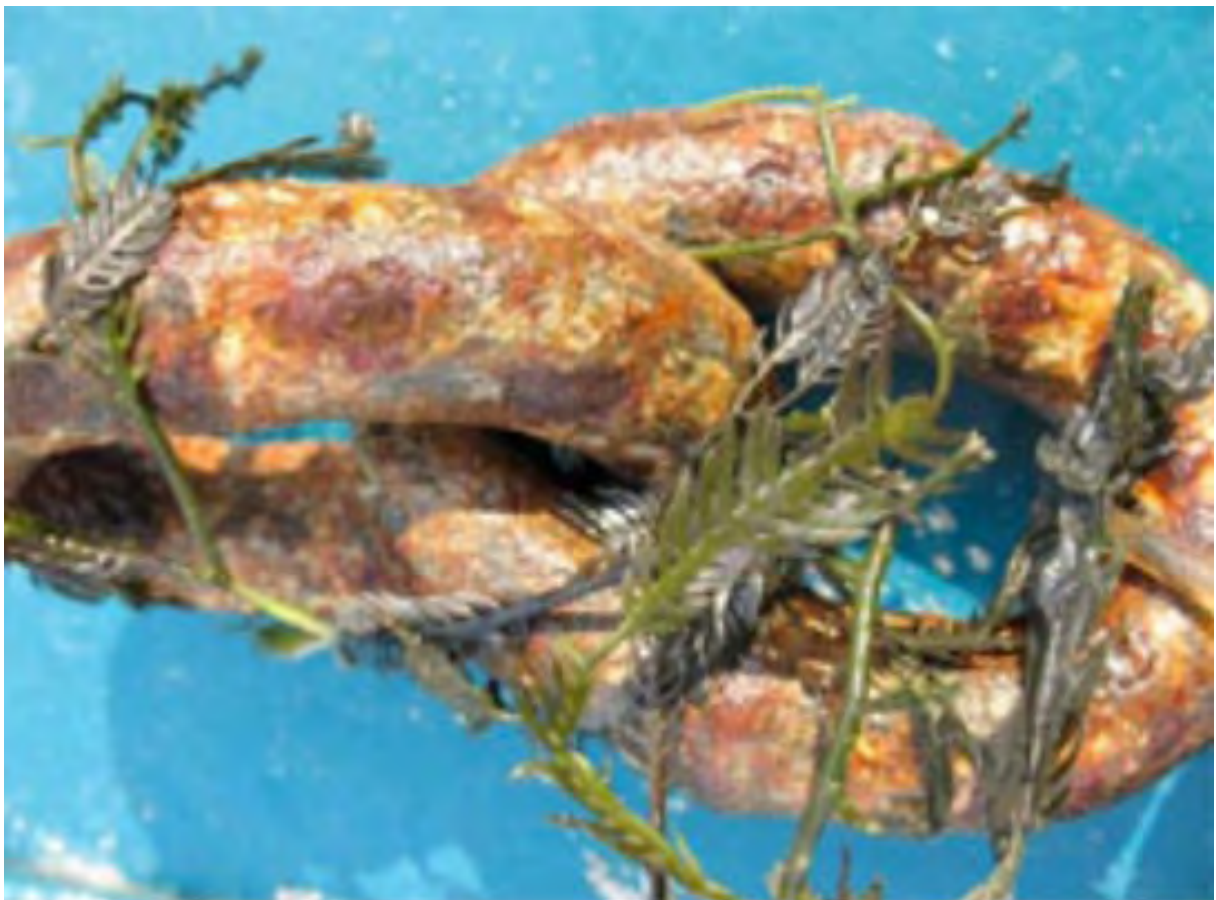
Figure 19 The pest algae *Caulerpa taxifolia* attached to a segment of chain.

Construction activities may also disturb and mobilise *Caulerpa taxifolia* fragments that can be carried to other estuaries not currently infested. Fragments can also adhere to equipment (ropes, cable, anchors) that can then be transported to other estuaries to infest these estuaries when the equipment is re-deployed (**Figure 19**). This risk will be mitigated by inclusion of the following *Caulerpa* Management protocols:
