## **PRELIMINARY GEOTECHNICAL ASSESSMENT:**

### **53 Duke Street, Forestville**

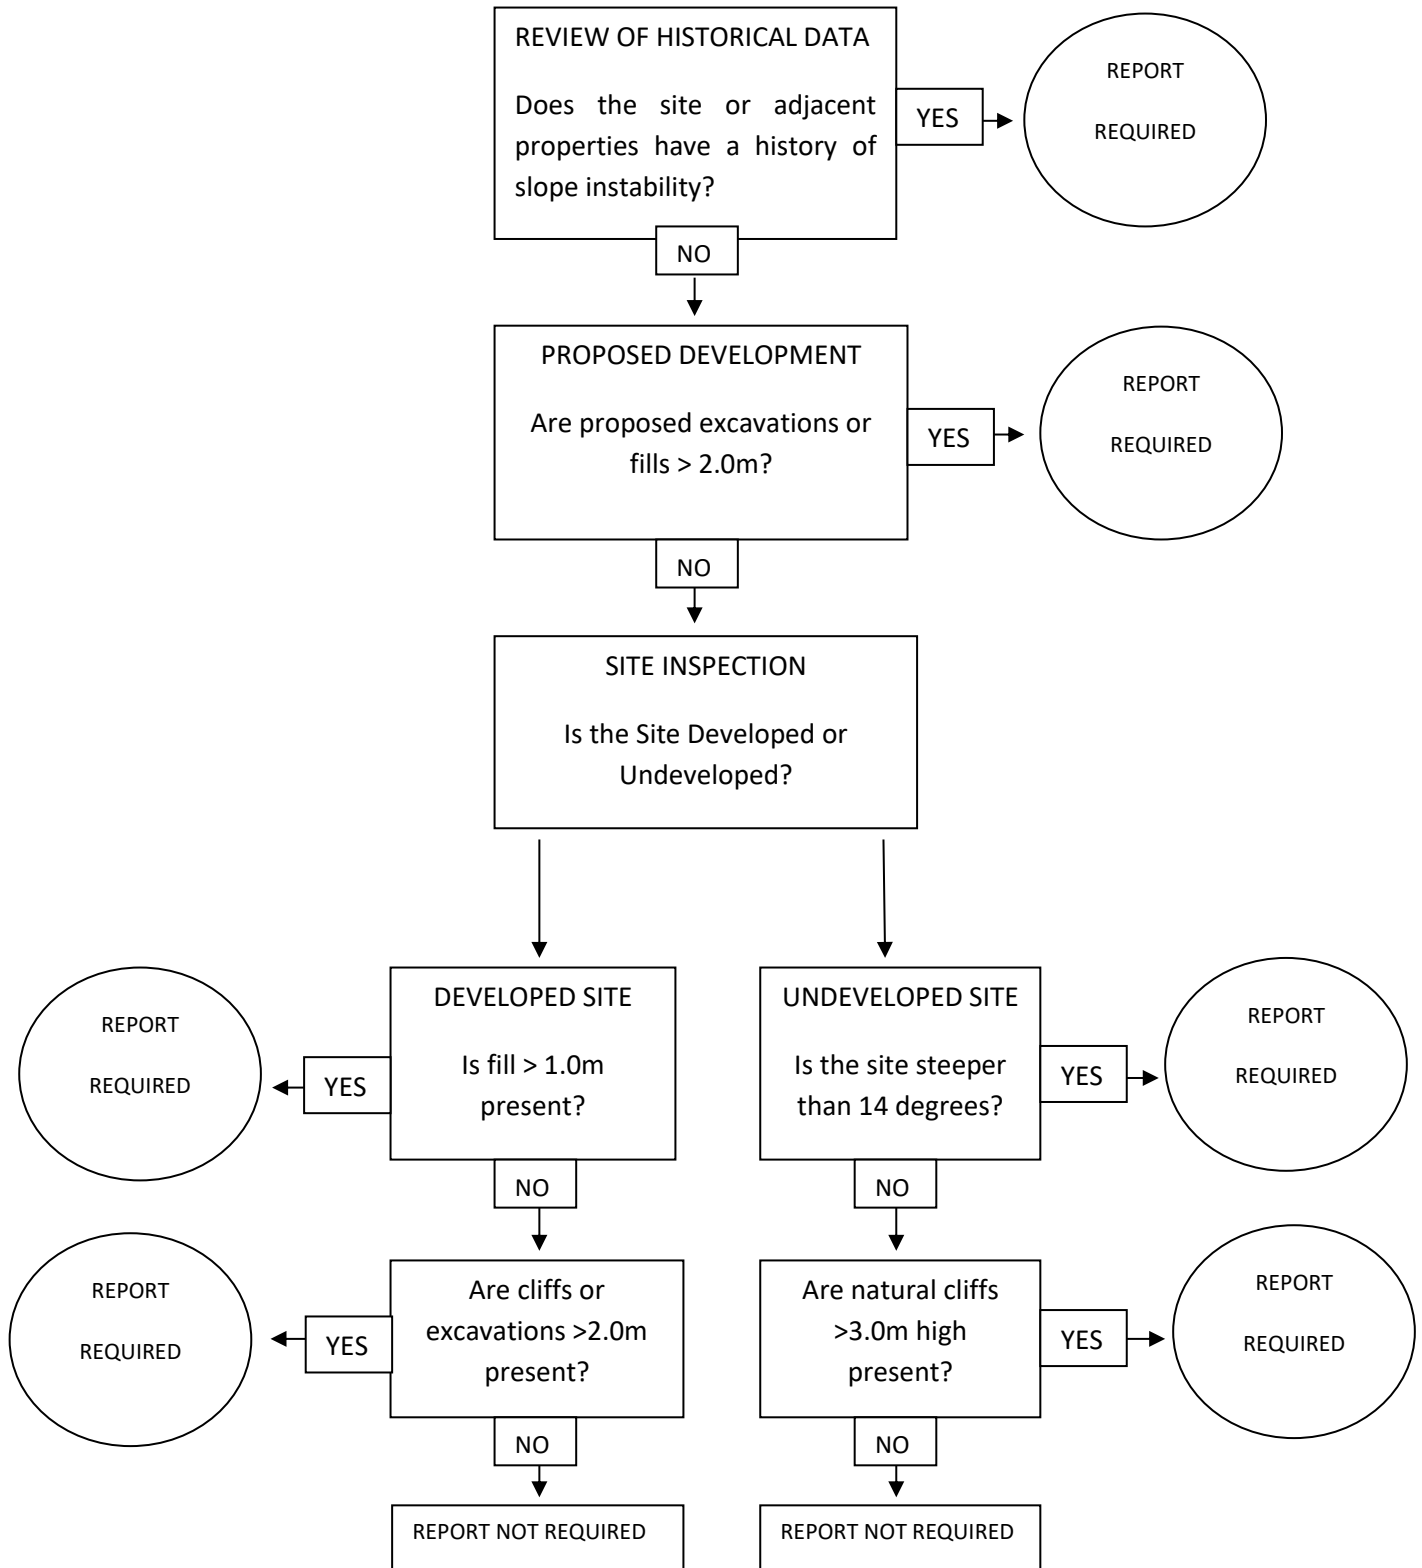
## Preliminary Assessment Flow Chart – Northern Beaches Council (Warringah)

The proposed development and site conditions were considered and applied to the Council Flow Chart.
