Geotechnical Assessment

Project: New Residence
128 Headland Road, North Curl Curl NSW.

REF: AG 20238
21st September, 2020

For New Residence at
128 Headland Road, North Curl Curl, NSW

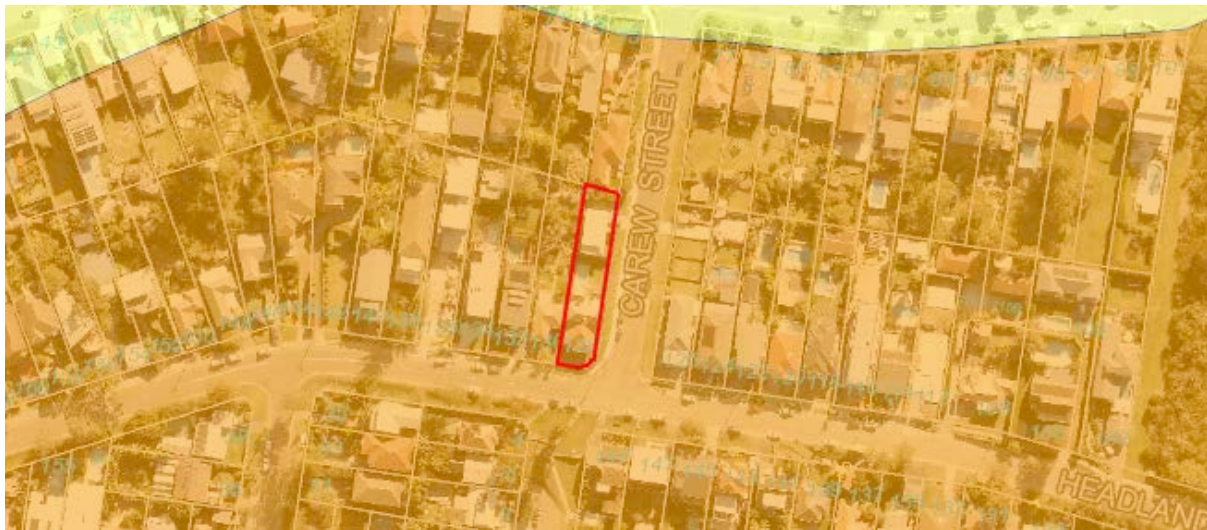
WARRINGAH LANDSLIP RISK MAP

- The existing structures including retaining walls displayed no evidence of significant cracking or settlement that could be attributed to slope instability.
- The property is classified as **Area B** with reference to Northern Beaches Council WLEP Landslip Risk Map Sheet (WLEP Landslip Risk Map **Image 2** below).

- Area A - Slope less than 5 degrees
- Area B - Flanking Slopes from 5 to 25 degrees
- Area C - Slopes more than 25 degrees
- Area D - Collaroy Plateau Area Flanking Slopes 5 to 15 degrees
- Area E - Collaroy Plateau Area Slopes more than 15 degrees

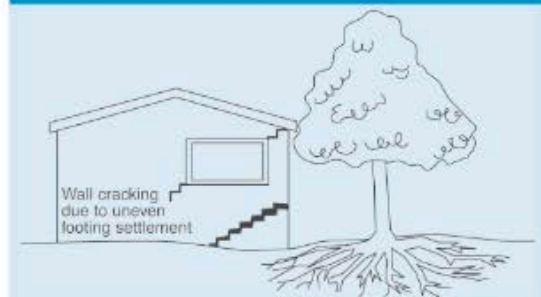
Trees can cause shrinkage and damage

As the weather pattern changes and the soil begins to dry out, the external footings will be first affected, beginning with the locations where the sun's effect is strongest. This has the effect of lowering the external footings. The doming is accentuated and cracking reduces or disappears where it occurred because of dishing, but other cracks open up. The roof lines may become convex.
