Preliminary Geotechnical Assessment

Project: Alterations & Additions 8 The Crest, Frenchs Forest

Prepared for: Craig and Nicola McMennamin 8 The Crest Frenchs Forest, NSW 2086 **Ref:** AG 22501 22 November 2022

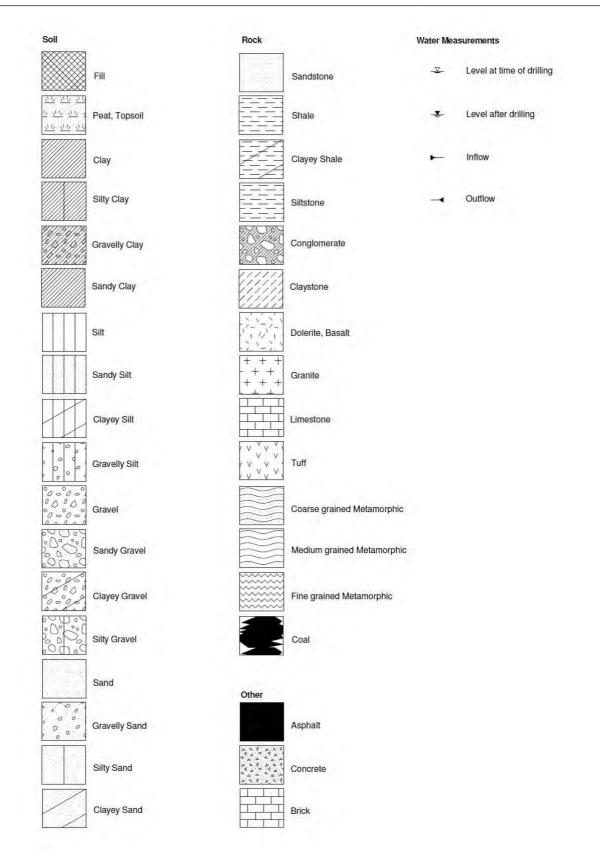
Graphic Symbols Index

Note: soil and rock descriptions are generally in accordance with AS1726-1993 Geotechnical Site Investigations
