Geotechnical Assessment

Project: Landscaping & Retaining Walls
101 George Street, Avalon Beach NSW.

REF: AG 21303
17 September 2021

For Landscaping & Retaining Walls at
101 George Street, Avalon Beach NSW

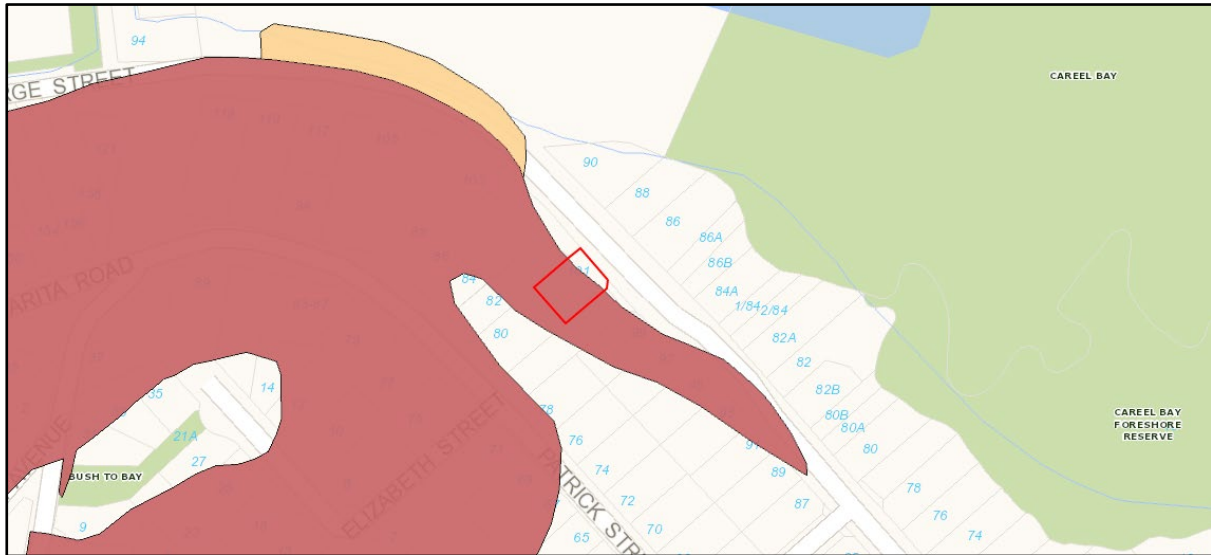
Image 2. PLEP Geotechnical Hazard Map
– 101 George Street, Avalon Beach NSW

- No evidence of significant soil creep, tension cracks or landslip instability were identified across the site or on adjacent properties as viewed from the subject site at the time of our inspection. Minor soil creep identified can be attributed to poorly compacted fill and/or the influence of inadequate downslope support from retaining structures.
- Based on reference to the plan entitled “Geotechnical Hazard Mapping” (Ref. P21DCP-BC-MDCP2002, dated 2007) prepared by GHD LONGMAC on behalf of Pittwater Council, the site is mapped as a **Geotechnical Hazard H1** area.

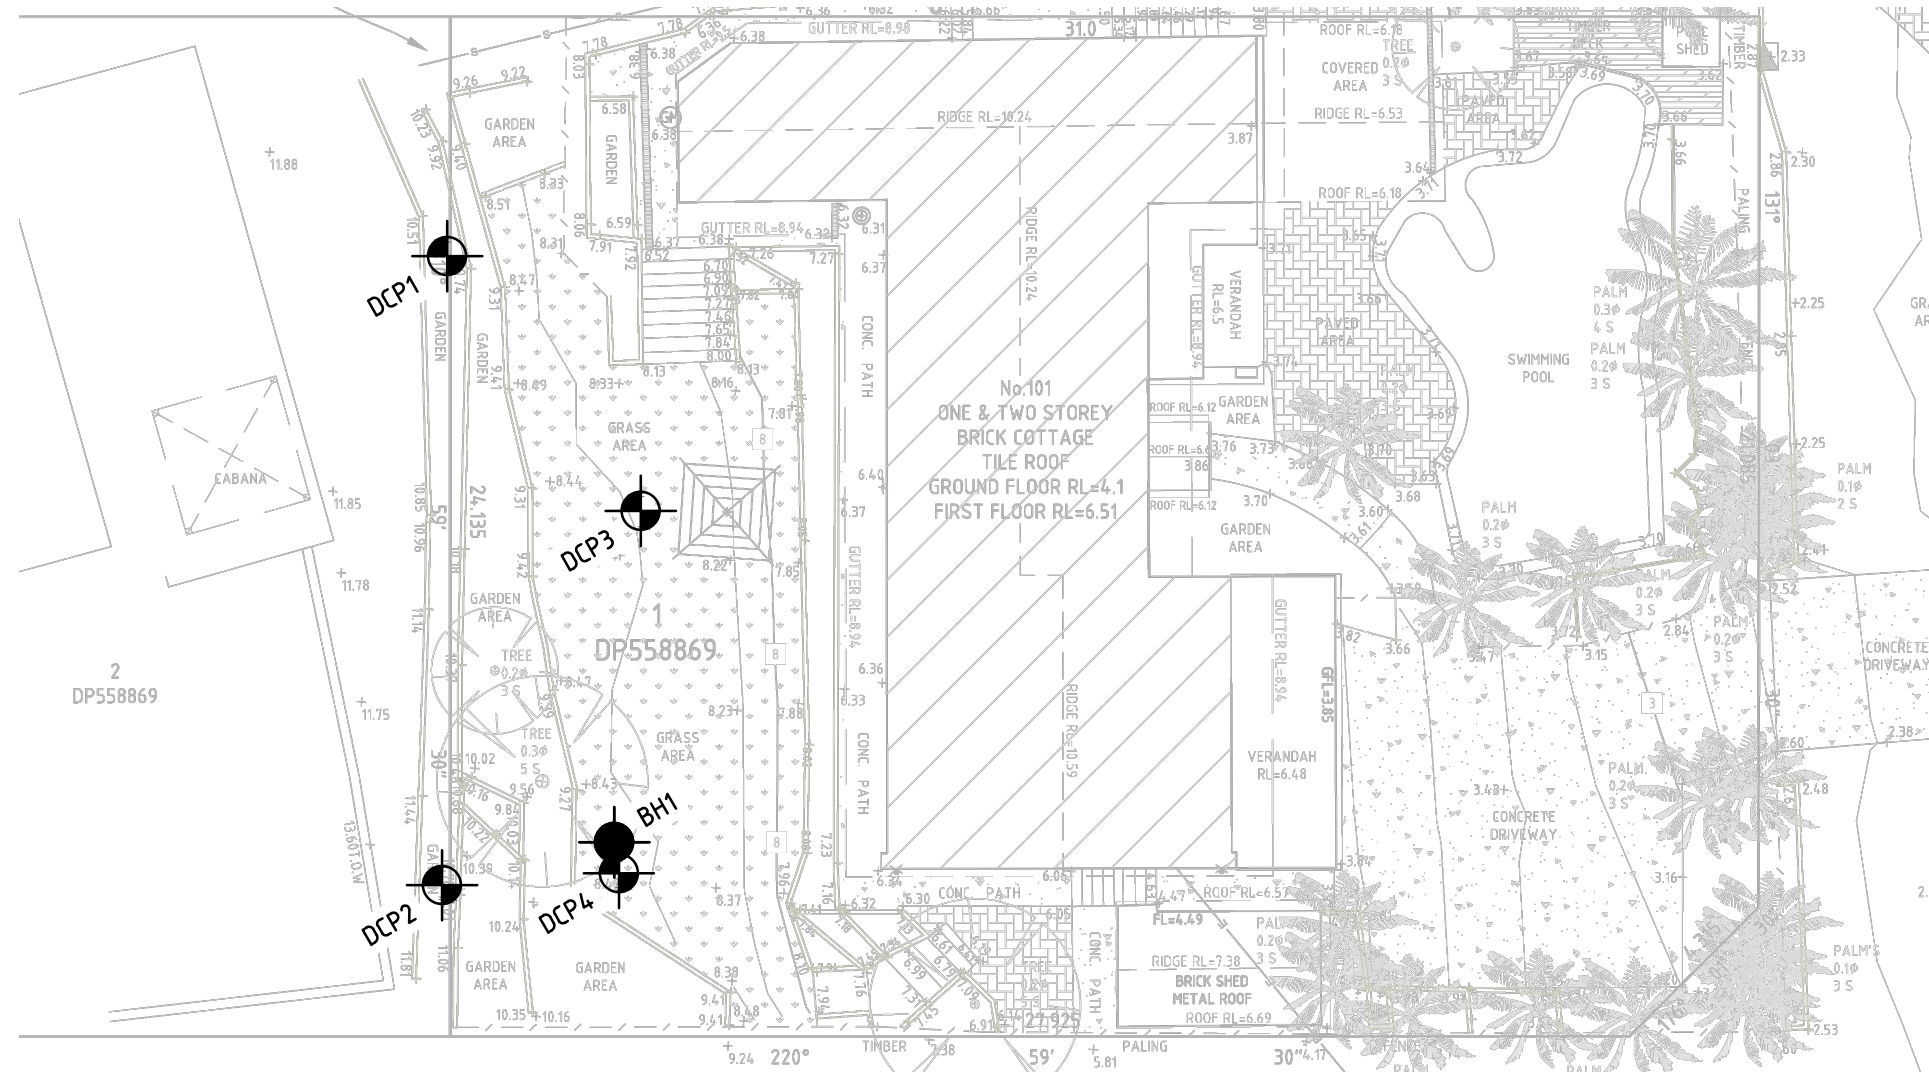
SITE PLAN/GROUND TEST LOCATIONS
SCALE NTS

DCP LOCATIONS
BOREHOLE LOCATION
