# ENVIRONMENTAL MANAGEMENT PLAN

MONA VALE BUS  
DEPOT - 58 DARLEY  
ST, MONA VALE  
NSW

Environmental Management Plan  
Mona Vale Bus Depot - 58 Darley St, Mona Vale NSW  
State Transit Authority

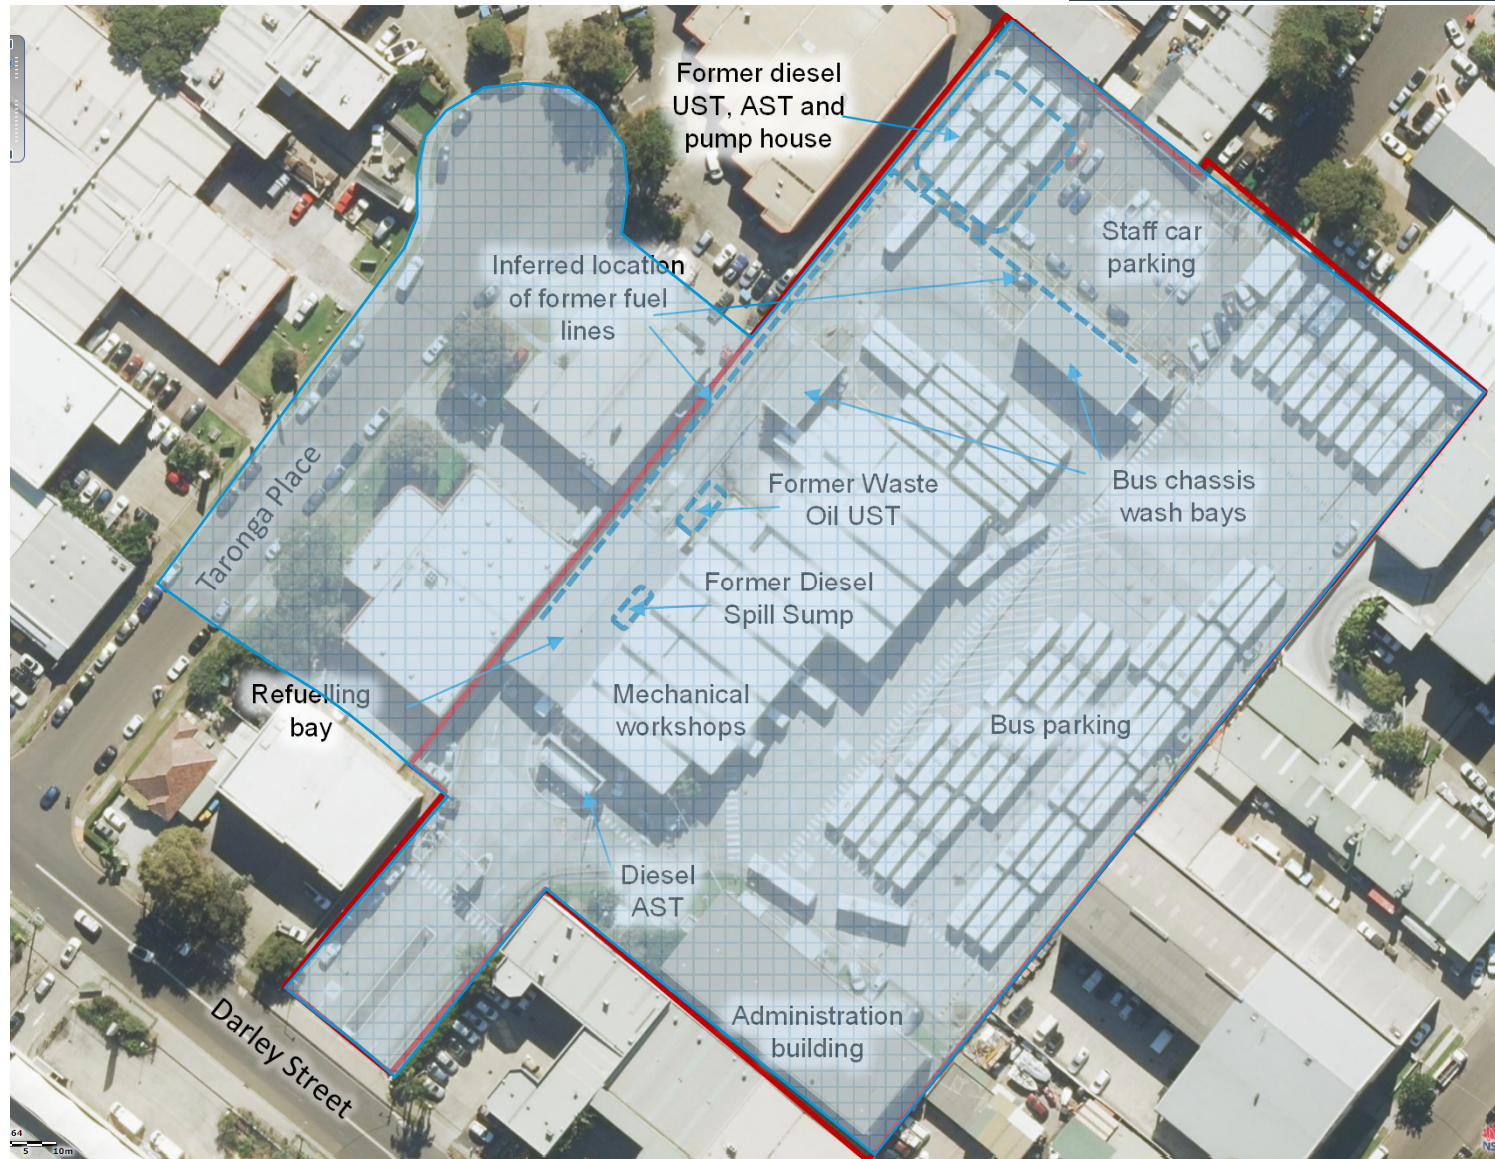
**Figure 3 Site Current and Historical Features**  
PS111744 – EMP  
STA Bus Depot, 58 Darley Street Mona Vale

These features are shown on Figure 2 of Appendix A, while the location of the wells included in routine monitoring works are included in Figure 5.

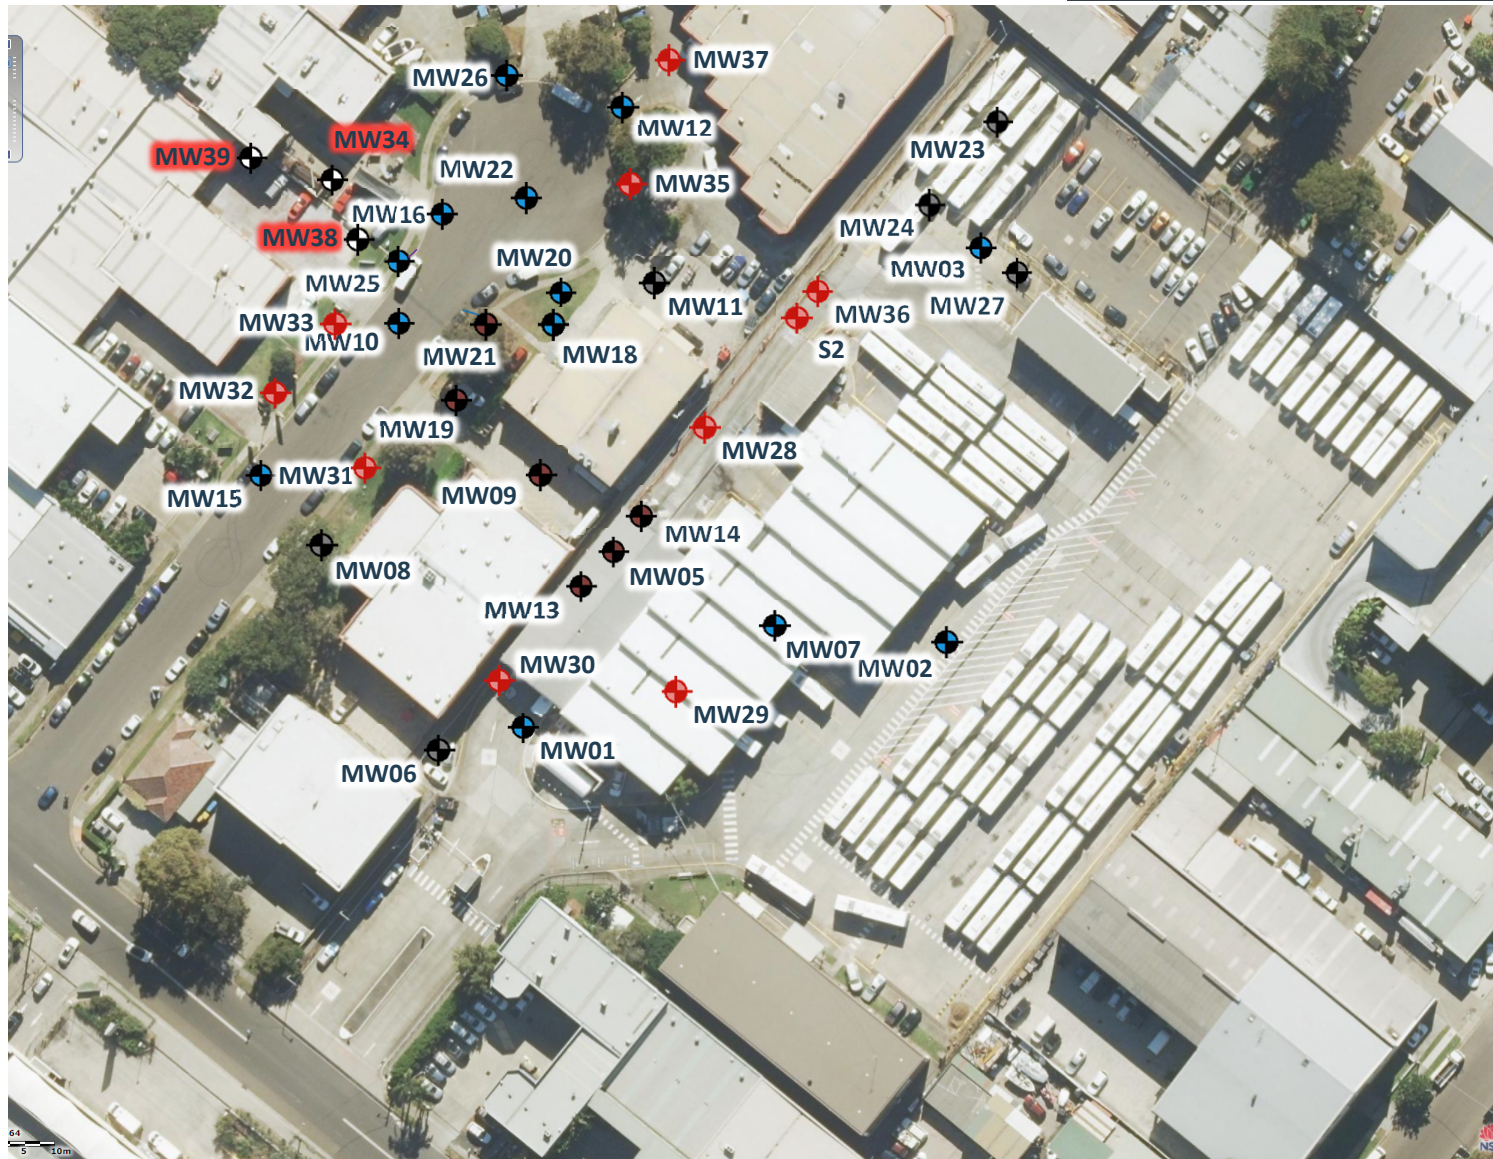
- Site Boundary
- ◆ Newly Installed Wells
- ◆ Gauged Wells
- ◆ Skimmer Wells
- Lost Wells
- ◆ Proposed wells

**Figure 5 Well Locations**  
PS111744 – EMP  
STA Bus Depot, 58 Darley Street Mona Vale

WORKS	STATUS	WORKS DETAIL	CONTRACTOR
Source abandonment (diesel spill sump pit), soil excavation and offsite disposal	Completed October, 2013	The 2,000 litre spill sump was pumped out of residual product and then backfilled with 25 mPa concrete.  6.74 tonnes of heaviest contaminated soils, in a 2m x 3m footprint, were excavated adjacent the backfilled abandoned spill sump, between sump and the western boundary of the Site.  The excavation was backfilled with suitable certified soils and the concrete slab in the fuel area driveway was reinstated	Australian Environmental Services (AES)  Worth Recycling (soil disposal)
Installation of two additional monitoring wells for enhanced free phase recovery within groundwater impacted zone	Completed October 2013	Additional wells (MW13 and MW14) were installed on the western boundary of the Site, adjacent to MW05.  Refer Figure 5, Appendix A for well locations	AES subcontracted to ENRS

WORKS	STATUS	WORKS DETAIL	CONTRACTOR
Decommissioning by excavation and offsite removal of 1x 35 kL AST and 1x 35 kL UST (both diesel) and the pump house area.	Completed April 2014 by Petrolink	UST and AST soil validation samples were reported below the validation criteria. Pump House area was only excavated to a depth of 0.5 m with validation samples showing elevated levels of TRH and PAHs remaining.	Petrolink
Installation of additional wells to existing network of 5 wells for the purpose of delineation and monitoring of natural attenuation. Various mobilisation.	November 2013  June 2014  September 2015  June 2016	MW15, MW16 and MW17 – installed for to assess extent of PSH.  MW08-B and MW12-B – installed after the original bores became blocked and were not accessible for sampling  MW18 and MW19 - further assess lateral extent of plume and provide additional points for PSH extraction from large diameter wells.  MW20 and MW21 - within road reserve adjacent private property as MW11 and MW18 no longer accessible.  MW22, MW25 and MW26 - down gradient of existing bore network to further assess offsite migration.  Refer Figure 5, Appendix A for well locations	ENRS
