## **PRELIMINARY GEOTECHNICAL ASSESSMENT:**

### **12 Brentwood Place, Frenchs Forest**

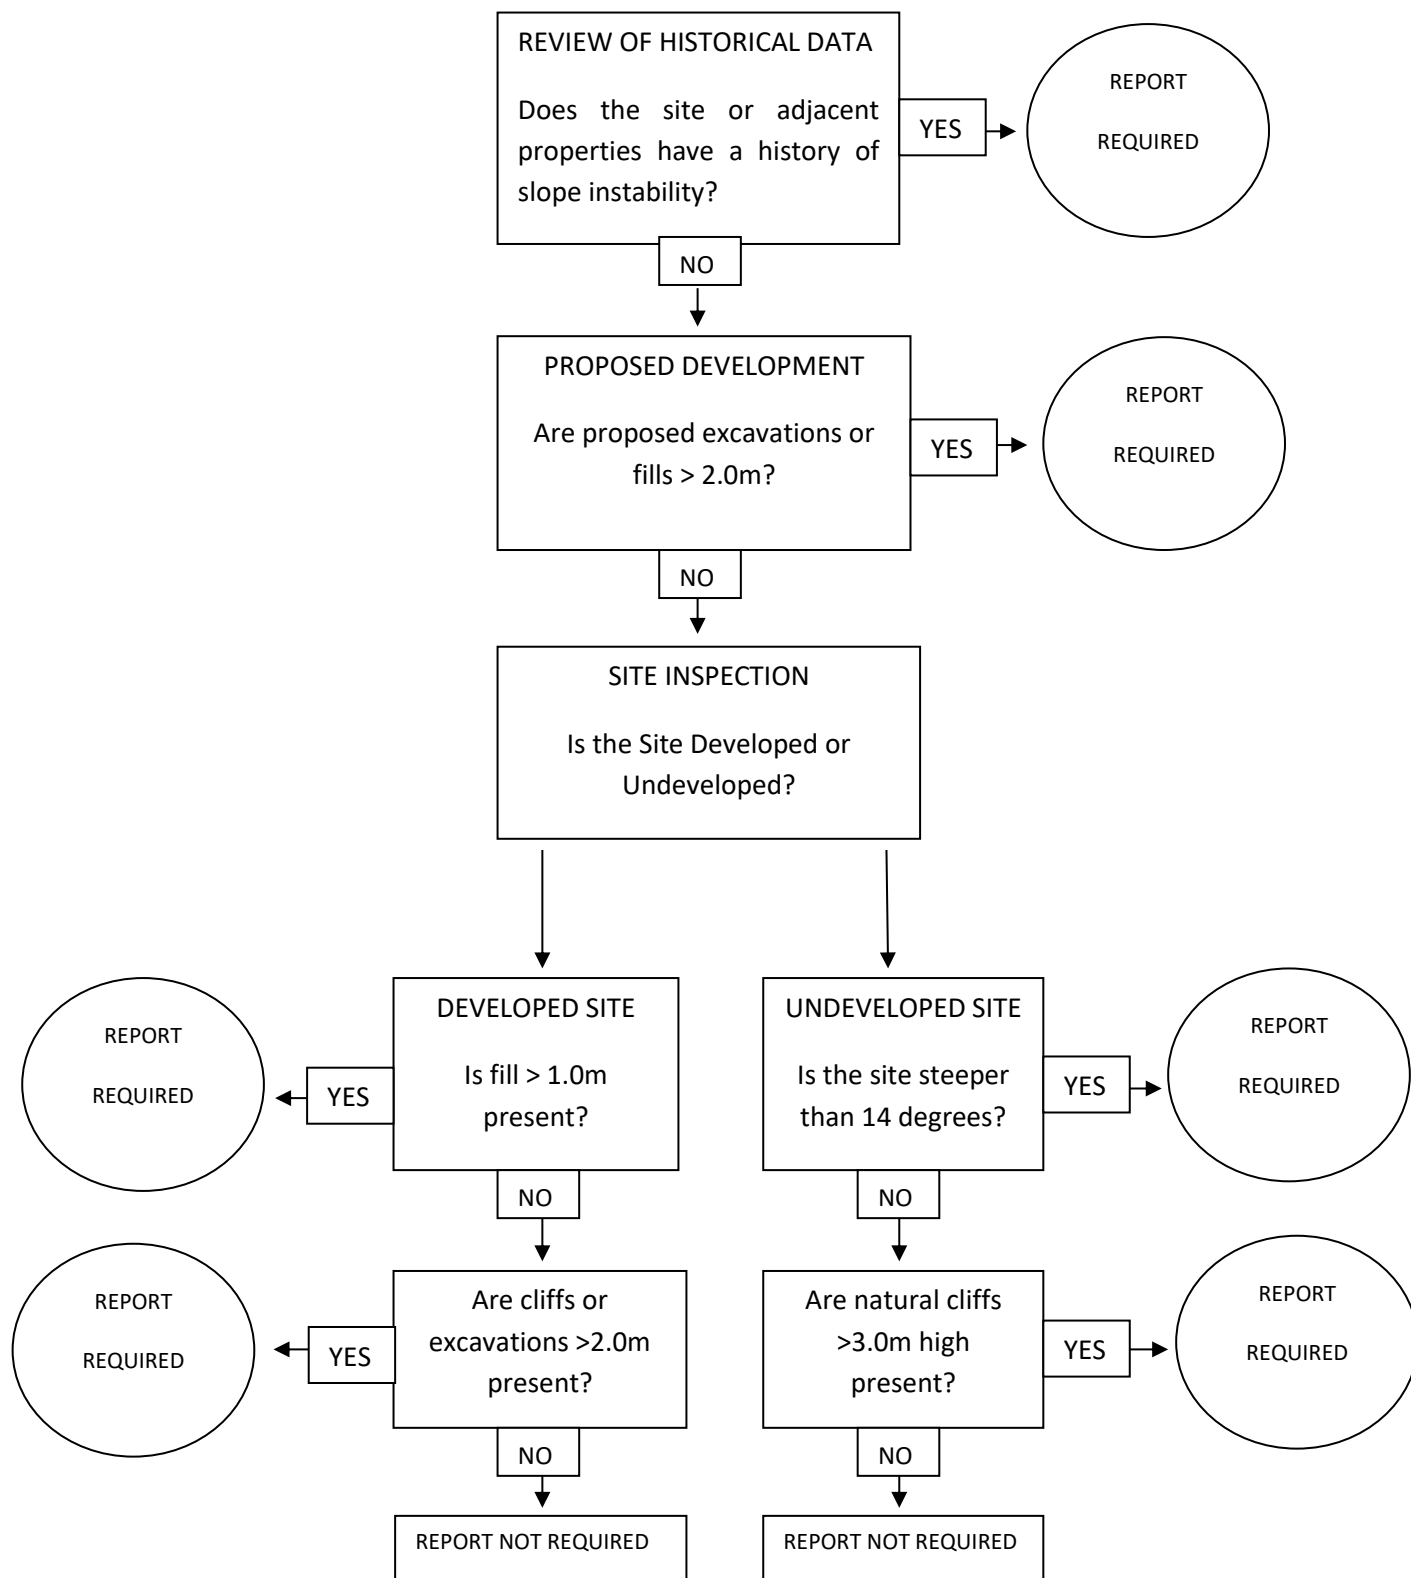
## Preliminary Assessment Flow Chart – Northern Beaches Council (Warringah)

The proposed development and site conditions were considered and applied to the Council Flow Chart.
