## Preliminary Geotechnical Assessment

**Project:** Alterations & Additions  
46A Keldie Street, Forestville NSW

**Ref:** AG 22509  
28 November 2022

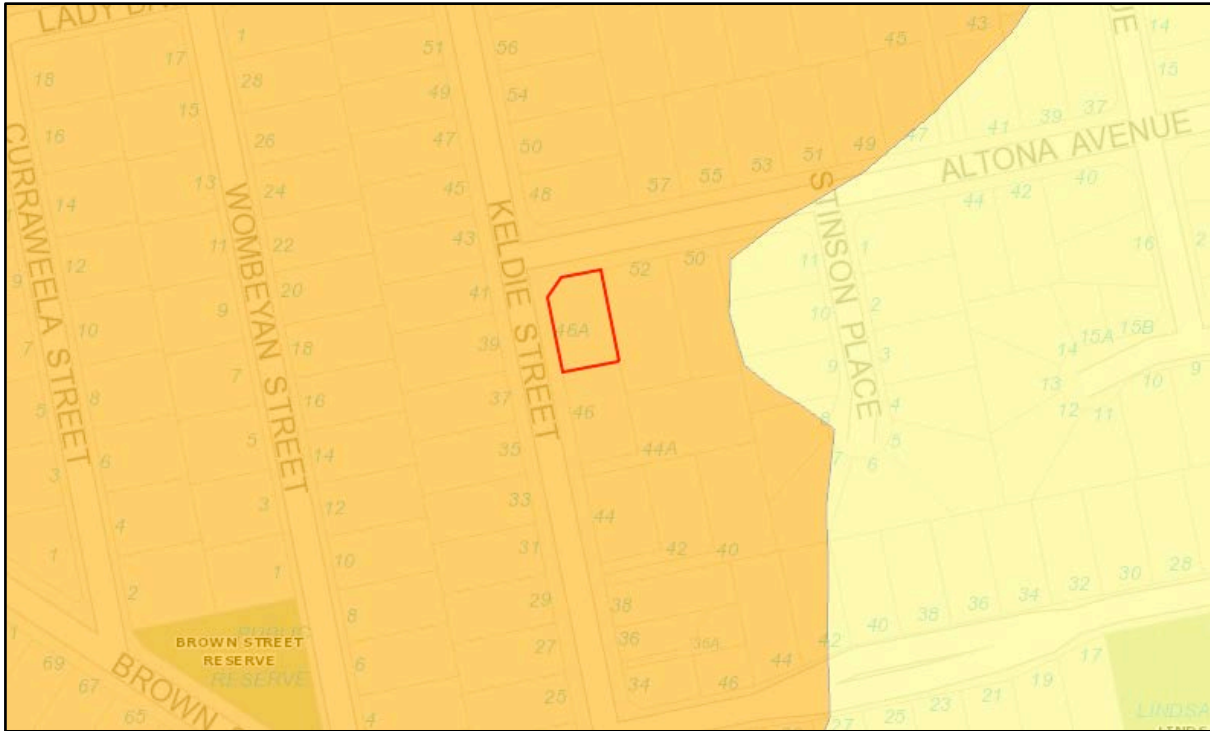
**Image 1.** Warringah Landslip Risk Map:  
46A Keldie Street, Forestville NSW (© NBC Maps)

The site is mapped as **Area B** subject to specific landslip risk/geotechnical hazard mapping with reference to the Warringah (WLEP) Landslip Risk Map, Northern Beaches Council (**Image 1**).
