RAFZAN
Consulting Engineers

BOREHOLE & LABORATORY TEST REPORT

LOT 5 NO.51 AMOURIN STREET NORTH SYDNEY

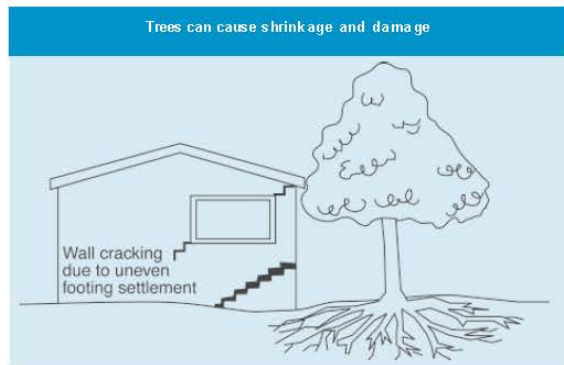
As the moisture absorption process completes its journey to the innermost areas of the building, the internal footings will rise. If the spread of moisture is roughly even, it may be that the symptoms will temporarily disappear, but it is more likely that swelling will be uneven, creating a difference rather than a disappearance in symptoms. In buildings with timber flooring supported by bearers and joists, the isolated piers will rise more easily than the strip footings or piers under walls, creating noticeable doming of flooring.

As the weather pattern changes and the soil begins to dry out, the external footings will be first affected, beginning with the locations where the sun's effect is strongest. This has the effect of lowering the external footings. The doming is accentuated and cracking reduces or disappears where it occurred because of dishing, but other cracks open up. The roof lines may become convex.

The first noticeable symptom may be that the floor appears slightly dished. This is often accompanied by some doors binding on the floor or the door head, together with some cracking of cornice mitres. In buildings with timber flooring supported by bearers and joists, the floor can be bouncy. Externally there may be visible dishing of the hip or ridge lines.
