Our ref: 7757-R1
28 February 2025

Residential Development, 1A Coonawarra Road, Terrey Hills NSW

Geotechnical investigation

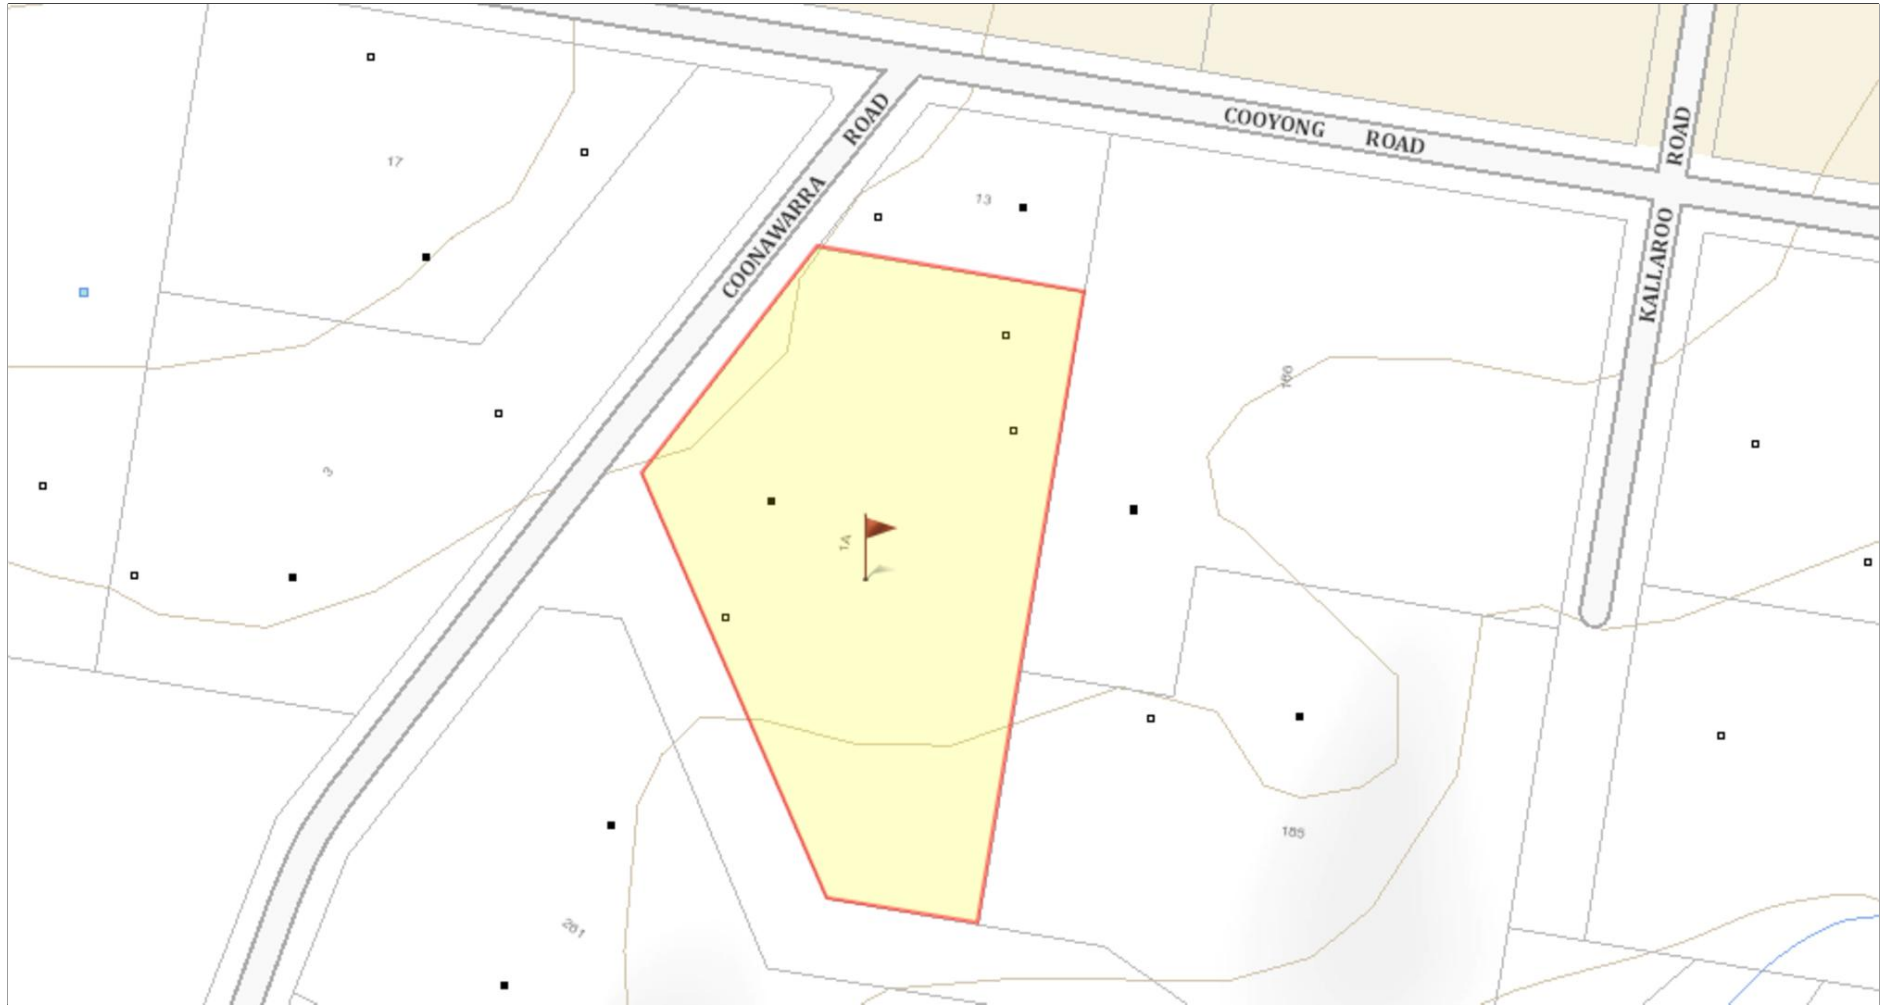
job no.:
 7757
fig:
 1
issue:
 A

APPROXIMATE ONLY
SOURCE: SIXMAPS

The Site is located at 1A Coonawarra Road, as shown in Figure 1. It has a street frontage of about 75m wide and is about 150m deep. The Site is bounded to the west by Coonawarra Road and to the north, east and south by 4 neighbouring developments.

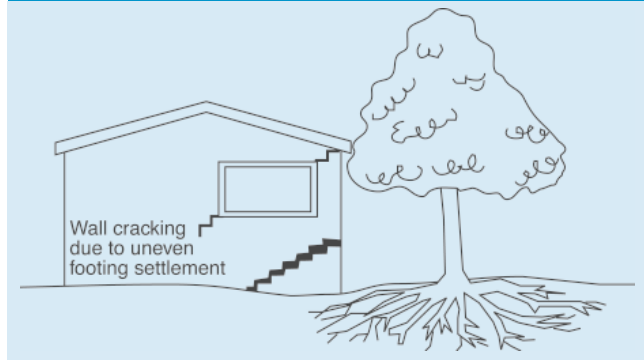
Trees can cause shrinkage and damage

As the weather pattern changes and the soil begins to dry out, the external footings will be first affected, beginning with the locations where the sun's effect is strongest. This has the effect of lowering the external footings. The doming is accentuated and cracking reduces or disappears where it occurred because of dishing, but other cracks open up. The roof lines may become convex.
