NASTASI & ASSOCIATES
Consulting Engineers

AS2870-2011 SITE CLASSIFICATION

Montgomery Homes

**Lot 10 No 20 Marmora Street,
Freshwater. New South Wales**

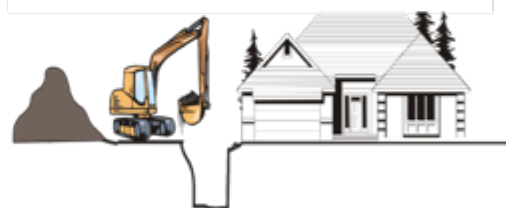
Fig. 11 De-stabilizing house foundations

- Ensuring that excavations are well supported or are dug to avoid collapses. (Fig. 11)
- Constructing well-compacted and retained 'soil aprons' around the building to stop erosion.

- Special considerations if any excavations are to be dug near adjoining structures. (Fig. 11)
- Sloping the soil and paths away from the building by the minimum amount required by the building regulations to prevent water flowing towards the building foundations. (Fig. 10 & 18)

- Running machinery over shallow drain pipes may break them causing leaks and subsequent foundation movements.
- Any excavations close to building footings can cause them to sink by disturbing the foundation material or by drying the foundation clay. (Fig 11)

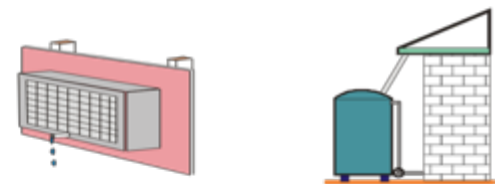
Fig. 16 Air con, up to 35 L/day loss

Fig. 17 Leaky pipe:
