## **Geotechnical Assessment**

**Project:** Swimming Pool & Associated Works  
16 Wandeen Avenue, Clareville NSW

**Ref:** AG 22447  
17 October 2022

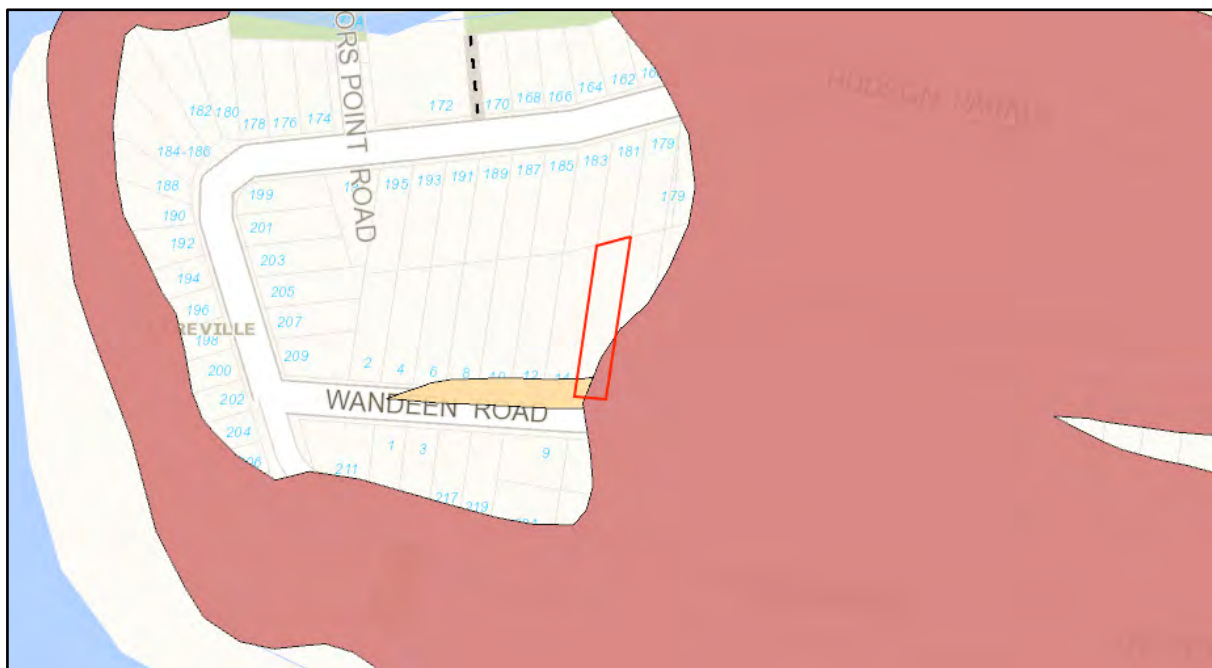
**Image 2.** PLEP Geotechnical Hazard Map  
– 16 Wandeen Avenue, Clareville NSW (NBC Maps)

- No evidence of significant soil creep, tension cracks or landslip instability were identified across the site or on adjacent properties as viewed from the subject site at the time of our inspection.
- Damage to retaining structures on site can be attributed to inadequate design and construction, rather than slope instability more generally.
- Based on reference to the plan entitled "Geotechnical Hazard Mapping" (Ref. P21DCP-BC-MDCP2002, dated 2007) prepared by GHD LONGMAC on behalf of Pittwater Council, the site is mapped as a **Geotechnical Hazard H1** zone.

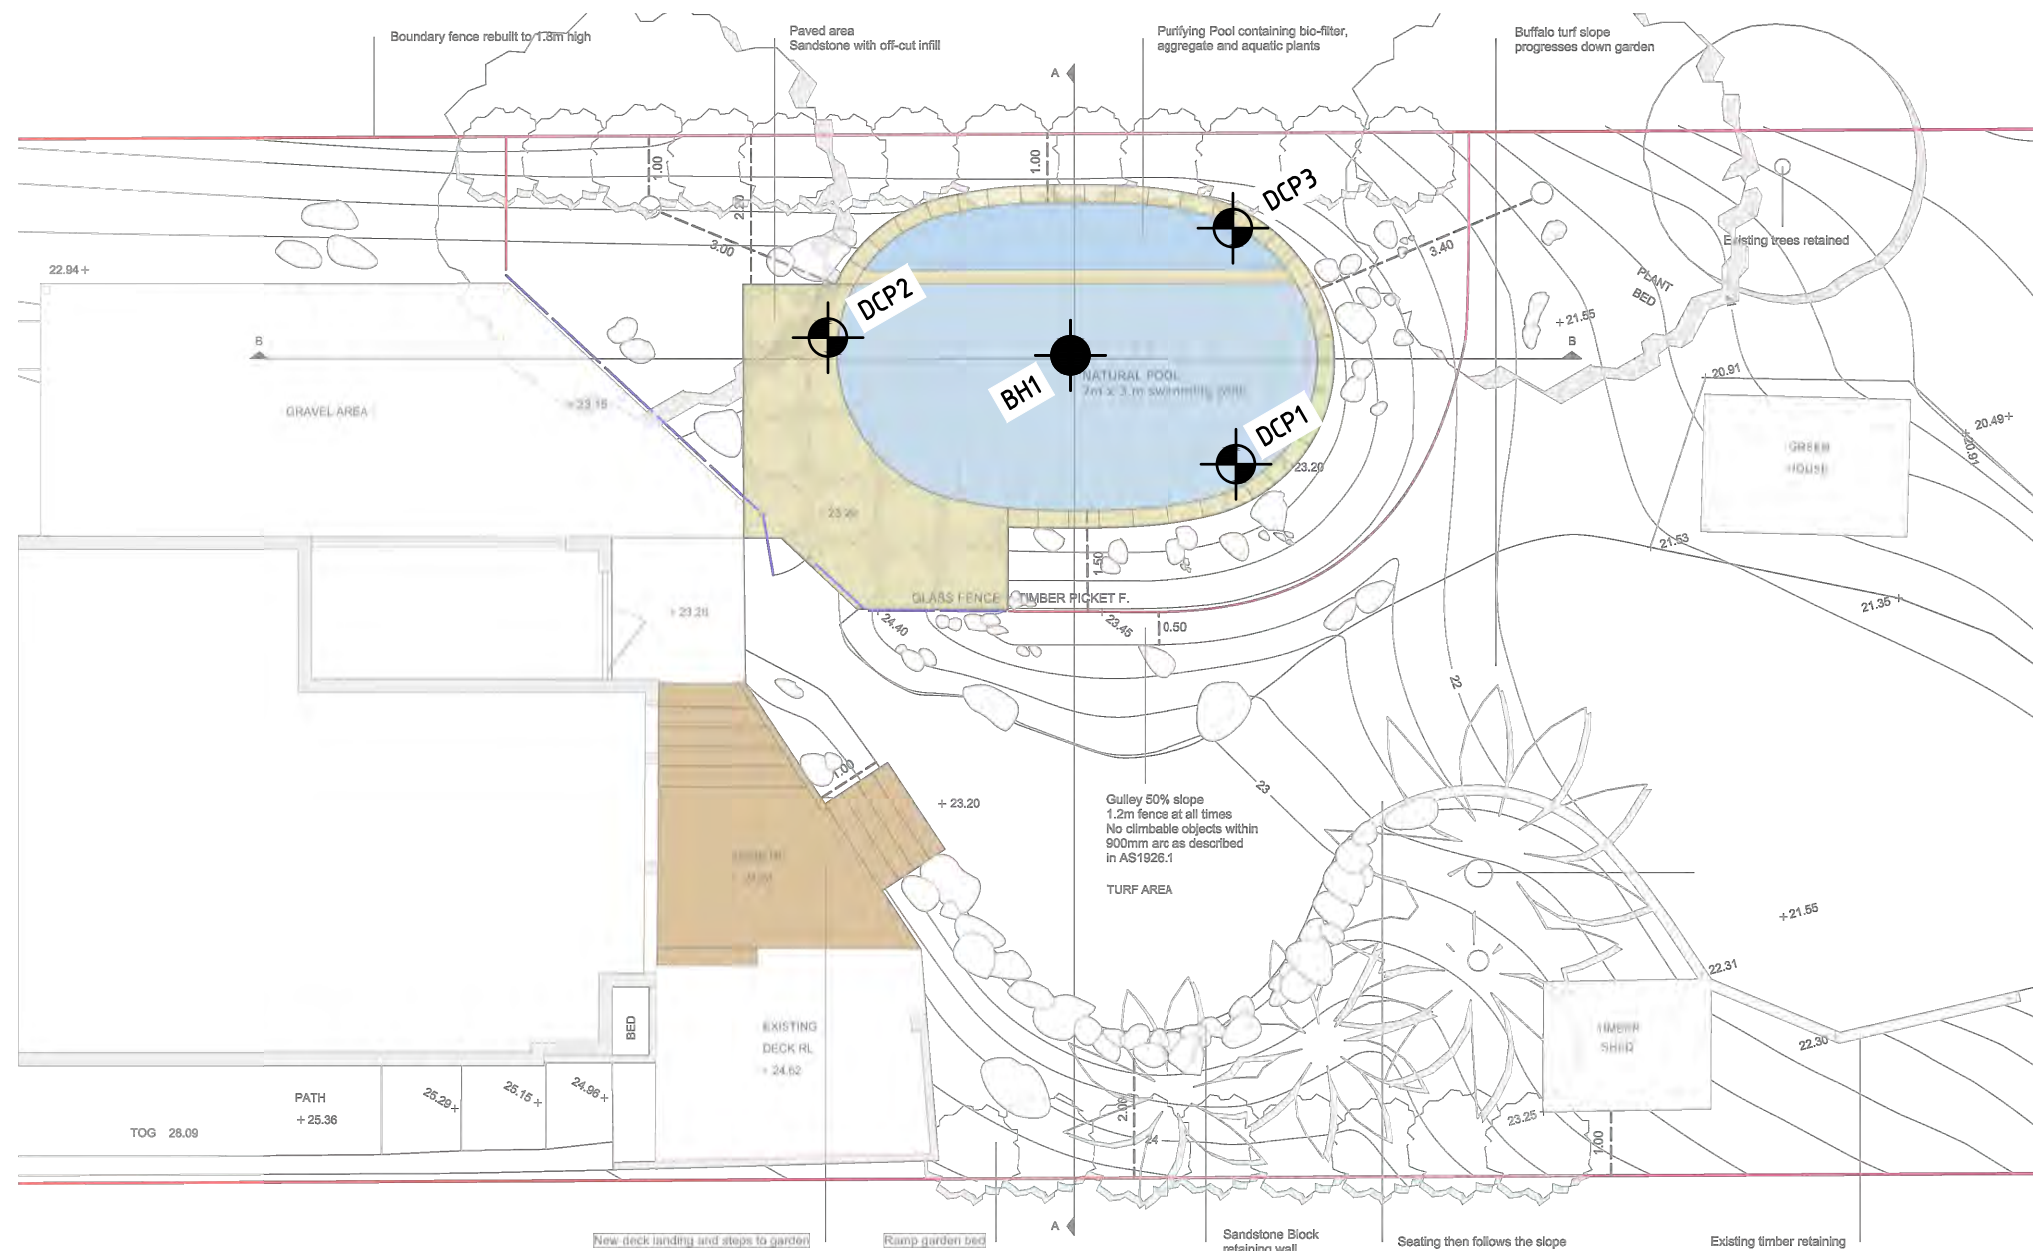
## SITE PLAN/GROUND TEST LOCATIONS

## DCP LOCATIONS

BOREHOLE LOCATION

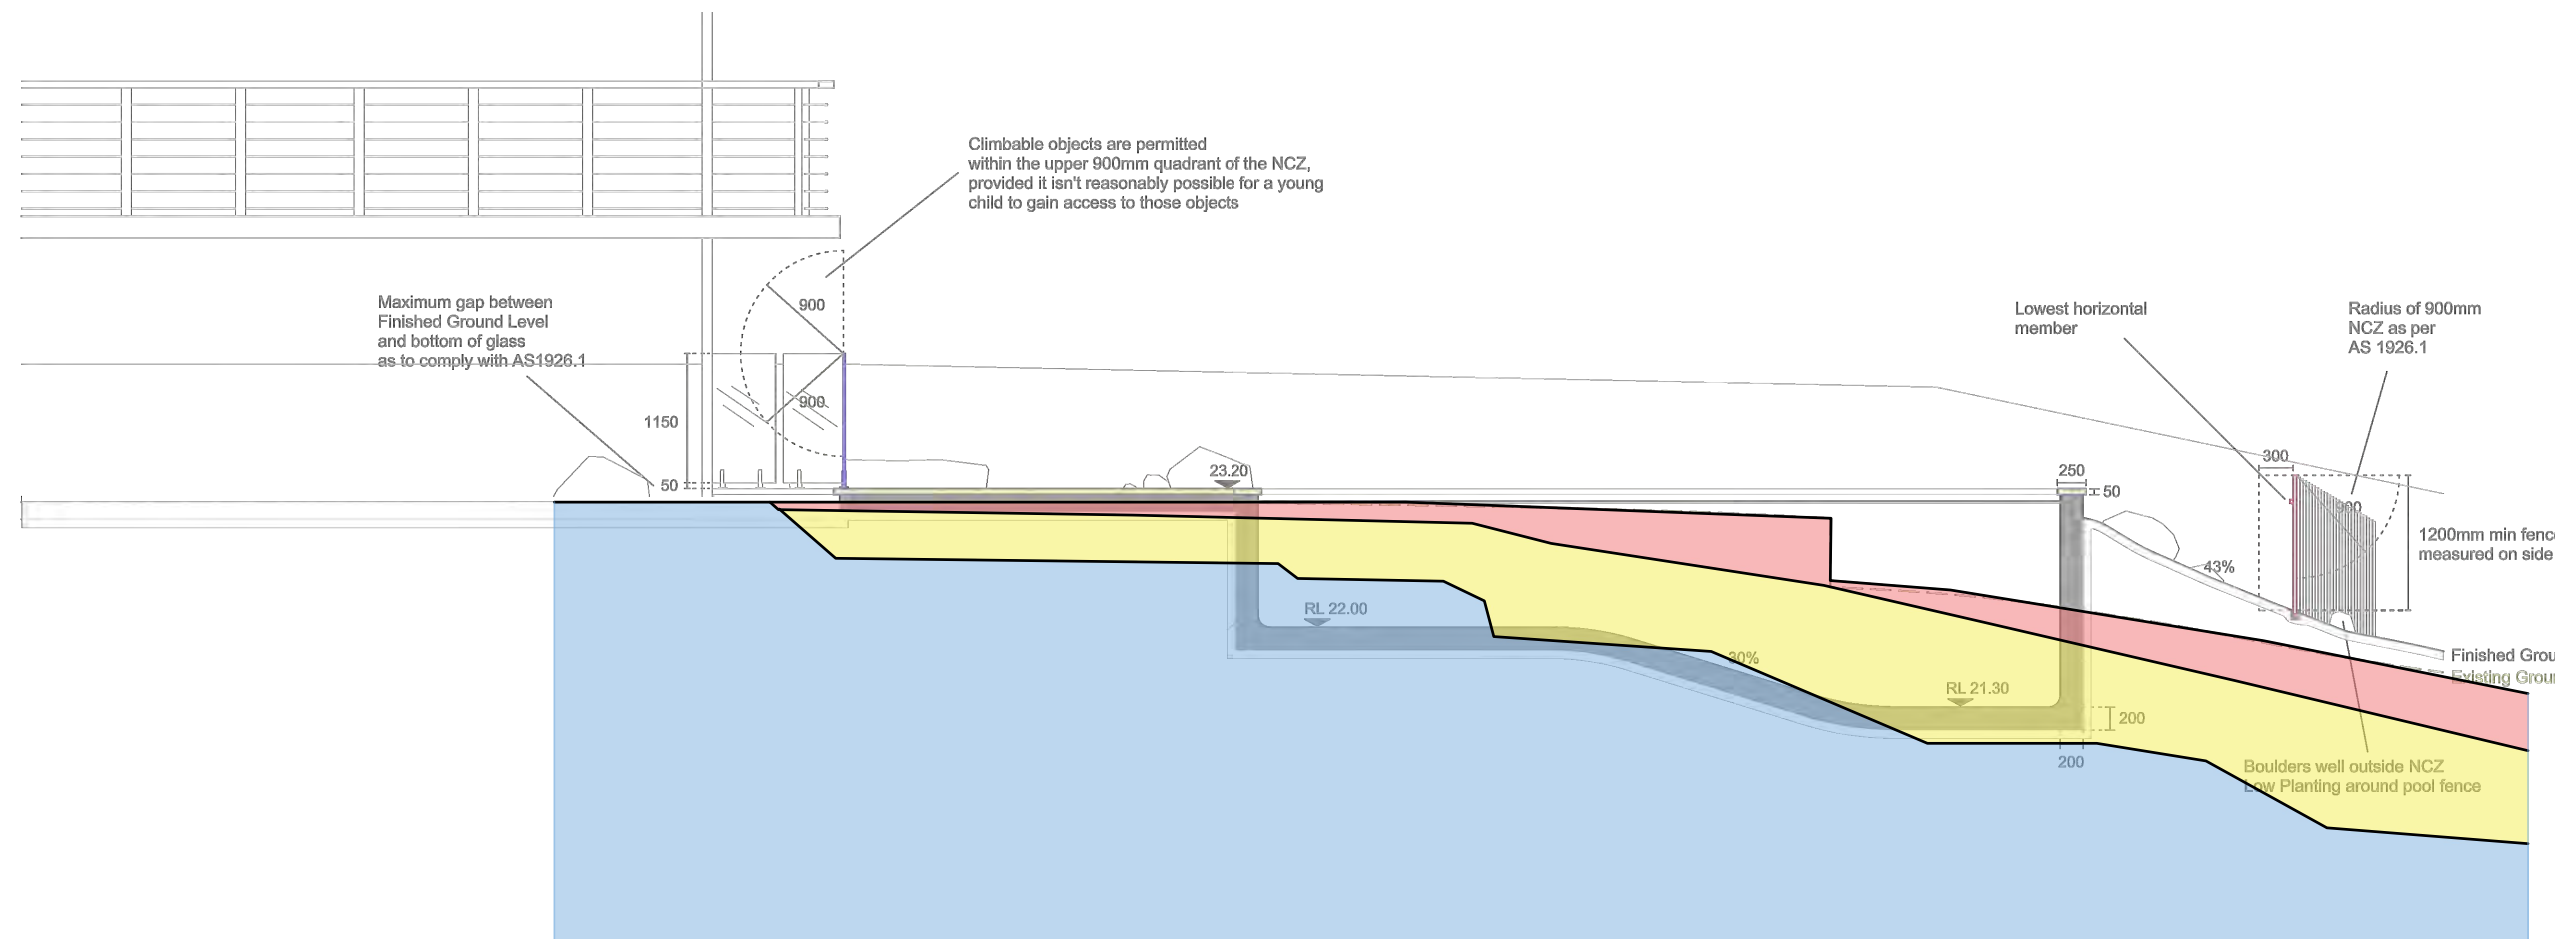
**INFERRED GEOLOGICAL SECTION**  
SCALE NTS

INTERPRETED SUBSURFACE SECTION ONLY.  
ACTUAL GROUND CONDITIONS MAY VARY.

- UNCONTROLLED FILL / SILTY CLAY TOPSOIL
- SILTY CLAY
- NEWPORT FORMATION BEDROCK

The soil profile consists of shallow uncontrolled silty fill and silty topsoil (O & A Horizons), silty clay (B Horizon) and weathered low strength bedrock (C Horizon). Detached sandstone floaters are also possible on and within the soil profile on site. Based on our observations and the results of testing on site, we would expect weathered low strength bedrock to be found within 0.60 to 2.20 metres below current surface levels across the area of the proposed works, and potentially deeper where filling has been carried out.
